02/28/84 Scandinavian Airlines System

Official Accident Report Index Page

Report Number	NTSB/AAR-84/15
Access Number	PB84-910415
Report Title	Scandinavian Airlines System Flight 901 McDonnell Douglas CD-10-30 Norwegian Registry LN-RKB John F. Kennedy International Airport Jamaica, New York, February 28, 1984
Report Date	November 15, 1984
Organization Name	National Transportation Safety Board Bureau of Accident Investigation Washington, D.C. 20594
WUN	3894-A
Sponsor Name	NATIONAL TRANSPORTATION SAFETY BOARD Washington, D. C. 20594
Report Type	Aircraft Accident Report February 28, 1984
Distribution Status	This document is available to the public through the National Technical Information Service Springfield, Virginia 22161
Report Class	UNCLASSIFIED
Pg Class	UNCLASSIFIED
Pages	85
Keywords	Landing accident, autothrottle speed control system, crew overreliance, crew procedures, wind shear.

Synopsis

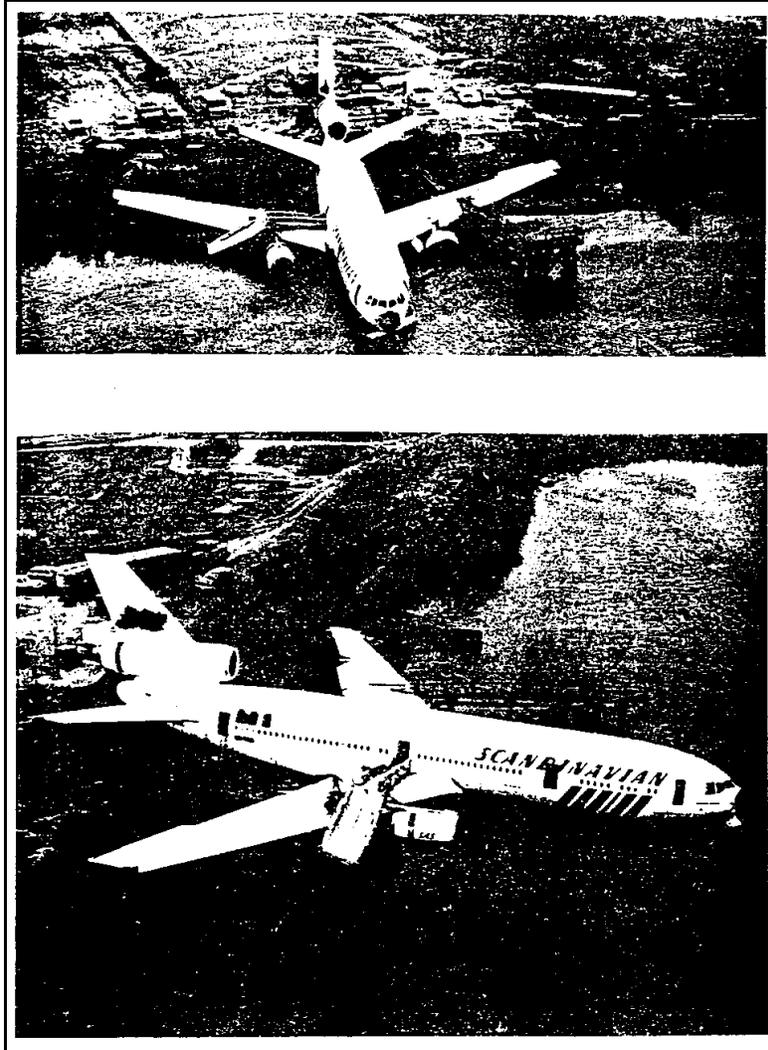
The forward section of the airplane fuselage came to rest in Thurston Basin, a tidal waterway about 600 ft (182.88 meters) from the runway 4R departure end. The airplane was damaged substantially. (See figure 2.) The captain immediately began to execute the memory items of the "On-Ground Emergency Check List." However, neither he nor the systems operator could move the engine fire selectors or fuel cutoff levers to their full off positions.

Figure 2.--Flight 901 gt rest in Thurston Basin.

The aft portion of the fuselage remained generally intact. There was major damage at the lower nose area, to the radome, and to the forward pressure bulkhead at fuselage station (FS) 275. The nose landing gear structure had collapsed under the fuselage. The drag braces were fractured and had separated from their attachment fittings. The interior of the forward fuselage area was deformed and exhibited fractures at the flight deck and galley floor locations. Several floor beams below the galley floor were fractured and twisted.
