National Transportation Safety Board

Safety Recommendation

Date: May 5, 1999

In reply refer to: A-99-32 through -34

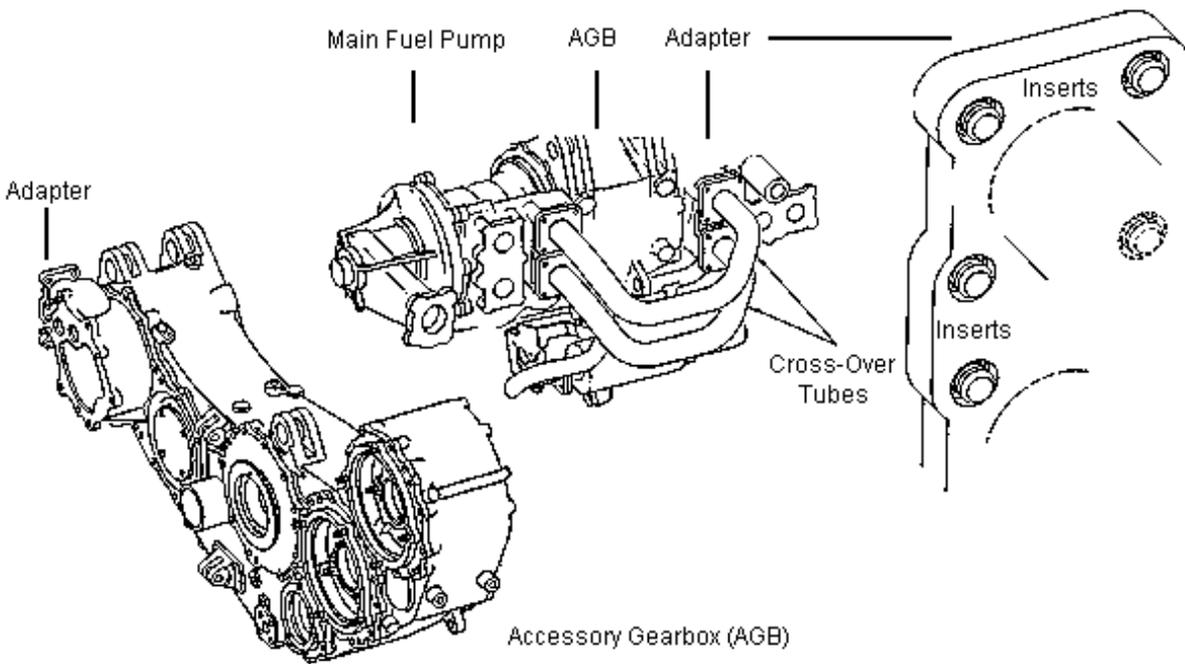
Figure 1. Accessory Gearbox Adapter Configuration and Insert Locations

Examination of the engine revealed that all the accessory gearbox (AGB) adapter attachment bolt inserts had backed out, allowing fuel lines (cross-over tubes) to unseat from the adapter (See figure 1). This allowed pressurized fuel to spray onto hot engine parts and ignite, resulting in the nacelle fire. Examination of the adapter revealed that it had been reworked per GEAE Service Bulletin (SB) 72-743, which called for the installation of new adapter inserts to permit a higher and more consistent bolt torque that would improve the clamping interface and eliminate fuel leaks from the adapter cross-over tube interface.

GEAE issued SB 72-743 on August 25, 1994, and AA approved the SB for incorporation in March 1995; however, AA discovered in September 1995 that the replacement insert specified in SB 72-743 was much smaller than the hole, allowing it to slide completely through. AA notified GEAE of the error and an alternate insert was authorized, but GEAE did not revise the SB. AA issued Supplement 1 to its SB 72-743 instructions to specify the new insert in October 1995. Meanwhile, the incident adapter had already been reworked to the original SB. Motoren- und Turbinen-Union (MTU) in Hannover, Germany, reworked the incident adapter on September 26, 1995, but installed inserts different than those specified in the SB. However, as with the inserts specified in the SB, the inserts from the incident adapter were also too small for the

adapter holes and were not the correct thread pitch. Consequently, the insert threads did not have the proper engagement with the housing and allowed fuel leakage. MTU did not notify GEAE or AA of any difficulties in complying with the SB or of its installation of alternate inserts not specified in the SB.

Although the Safety Board's investigation continues, it supports the corrective actions taken by GEAE and the Federal Aviation Administration (FAA) after the incident to address the cause of the engine fire. Specifically, GEAE has issued two all operators wires (AOWs) to inform all CF6-80C operators of the San Juan incident, the investigation's findings, and GEAE's and FAA's planned follow-on actions. These actions include suspension of SB 72-743; advance notification of Alert Service Bulletin (ASB) 73-A283³ and SB 73-284; and advance notification of the FAA's plan to issue an airworthiness directive (AD). On January 6, 1999, the FAA issued AD 99-01-01 to require compliance with GEAE SB 73-284.

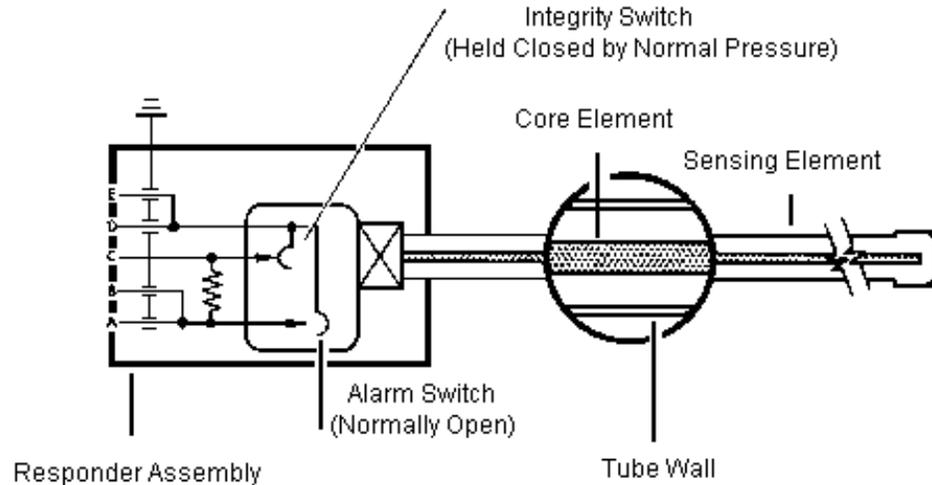
Figure 2. Internal Components of the Engine Fire Detection Loop Assembly

Application of heat to the fire loop causes an increase in internal gas pressure, which acts on a pressure diaphragm inside the responder assembly. If the gas pressure within the loop increases sufficiently, the alarm switch is closed (See figure 2), and a fire signal is sent to the FDC unit. A pressure drop inside the loop because of a gas leak causes the integrity switch to open, sending a fault signal to the FDC unit. A loss of electrical continuity from the responder will also send a fault signal.

Examination of the fire detection system from the incident airplane revealed extensive fire damage to the No. 1 engine's core wiring harness (loop B),⁶ which would have caused the loss of responder signal to the FDC unit. Because both loops were selected ON in the cockpit, the FDC unit would have interpreted the signal loss as a loop fault and consequently disengaged the fire warning and activated the loop fault warning in the cockpit.

Issue an airworthiness directive to require that all operators of Airbus A300-600 and A310 airplanes modify the engine and auxiliary power unit (APU) fire detection systems to automatically arm the remaining loop for fire detection in the event of a single loop fault in the engines or APU. (A-99-32)
