AIRCRAFT ACCIDENT REPORT

RUNWAY OVERRUN DURING LANDING
AMERICAN AIRLINES FLIGHT 1420
MCDONNELL DOUGLAS MD-82, N215AA
LITTLE ROCK, ARKANSAS
JUNE 1, 1999

**NTSB/AAR-01/02
PB2001-910402
Notation 7195A
Adopted October 23, 2001**

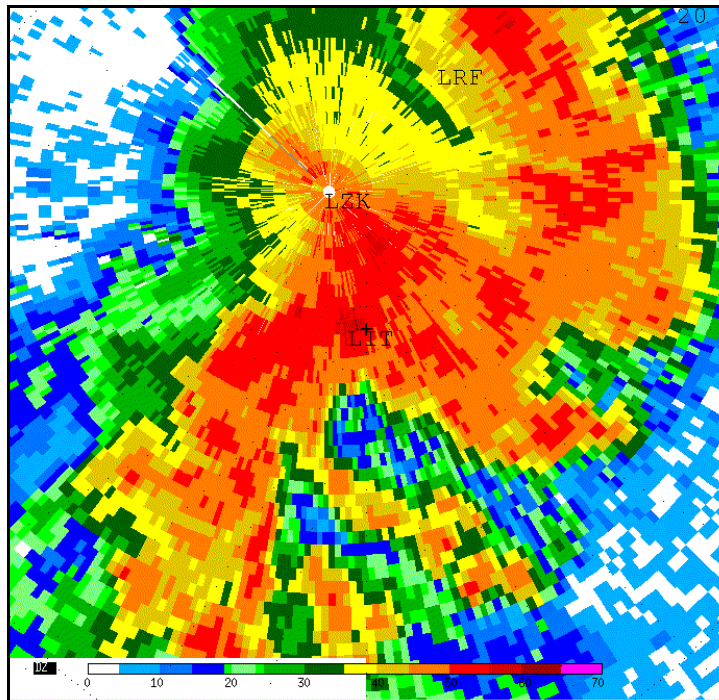
Figure 10. 0.4° Base Reflectivity Scan at 2351:59

At 2351:59, the 0.4° base reflectivity image depicted a maximum of 52 dBz, or level 5 (intense) activity, along the flight track, with maximum reflectivities of 60 dBz, or level 6 (extreme) activity, located 1 1/2 miles to the northwest. Figure 10 shows the base reflectivity product for this time period. Also, the 1.5° elevation scan at 2353:03 indicated returns of 58 dBz, or level 6 activity, with maximum reflectivities of 62.5 dBz 1/2 mile from the approach end of runway 4R.

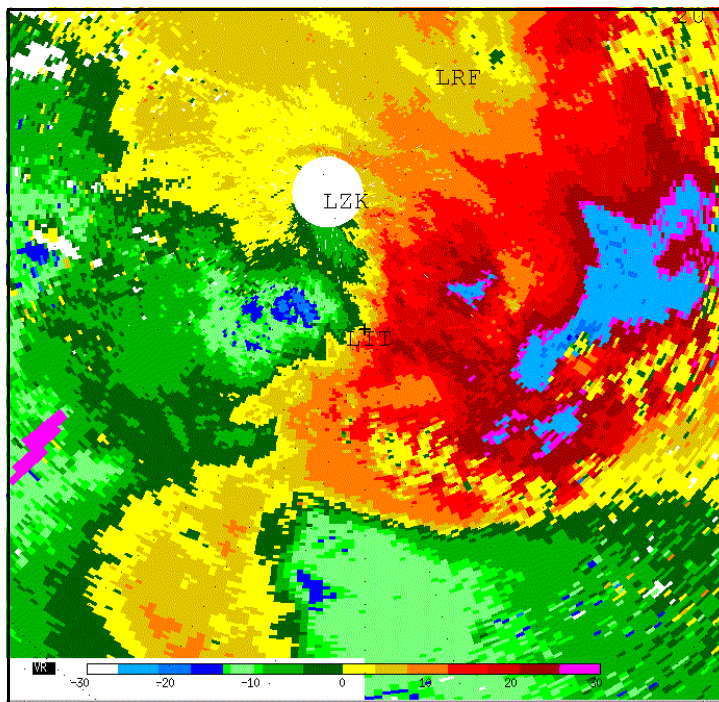
Figure 11. Radial Velocity Image Surrounding the Time of the Accident

The WSR-88D's radial velocity image (showing components of the wind speed that are coming directly toward or away from the radar) for 2346:29 indicated that winds from the northwest at 15 meters per second (30 knots) were over runway 4R. Figure 11 shows the radial velocity image for this time period with the airplane's flight track. At 2352:30, the radial velocity image depicted winds from the northwest at 18 meters per second (36 knots) over the runway with winds reaching 30 meters per second (60 knots) within 1/2 mile of the approach end of the runway.

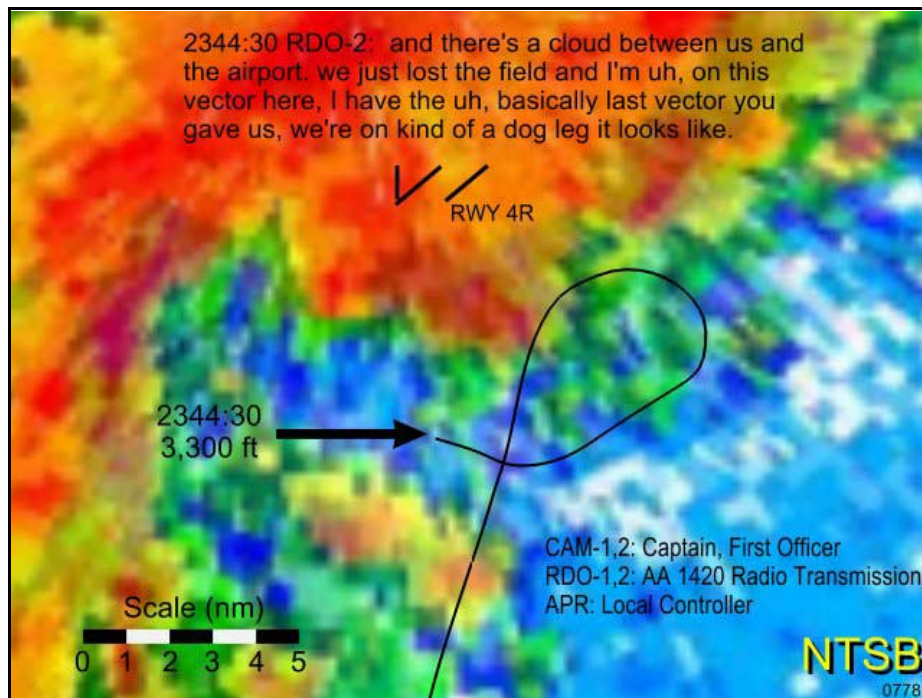
Figure 21. Weather and Flight Information for 2344:30

At 2344:19, the captain stated, "see we're losing it. I don't think we can maintain visual." The first officer notified the controller at 2344:30 that visual contact with the airport had been lost because of a cloud between the airplane and the airport. The controller then cleared the airplane to fly a heading of 220° for radar vectors for the ILS approach to runway 4R. (ATC radar indicated that, at this time, flight 1420 was about 6 miles south of runway 4R, heading westbound and away from the runway. Weather radar data indicated that heavy rain was occurring at the airport at the time that the airplane was flying on the 220° heading.) Figure 21 shows a map of the weather conditions at 2344:30 and flight 1420's location.

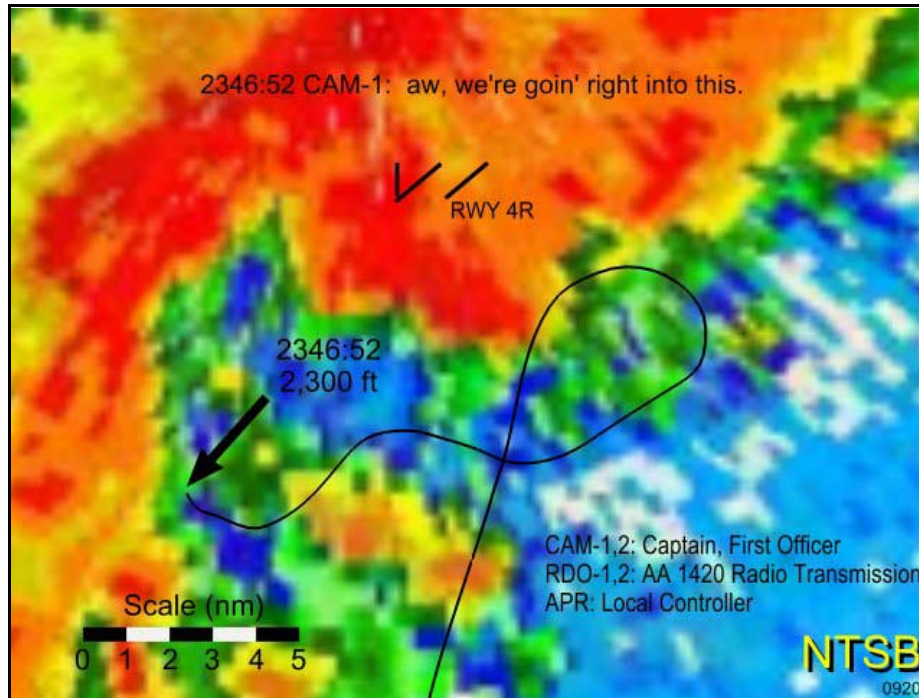
Figure 23. Weather and Flight Information for 2346:52

At 2346:52, the controller advised the flight crew that heavy rain was falling at the airport, visibility was less than 1 mile, ATIS information Romeo was no longer current, and the runway visual range (RVR) was 3,000 feet. Simultaneously, the captain

stated, “aw, we’re goin’ right into this.” Figure 23 shows a map of the weather conditions at 2346:52 and flight 1420’s location. About this point in the approach, the flight crew should have regained the use of the airborne weather radar to depict precipitation levels in front of the airplane. However, the Safety Board could not determine whether the radar was displaying this information or whether the flight crewmembers, given their workload, were able to perceive and interpret the information that the radar was providing.

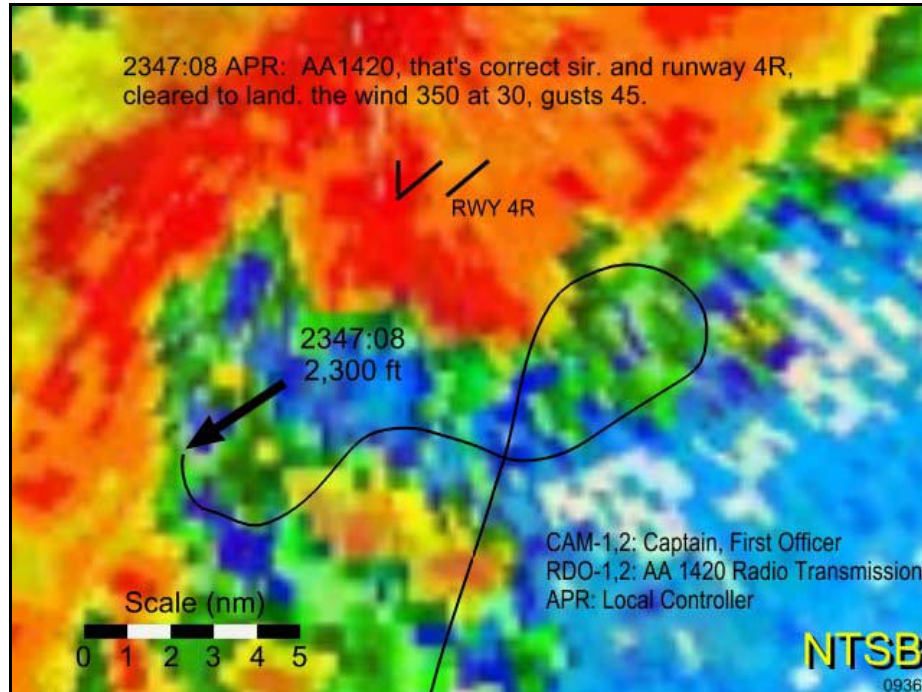
Figure 24. Weather and Flight Information for 2347:08

At 2347:08, the controller cleared flight 1420 to land and stated that the wind was 350° at 30 knots gusting to 45 knots. The CVR indicated that flight crew did not discuss the wind information, the heavy rain that was already falling at the airport, or the depiction of the weather on the airborne weather radar. Figure 24 shows a map of the weather conditions at 2347:08 and flight 1420’s location.

Statements from the CVR and the first officer’s postaccident interviews indicated the flight crew’s concern about the location of the thunderstorm in relation to the airport and the airplane. However, the Safety Board concludes that, because the first officer was able to maintain visual contact with the runway as the airplane was vectored for the final approach course, both flight crewmembers might still have believed that flight 1420 could arrive at the airport before the thunderstorm. The Board understands that some other flight crews might continue an approach to a runway under the same circumstances. On the other hand, the Board also recognizes that the approaching storm and the reports of heavy rain, dropping visibility, and increasing crosswinds (from 10 to 30 knots with

gusts to 45 knots) would be sufficient for some flight crews to hold until the storm passed or proceed to an alternate airport.

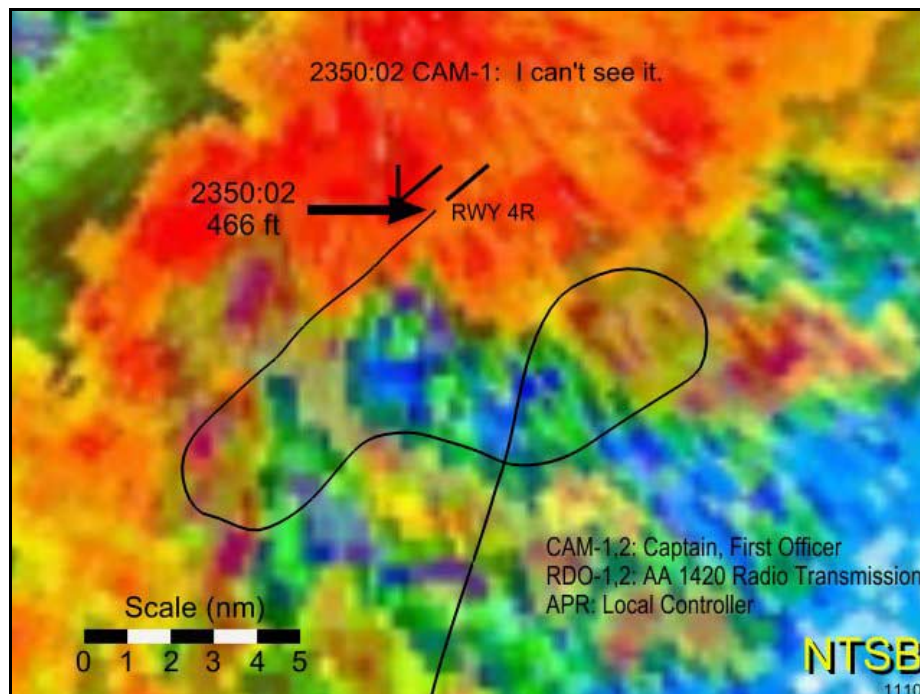
Figure 26. Weather and Flight Information for 2350:02

At 2350:02, the captain stated, "I can't see it." Calculations based on FDR data indicated that the airplane was between 5 and 20 feet above the decision height at that time. The Safety Board was not able to determine whether the captain's comment referred to his loss of visual contact with the runway or with its environment. Figure 26 shows a map of the weather conditions at 2350:02 and flight 1420's location.
