**Aircraft Accident Report**

**Loss of Control and Impact with Pacific  
Ocean Alaska Airlines Flight 261  
McDonnell Douglas MD-83, N963AS  
About 2.7 Miles North of  
Anacapa Island, California  
January 31, 2000**

**National  
Transportation  
Safety Board**  
Washington, D.C.

**NTSB/AAR-02/01  
PB2002-910402  
Notation 7263E  
Adopted December 30, 2002**

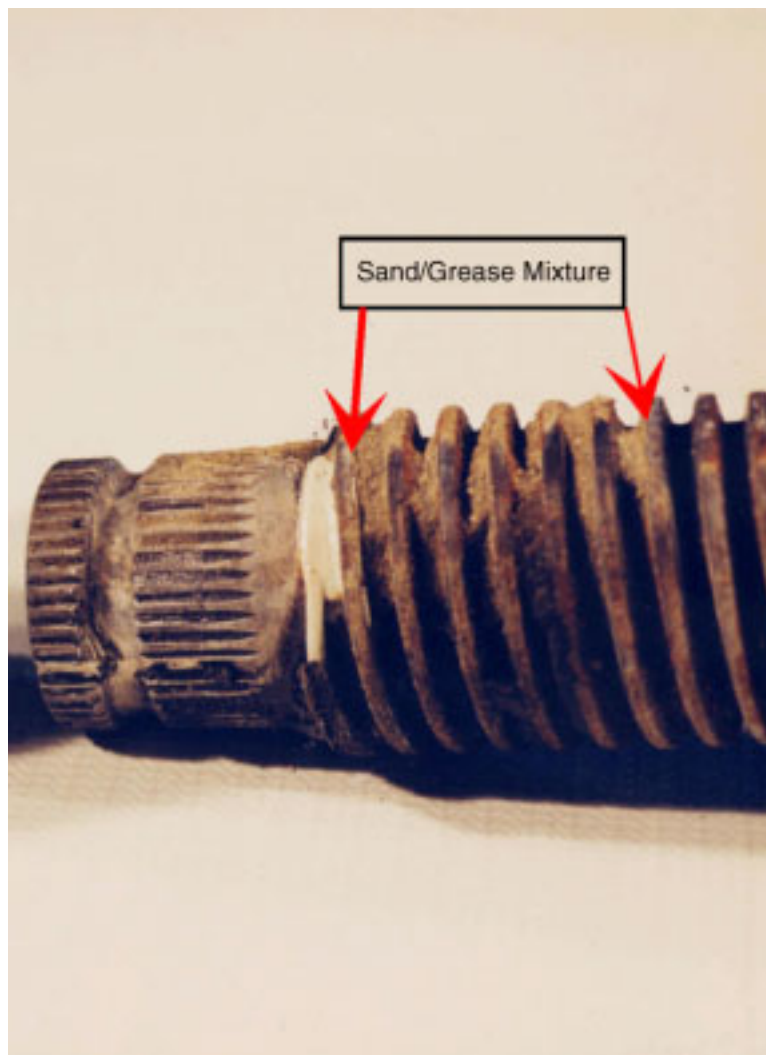
On-scene visual and tactile inspections by Safety Board metallurgists of the acme screw's threaded areas found no evidence of grease in any condition, either semi-fluid (that is, fresh) or solid/dry (that is, old or degraded), or other lubricants in the central "working region" of the screw threads.<sup>129</sup> Laboratory examinations found small flakes of dried and hardened grease attached to some of the thread remnants in this region. The acme screw's lower threads (which are outside of the working region) were found partially packed with a mixture consistent with sand and grease. (Figure 14 shows the sand/grease mixture packed between the acme screw's lower threads.) Parts of the acme screw's upper six to eight threads had an oily sheen, and small deposits of greaselike material were found between the threads.

**Figure 14.** A photograph of the sand/grease mixture packed between the acme screw's lower threads.

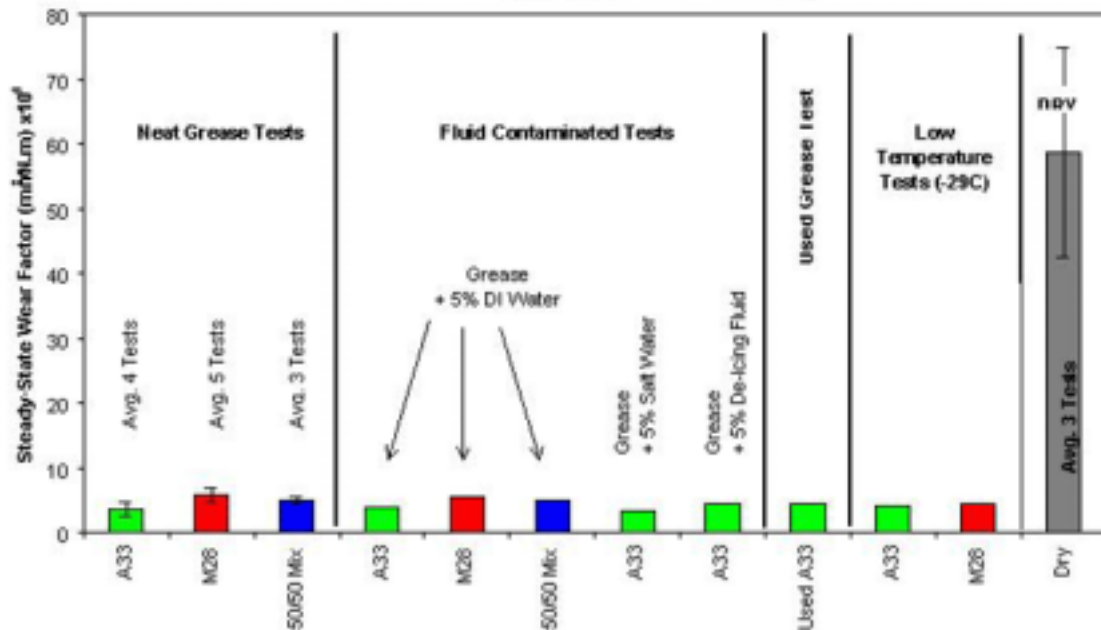
The results of the wear tests showed that, in all ranges of contact pressure, lower wear rates were generated when Aeroshell 33 was used than when Mobilgrease 28 was used. Additionally, the effects of contamination, aging, and subzero temperature exposure were determined to have little effect on the lubricating effectiveness of Aeroshell 33. Only the tests run without any lubrication generated wear rates significantly higher than those generated when Mobilgrease 28 was used. In these cases, wear rates were seen to transition up to 10 times higher than those with equivalent conditions lubricated with Mobilgrease 28. Figure 19 shows a summary of the results of the high-load wear tests, including the contamination and low-temperature tests.

**Figure 19.** A summary of the results of the high-load wear tests, including the contamination and low-temperature tests.

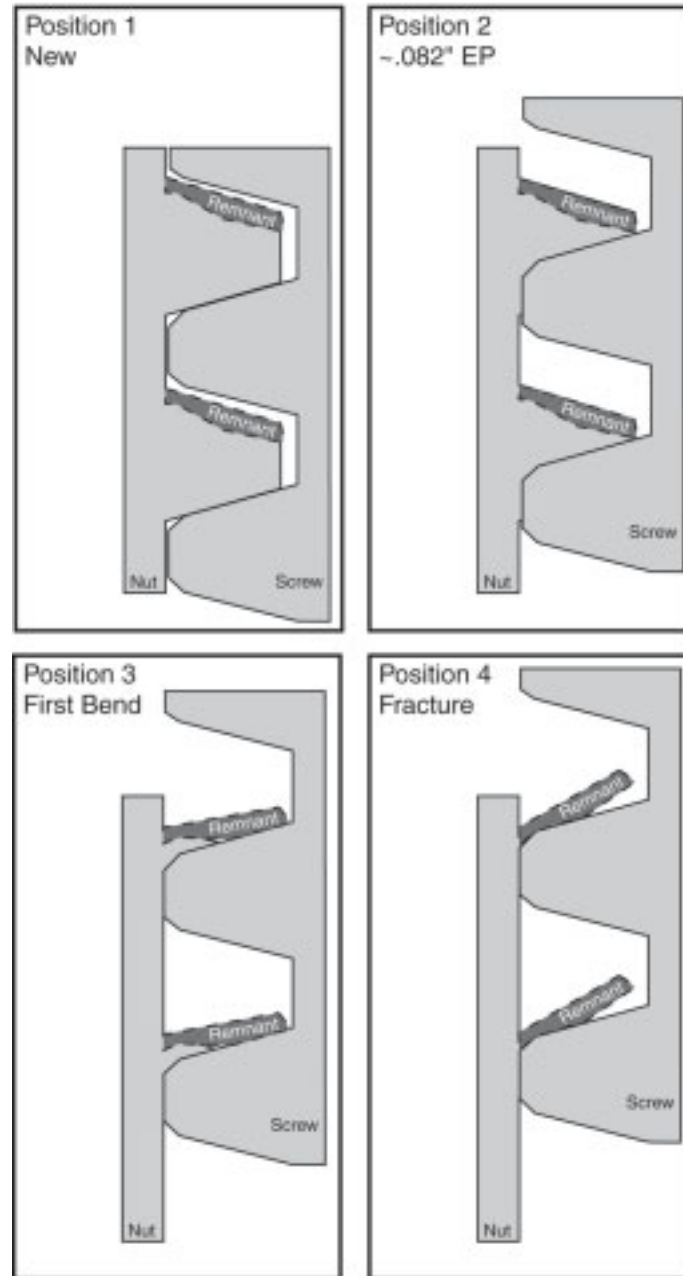
<sup>216</sup> It was theorized that, as the last of the acme nut thread remnants shear fractured and the screw threads tried to override the resulting ridges in the nut as the screw was pulled upward by aerodynamic loads and rotated circumferentially by the primary trim motor, the combined pinching and friction loads became greater than the combined aerodynamic and primary trim motor forces.

**Figure 20.** A graphical depiction of the stages of acme nut thread wear to the point of fracture.
