Runway Overrun During Landing
Shuttle America, Inc.
Doing Business as Delta Connection Flight 6448
Embraer ERJ-170, N862RW
Cleveland, Ohio
February 18, 2007

NTSB/AAR-08/01
PB2008-910401

Aircraft Accident Report

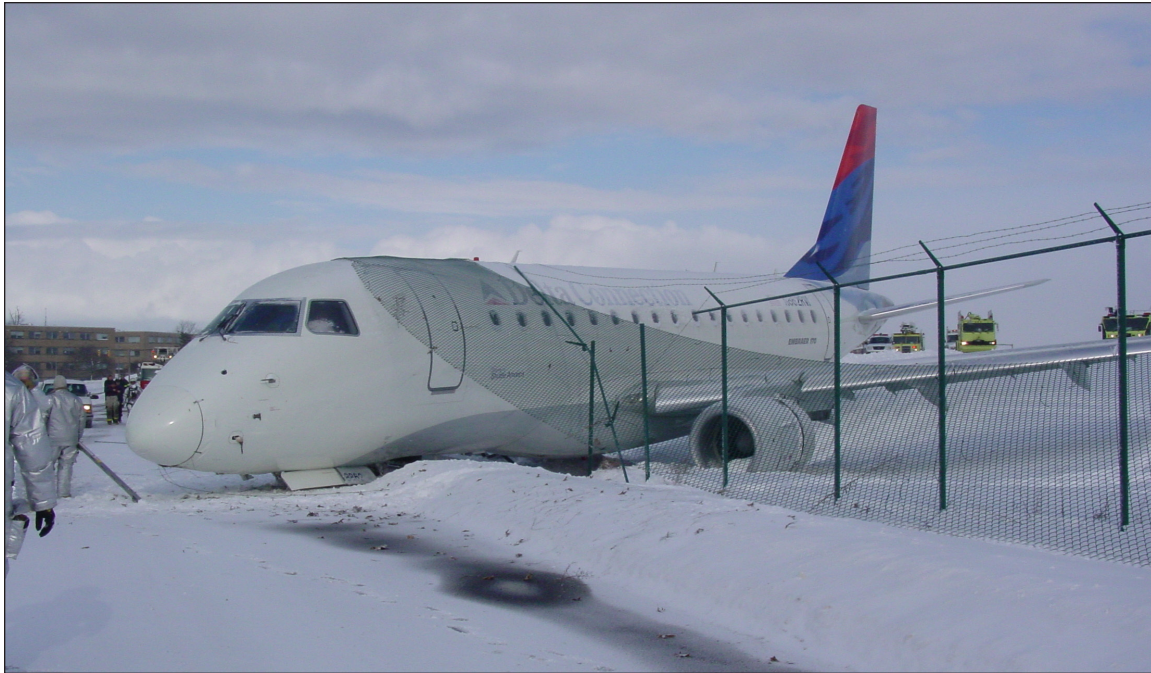
Figure 2. Airplane's Location Southwest of the Extended Runway 28 Centerline

The CVR recorded the sound of numerous impacts starting about 1505:50 and a sound similar to the airplane coming to a stop about 1505:57. The airplane came to rest on a snow-covered grass surface located southwest of the extended runway 28 centerline. Figure 1 shows the location of the airplane at the time of the captain’s go-around callout and as it passed the runway threshold. Figure 1a shows the pertinent events from the airplane’s touchdown to its overrun. Figure 2 shows the airplane in its final resting location.

The airplane's nose landing gear, right wing leading edge, right wing leading edge devices, and both engine nacelles received substantial damage from the impact forces.

An ILS antenna and the airport perimeter fence were damaged.

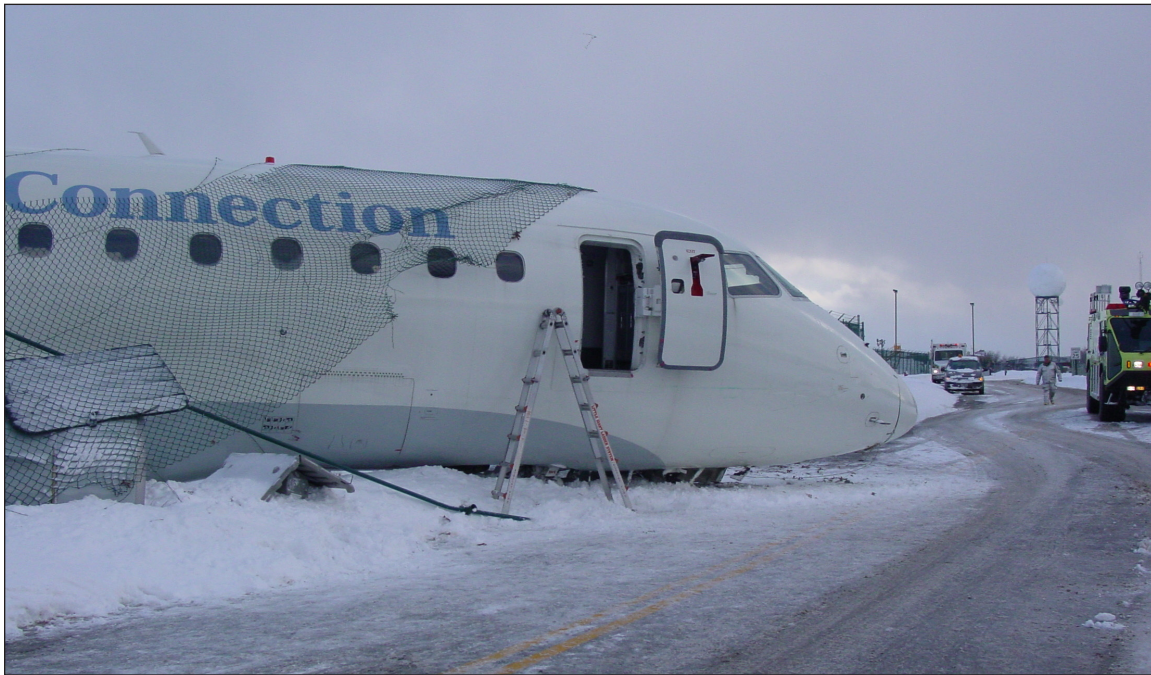
Figure 3. Accident Airplane and Ladder Used for Deplaning

The captain stated that he considered an evacuation but then decided to keep everyone on board until the buses arrived because no one was in imminent danger, ARFF had informed him that the airplane was secure (that is, no fuel leaks or sources of ignition were in the area), and it had been snowing heavily outside. According to the ARFF chief, the flight crew and ARFF personnel agreed that, after shuttle buses arrived on scene, the passengers would deplane and be transported to the ARFF station. The CLE operations log showed that the passengers began deplaning about 1555. ARFF personnel assisted the passengers down the station's A-frame ladder, shown in figure 3, at the right front door (1R) exit. The ARFF chief and a CLE operations supervisor indicated that the ladder was open to its A-frame configuration during the deplaning. The ARFF log showed that passenger deplaning was completed by 1630. The flight attendants and flight crew deplaned afterward using the ladder. They were then transported to the ARFF station in an airport vehicle.
