In-Flight Left Engine Fire American Airlines Flight 1400 McDonnell Douglas DC-9-82, N454AA St. Louis, Missouri September 28, 2007

Accident Report

NTSB/AAR-09/03 PB2009-910403

NTSB/AAR-09/03 PB2009-910403 Notation 8087 Adopted April 7, 2009

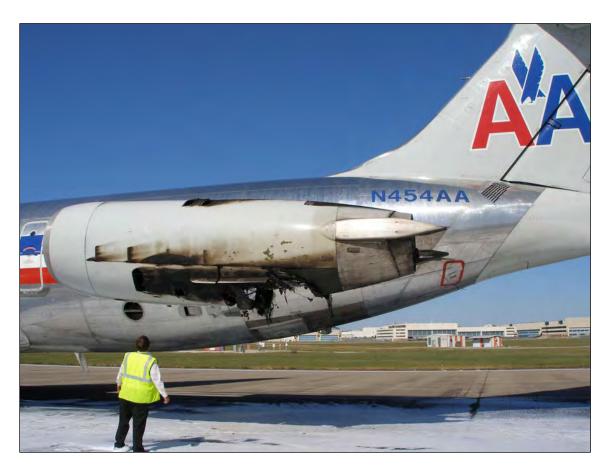
Figure 1. Photograph of the left side of the airplane after fire-extinguishing efforts were completed.

The airplane sustained substantial structural damage because of the fire.

The left engine nacelle cowling was destroyed by fire. The pylon skin and engine mounts and a small area of fuselage skin around the pylon intersection exhibited thermal damage. The external engine components, including the AGB, hydraulic pump, ATS, and ATSV, exhibited fire damage. The internal engine components were not damaged. No indications of case rupture or uncontainment were found. Multiple fluid leaks were found in the fuel and hydraulic lines. The segment of the ATSV wiring harness from the cockpit overhead panel to the left engine area was tested for continuity and short errors, and no fault was found.

³⁴ The airplane was returned to service after the accident after American Airlines removed and replaced the left engine, pylon, cowls, engine pylon apron, engine mounts, cone bolts, and inspected the structural area for fire damage in accordance with its maintenance procedures and structural repair manuals.

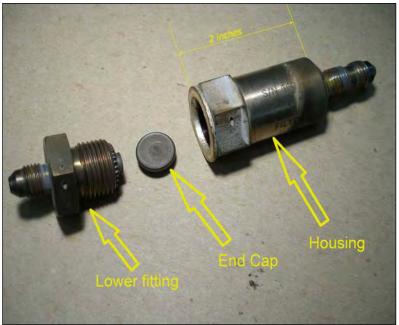
The recovered ATSV-air filter assembly components were removed and sent to the PTI facility, in Oxford, California, for teardown and examination under NTSB supervision. The filter element of the ATSV-air filter assembly was found fractured along a line from the lower air filter fitting to just above the fitting braze joint. About 70 percent of the filter element material was missing. The remaining material was found adhered to the inner wall of the housing and

appeared to be reddish-brown. Some mesh material was still attached to the end cap, and this mesh, as well as the cap edges appeared to be worn and rounded off.³² An incorrect housing was found installed on the assembly.³³ The end cap was found intact but separated from the filter element and in an inverted orientation, partially covering the air outlet within the ATSV-air filter housing.

The ATSV-air filter was then sent to the NTSB's Materials Laboratory in Washington, DC, for further examination. The filter element adjacent to the braze joints at the fitting and the end cap was separated through the filter mesh. Magnified optical examinations found severe

rubbing damage at the separations. The rubbing damage completely obliterated any fracture features at the separations and separation features on the portion of the mesh removed from the housing. The outer diameter edge of the end cap was rubbed and rounded. Comparisons of the accident end cap to exemplar end caps revealed that the accident cap was reduced in diameter by about 0.020 inches. The end cap's inner diameter was also rubbed and rounded, and a similar mating pattern was found on the inner diameter of the fitting.

Figure 5. Photograph of the damaged ATSV-air filter housing, end cap, and lower fitting.

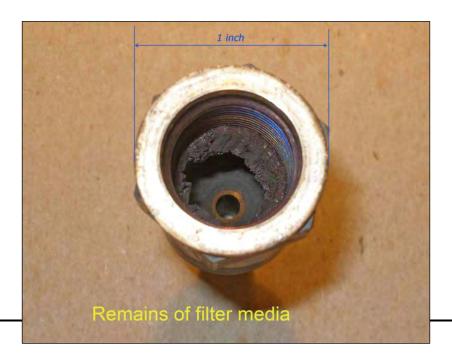
Figure 6. Photograph of the damaged ATSV-air filter housing and remaining filter material.

Investigators longitudinally sectioned the filter housing. The central region of the cylindrical interior surface was found burnished and polished smooth. The damage obliterated most of the original machined surface finish, which only remained in small bands at the upper and lower ends of the section. The damage to the interior of the housing, end cap, and filter mesh was consistent with vibratory motion of the filter mesh and end cap within the housing. The extent of the polishing of the housing was consistent with the downward progression of the end cap to the point of contact with the fitting end.

After the accident, American Airlines revised Maintenance Work Card 7751, (revision dated May 28, 2008), to add visual inspection criteria. The revised card calls for the inspection of the ATSV-air filter for breaks, tears, cracks, or other structural degradation. The card also stated that the key inspection points included the ends of the ATSV-air filter screen where it is brazed to the threaded fitting and where the end cap is attached. Further, the card stated that a slight waving of the pleats is acceptable but that frayed or broken wire strands are not.

As a result of this accident, an incident at Salt Lake City International Airport (SLC), Salt Lake City, Utah (discussed in section 1.18.1), and postaccident examinations of the accident and exemplar ATSV-air filter assemblies (discussed in sections 1.18.1.1 and 1.18.1.2), American Airlines issued Engineering Change Order K3338, requiring the replacement all of its MD-80 airplanes' ATSV-air filters, which was accomplished
