AIRCRAFT ACCIDENT REPORT

**North Central Airlines, Inc.
McDonnell Douglas DC-9-31, N954N
and**

**Delta Air Lines, Inc.
Convair CV-880, N8807E
O'Hare International Airport**

Report Number: NTSB-AAR-73-15

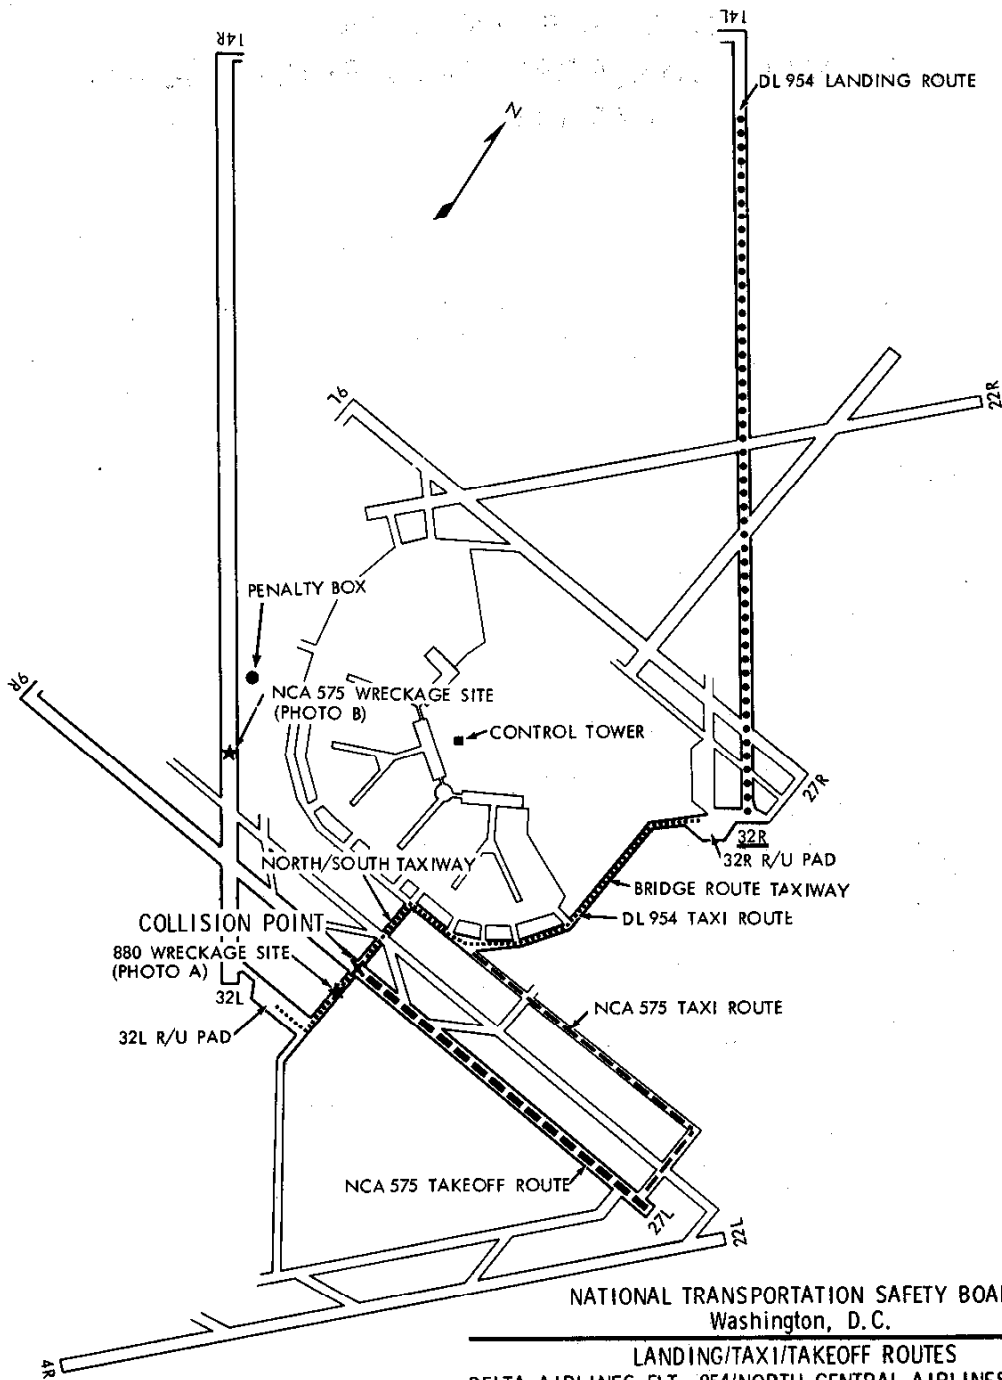
LANDING/TAXI/TAKEOFF ROUTES
DELTA AIRLINES FLT. 954/NORTH CENTRAL AIRLINES FLT. 575
CONVAIR 880 N8807E/McDONNELL DOUGLAS DC-9-31 N954N
Collision at Chicago-O'Hare International Airport
December 20, 1972
