**NATIONAL  
TRANSPORTATION  
SAFETY  
BOARD**

**AIRCRAFT ACCIDENT REPORT**

**AIR CANADA FLIGHT 797  
McDONNELL DOUGLAS DC-9-32, C-FTLL  
GREATER CINCINNATI  
INTERNATIONAL AIRPORT  
COVINGTON, KENTUCKY  
JUNE 2, 1983**

**NTSB/AAR-86/02**

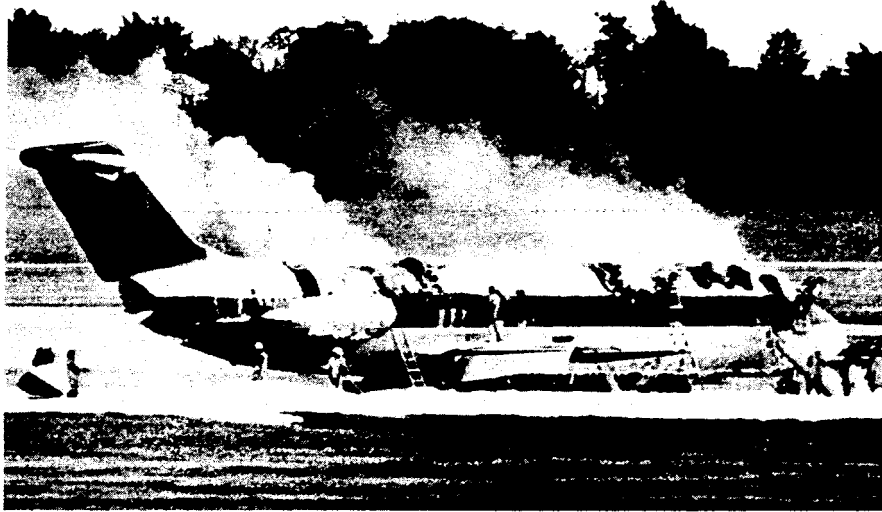
Figure 2.-Airplane after fire burned through top of fuselage.

The cabin area of the upper fuselage down to below the level of the cabin windows was damaged heavily by fire; below that level the fuselage was relatively intact. The majority of the cabin windows were either missing or had partially melted out. (See figures 3 and 4.) Forward of the aft pressure bulkhead, the upper areas of the cabin windows were discolored and burned away in several locations. The fuselage skin above the left aft lavatory was intact, but a rectangular area corresponding closely to the shape of the lavatory had been discolored to dark brown and a large area of paint had been burned away. The rectangular area began above the engine pylon and extended to the top of the fuselage. (See figures 3 and 4.)

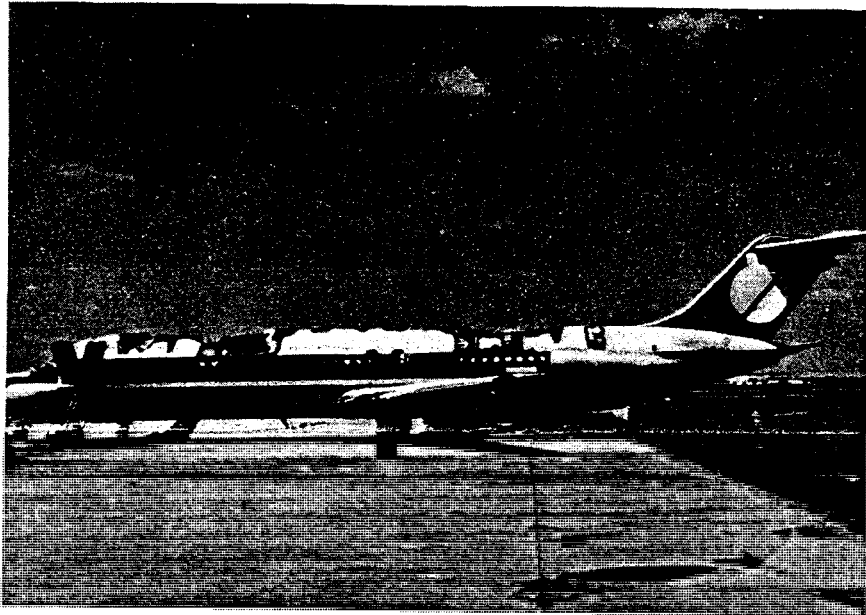
Figure S.-Left side of the airplane.

Forward of the aft lavatory, between fuselage station (**FS**) 929 and FS 758, the top of the fuselage was damaged heavily by heat and had been burned away down to the top of the cabin windows. Between FS 758 and FS 484, the fuselage upper skin was intact but was buckled and discolored by heat at the very top between the 11 o'clock and 2 o'clock positions (aft looking forward). Between FS 484 forward to the cabin entry door (**FS 200**), the upper skin of the fuselage had burned away partially. Except for some sooting around the edges of the left and right forward cabin entrance doors, the fuselage forward of FS 200 was intact with no apparent heat or fire damage.

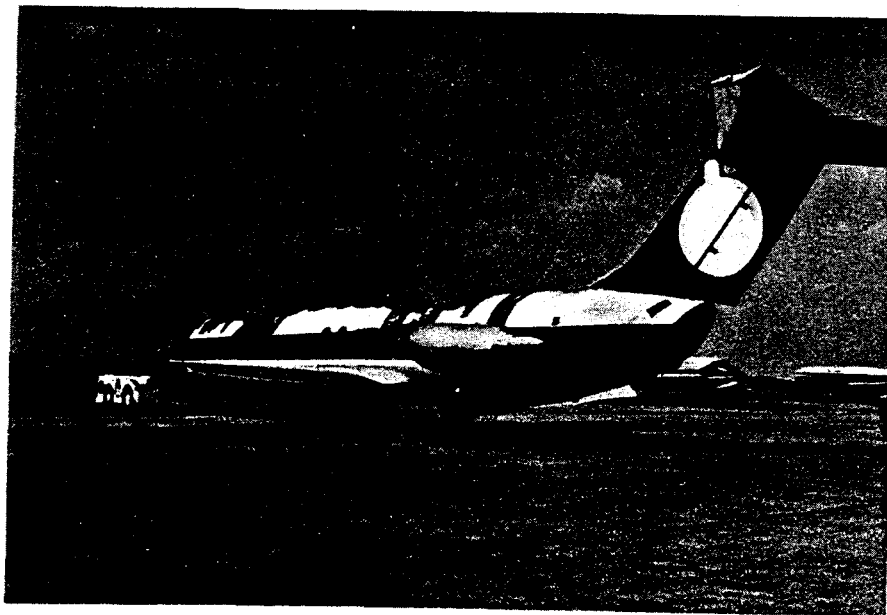
Figure 4.-Left side of the airplane, rear view, depicting rectangular burn pattern and Soot trail. .

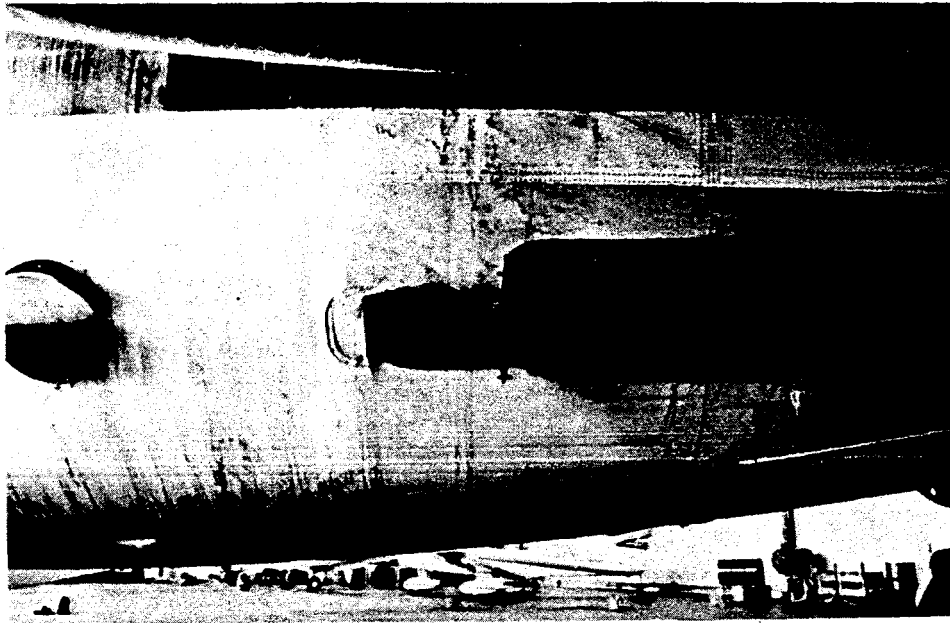
There were thick soot deposits along the lower side of the fuselage beginning at the cabin air outflow valve at FS 945 and from around the access **door** in the lavatory service panel at FS 965. The soot pattern trailed rearward along the airplane's side,

including the tailcone. The cabin air dump valve, at FS 920, was open, and light soot deposits trailed aft from around the edges of the valve. (See figure 5.)

Figure S.—Soot trail deposits on left side of fuselage at lavatory, service panel and outflow valve.

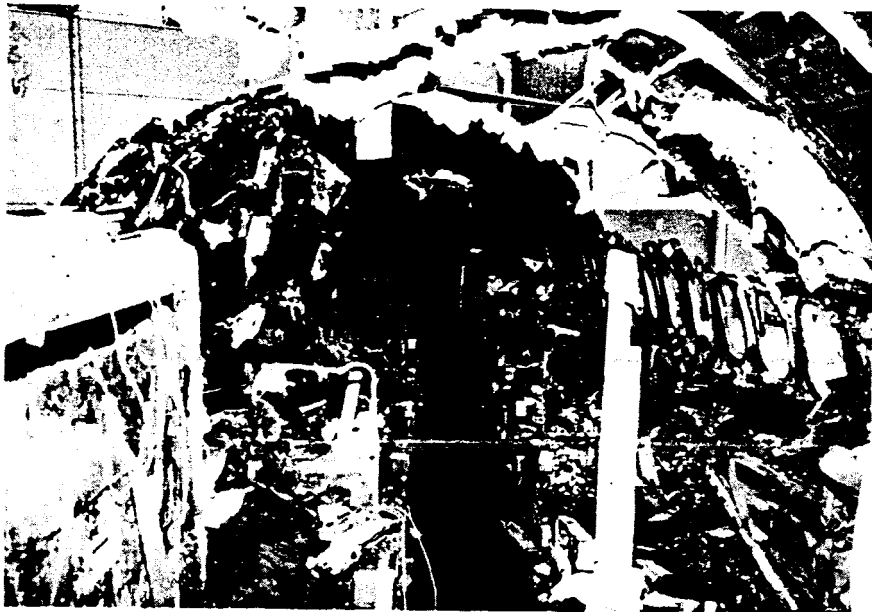
Except for the cabin floor and the aisle carpet, the entire passenger cabin back to the aft lavatory was either consumed or damaged by fire. The aisle carpet was covered by debris but had not been discolored or damaged by heat. Of the 100 passenger seats, only the seat frames and cushions of Nos. 12A and 12B remained intact. Seat Nos. 12A and 12B are adjacent to the left forward **overwing** emergency exit which had been opened during the passenger evacuation and had been used as access by firemen to apply water to the fire. The remaining seats were either completely or partially destroyed by the fire. (See figures 7 and 8.)

Figure 7.—Cabin interior viewed aft from the forward galley area.

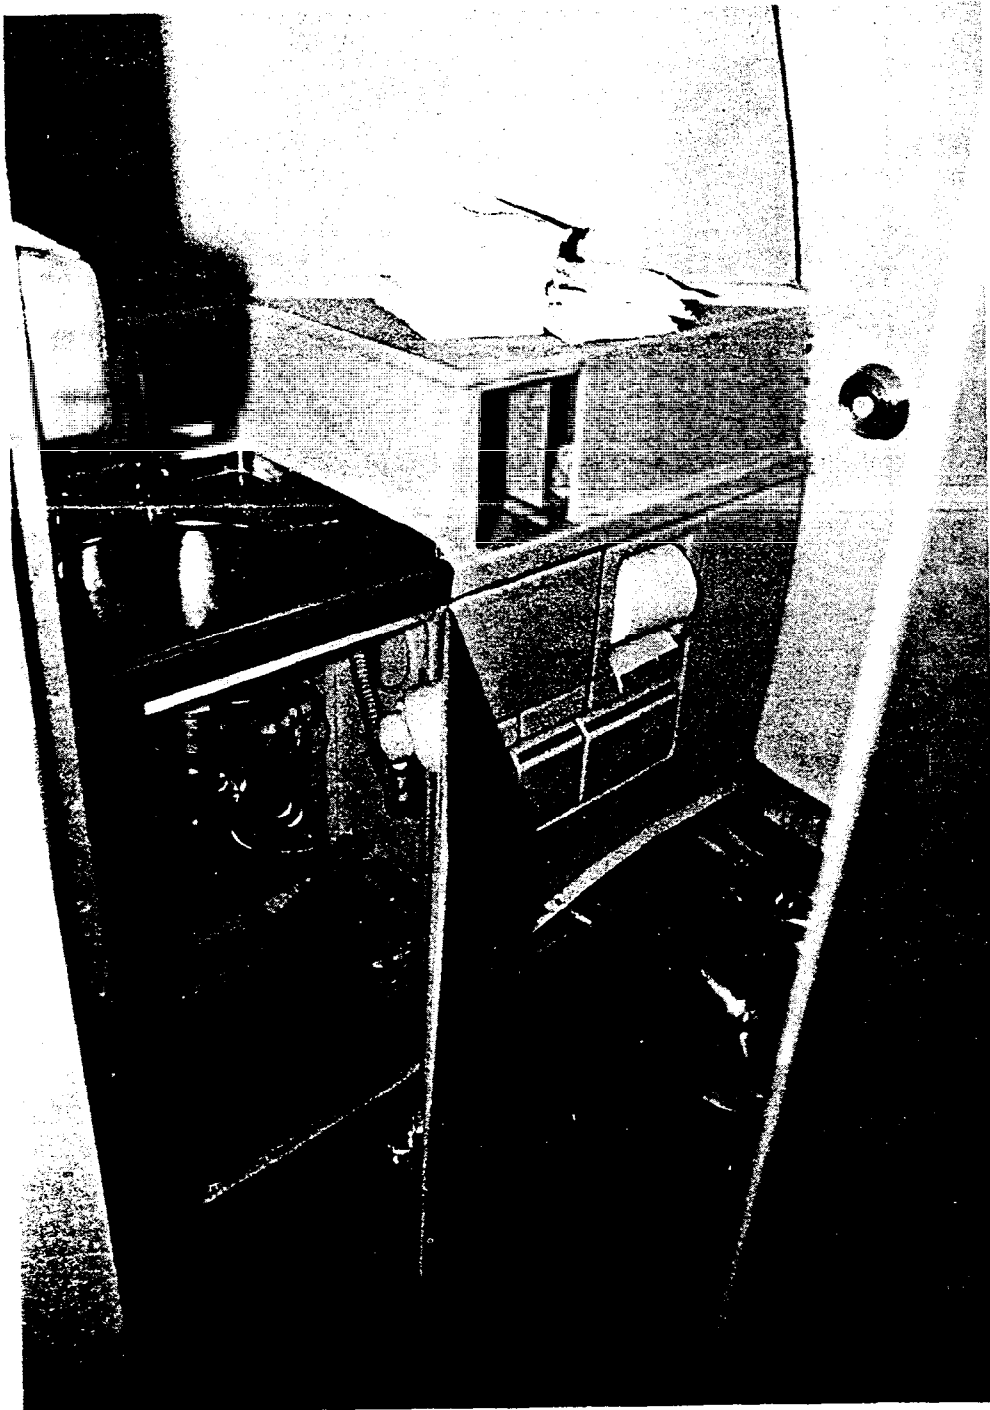
Figure 10.—Aft lavatory viewed toward aft and outboard wall.  
Lavatory sink door is open exposing trash receptacle:  
Toilet shroud has been removed showing the top of the  
flush motor between the commode and forward wall of  
the amenities section.

The aft lavatory was damaged extensively by fire and heat. Most of the lavatory's interior walls had been burned away. The entry door, which had been kept closed, was destroyed except within 16 inches of the floor. The aft pressure bulkhead and fuselage skin which comprised the outermost portion of the lavatory enclosure were intact, but were buckled and discolored to dark brown.

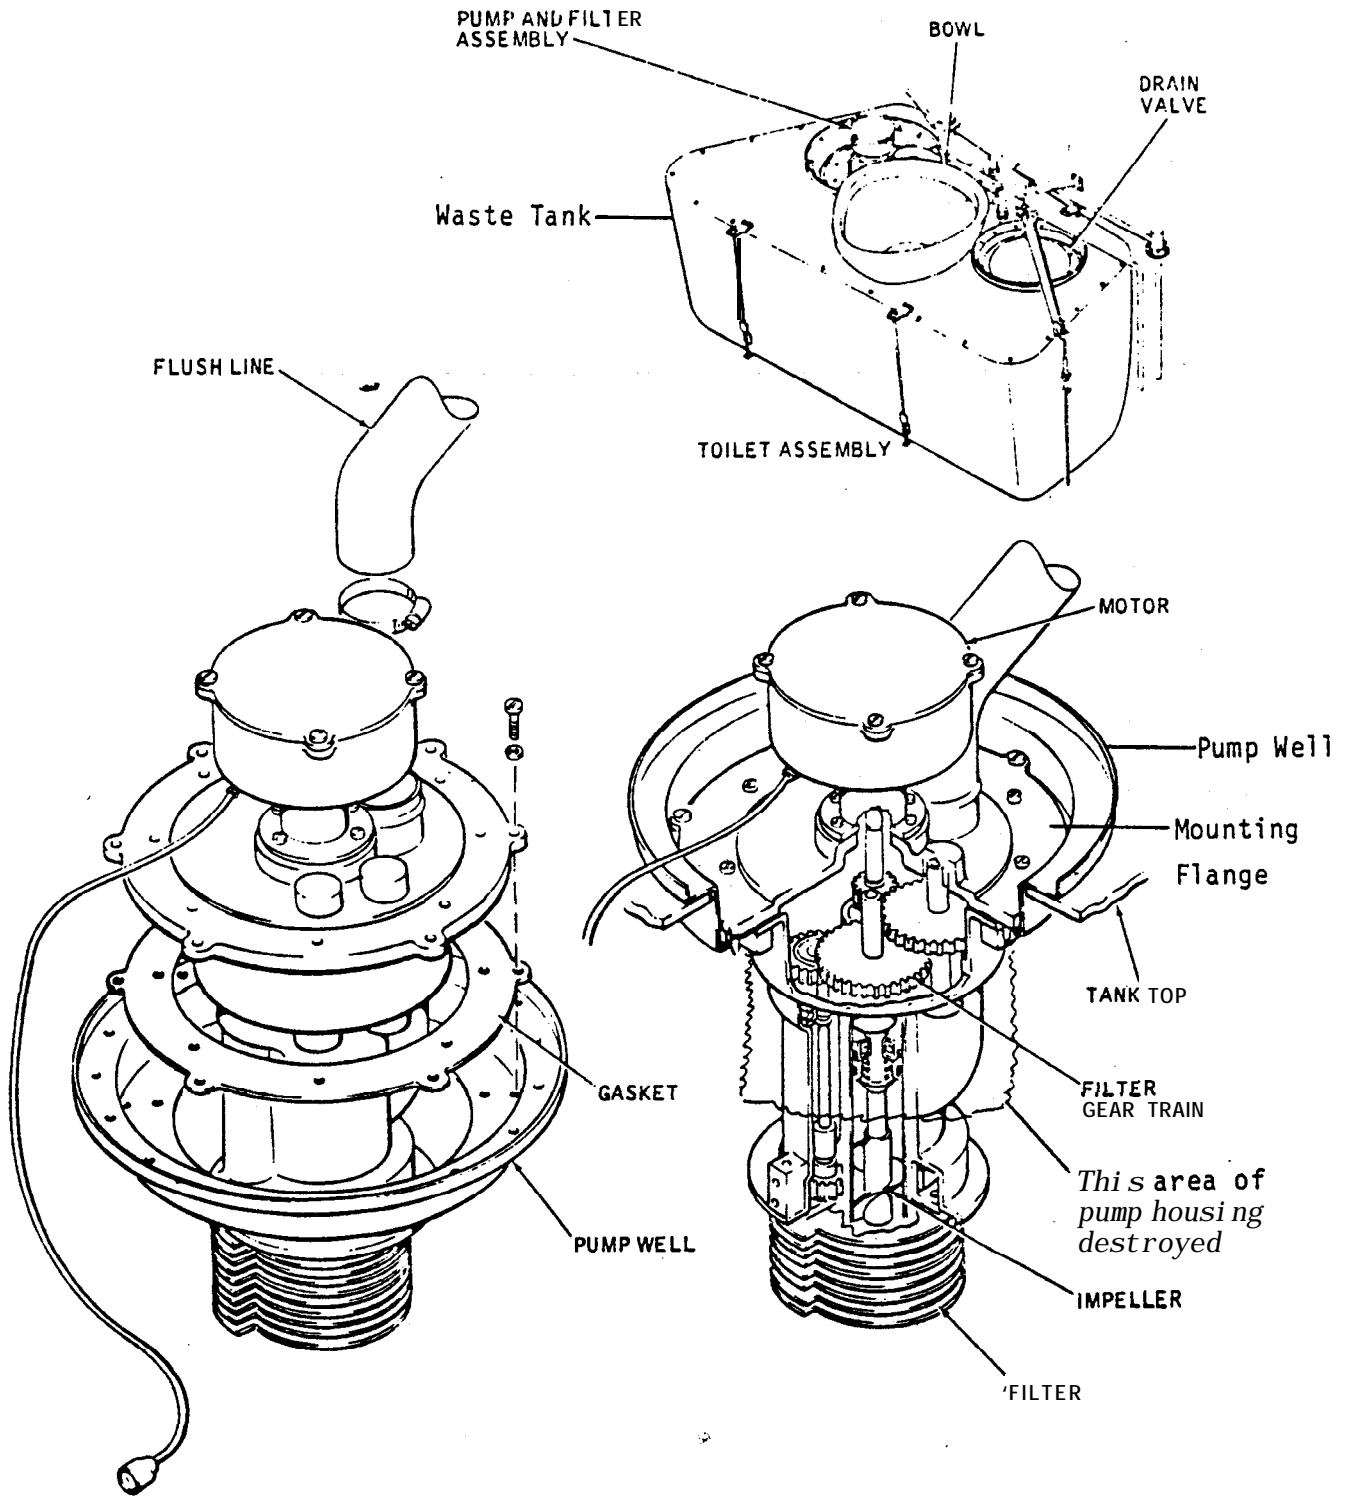
Figure 11.—Lavatory pump and filter system.

The flush motor was found attached to its mounting flange which was attached to the pump well. The flush motor assembly was found in approximately its normal position in the waste tank next to, but detached from, the flush pump and filter assembly. The motor housing was completely melted. Large concentrations of molten metal were found on the forward side of the mounting flange facing the toilet bowl, and on the aft side where the **3-phase** electrical leads enter the motor housing. A portion of the wiring harness which supplies **a.c.** power to the flush timer, flush motor, and flush button was encased in the molten metal on the aft side of the motor. The rotor section of the flush motor was encased in molten metal above the field windings; however, the rotor did not appear to have been damaged extensively by heat. (See figure 11.)

The flush pump and filter assembly found in the waste tank was partially intact. The filter and pump mechanisms, which apparently had been located below the water line in the waste tank, were in good condition. Above the water line, the plastic housing for the pump and filter was melted away. This housing also encloses the filter gear train and is part of the assembly used to mount the pump and filter to the pump well. The exposed shaft and gears showed heat damage. The gears, which make up the filter gear train that connects the motor to the pump and filter, were found lying in the waste tank. The plastic mounting ring, which mates the pump and filter housing to the pump well, was found intact among the debris in the waste tank. There was some slight melting of the top surface of the mounting ring. All of the components of the flush motor and pump assembly were removed for further examination.
