NATIONAL TRANSPORTATION SAFETY BOARD

AIRCRAFT ACCIDENT REPORT

**AIR CANADA FLIGHT 797
McDONNELL DOUGLAS DC-9-32, C-FTLL
GREATER CINCINNATI
INTERNATIONAL AIRPORT
COVINGTON, KENTUCKY
JUNE 2, 1983**

**NTSB/AAR-86/02
(SUPERSEDES - - NTSB/AAR-84/09)**

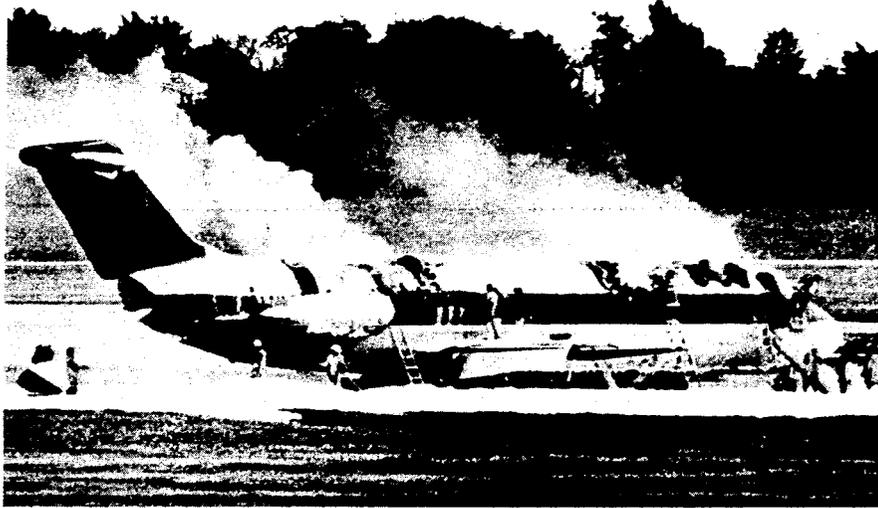
Figure 2.-Airplane after fire burned through top of fuselage.

The cabin area of the upper fuselage down to below the level of the cabin windows was damaged heavily by fire; below that level the fuselage was relatively intact. The majority of the cabin windows were either missing or had partially melted out. (See figures 3 and 4.) Forward of the aft pressure bulkhead, the upper areas of the cabin windows were discolored and burned away in several locations. The fuselage skin above the left aft lavatory was intact, but a rectangular area corresponding closely to the shape of the lavatory had been discolored to dark brown and a large area of paint had been burned away. The rectangular area began above the engine pylon and extended to the top of the fuselage. (See figures 3 and 4.)

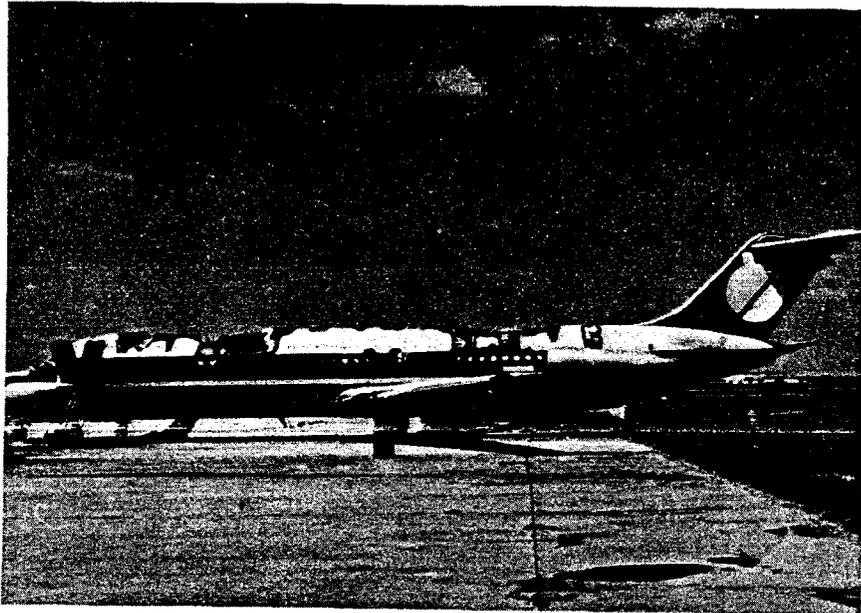
Figure S.-Left side of the airplane.

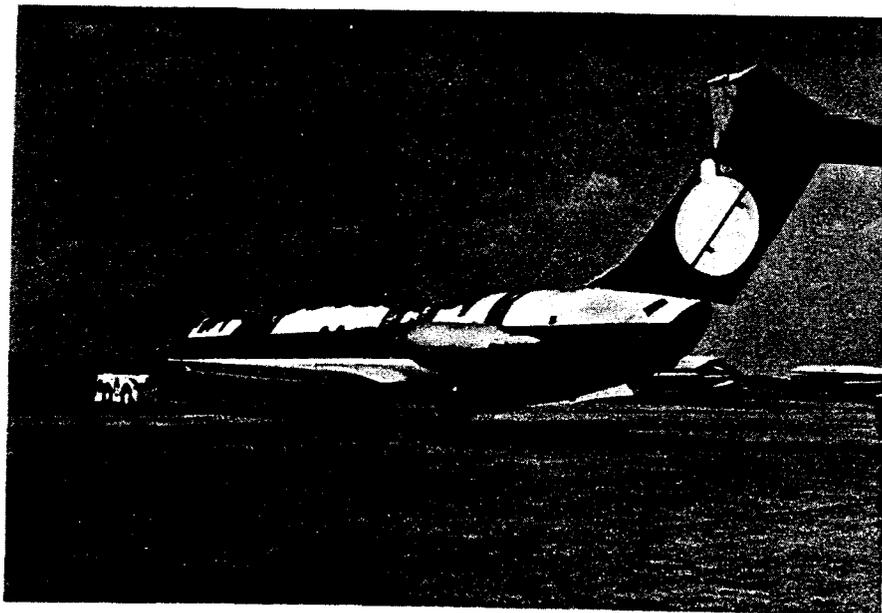
There were thick soot deposits along the lower side of the fuselage beginning at the cabin air outflow valve at FS 945 and from around the access **door** in the lavatory service panel at FS 965. The soot pattern trailed rearward along the airplane's side,

Figure 4.-Left side of the airplane, rear view, depicting rectangular burn pattern and Soot trail. .

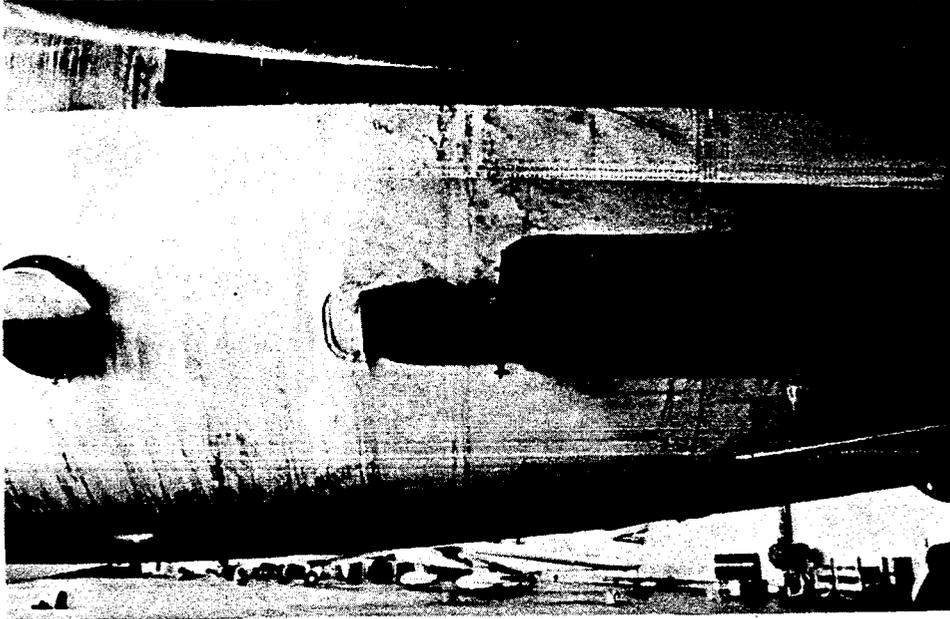
including the tailcone. The cabin air dump valve, at FS 920, was open, and light soot deposits trailed aft from around the edges of the valve. (See figure 5.)

Figure S.-Soot trail deposits on left side of fuselage at lavatory, service panel and outflow valve.

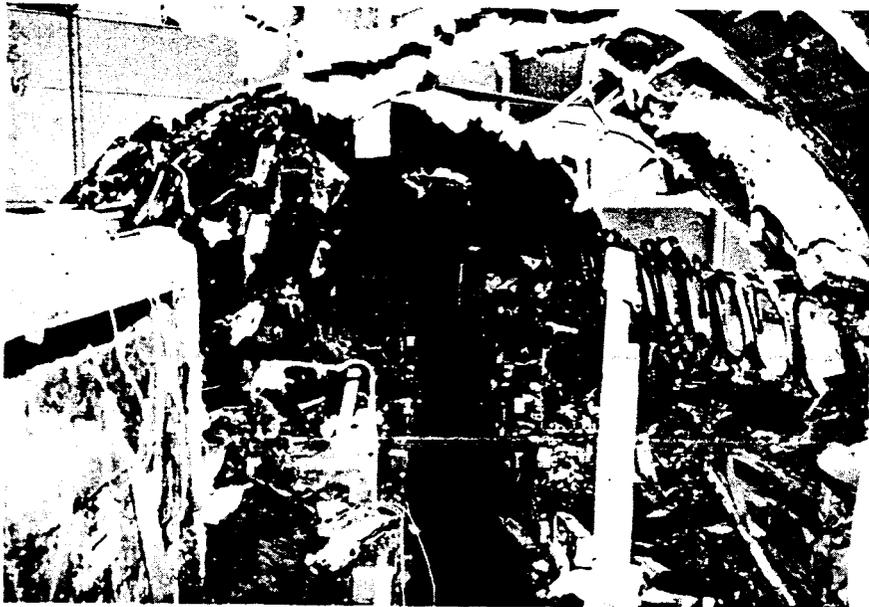
Except for the cabin floor and the aisle carpet, the entire passenger cabin back to the aft lavatory was either consumed or damaged by fire. The aisle carpet was covered by debris but had not been discolored or damaged by heat. Of the 100 passenger seats, only the seat frames and cushions of Nos. 12A and 12B remained intact. Seat Nos. 12A and 12B are adjacent to the left forward **overwing** emergency exit which had been opened during the passenger evacuation and had been used as access by firemen to apply water to the fire. The remaining seats were either completely or partially destroyed by the fire. (See figures 7 and 8.)

Figure 7.—Cabin interior viewed aft from the forward galley area.

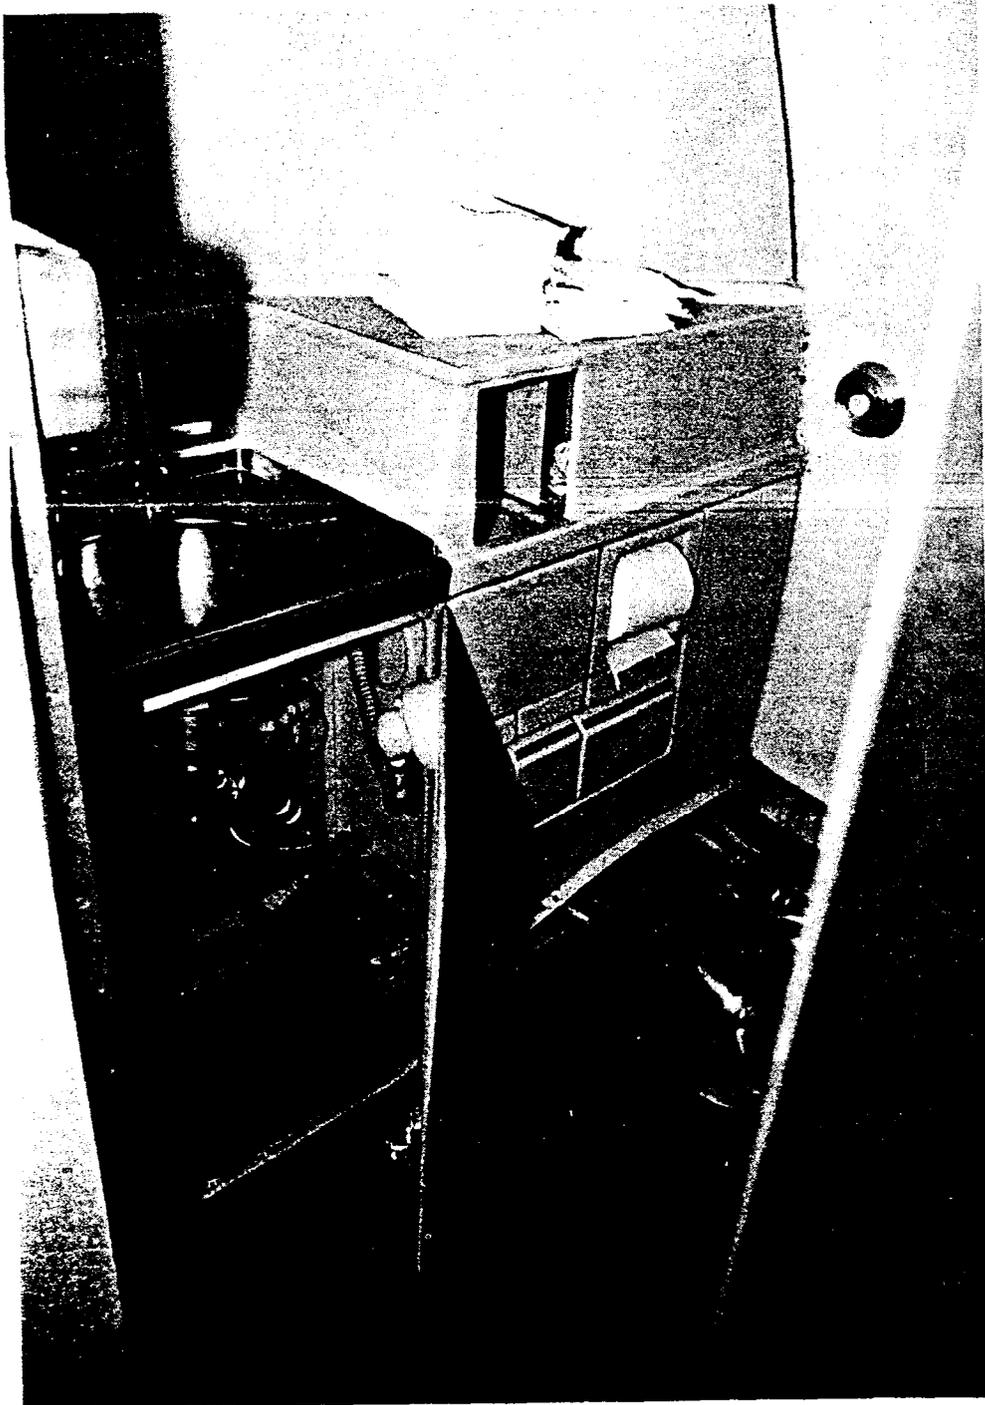
Figure 10.—Aft lavatory viewed toward aft and outboard wall.
Lavatory sink door is open exposing trash receptacle:
Toilet shroud has been removed showing the top of the
flush motor between the commode and forward wall of
the amenities section.

The aft lavatory was damaged extensively by fire and heat. Most of the lavatory's interior walls had been burned away. The entry door, which had been kept closed, was destroyed except within 16 inches of the floor. The aft pressure bulkhead and fuselage skin which comprised the outermost portion of the lavatory enclosure were intact, but were buckled and discolored to dark brown.

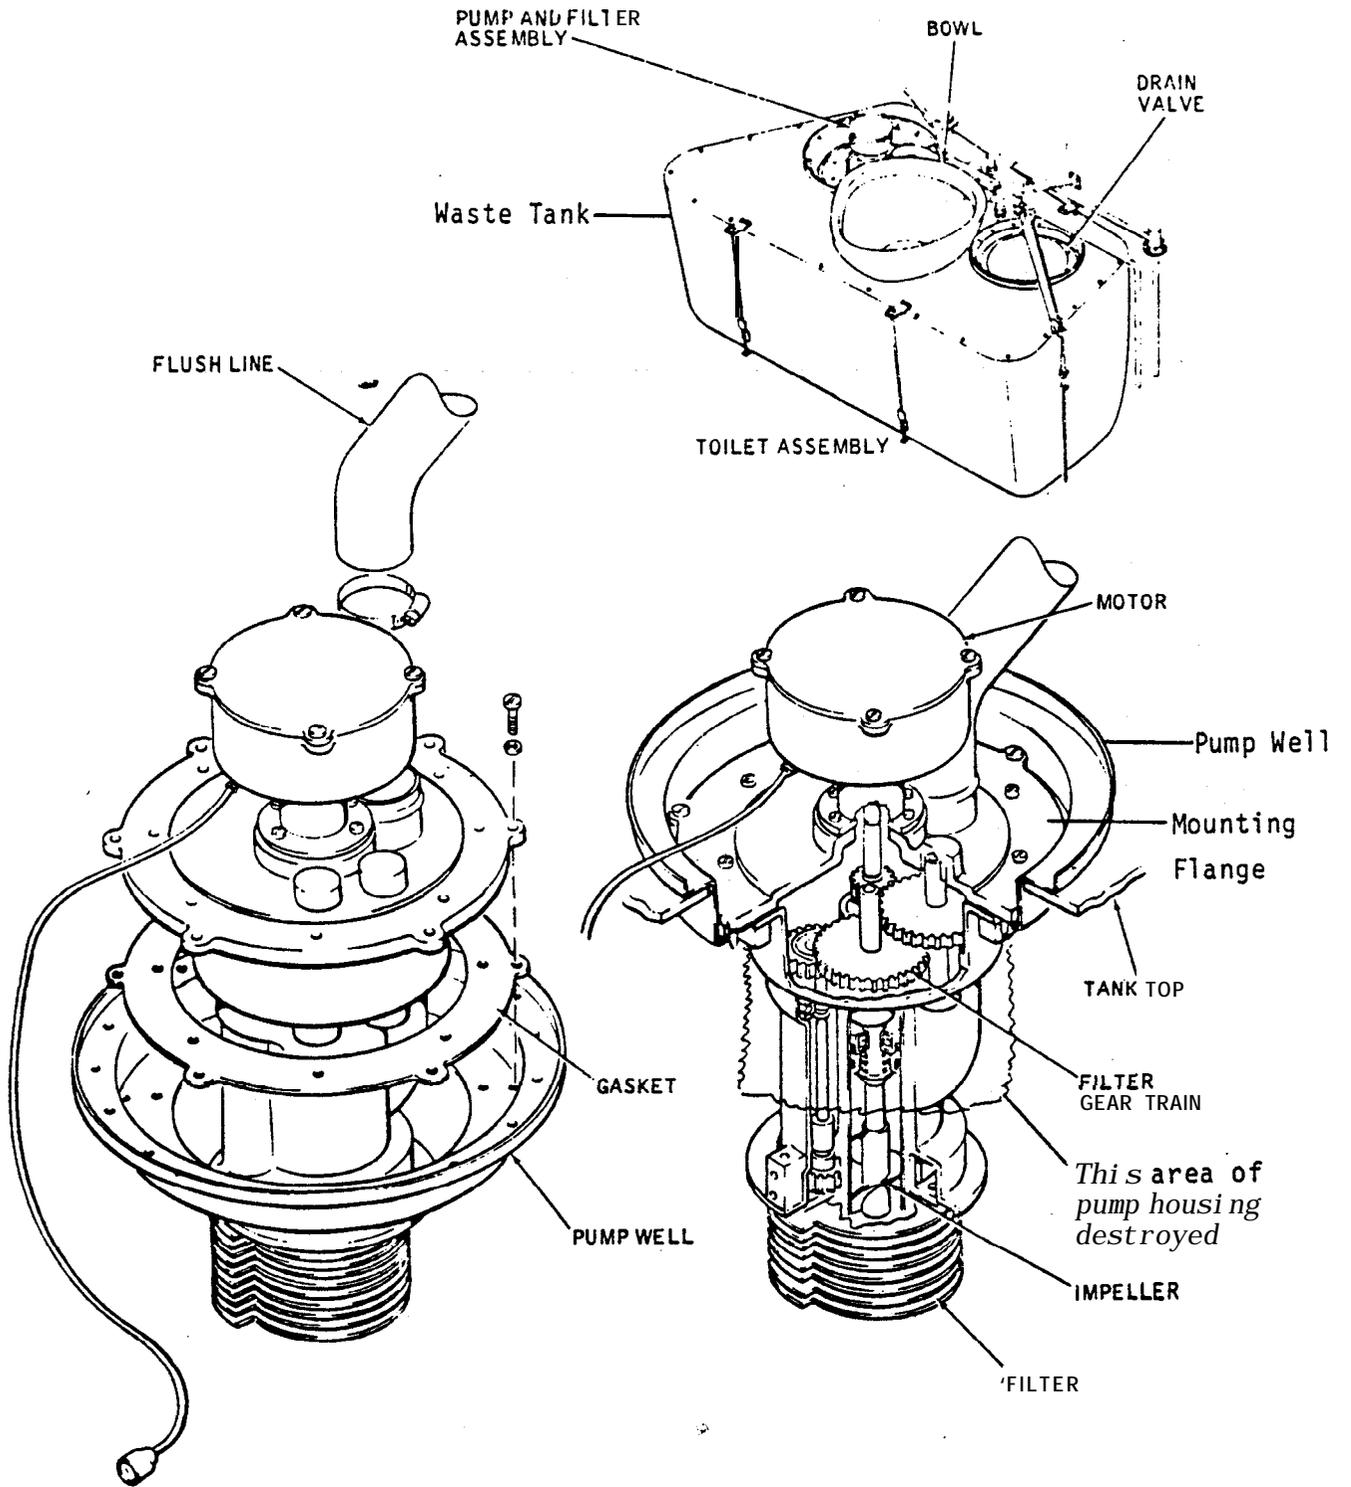
The flush motor was found attached to its mounting flange which was attached to the pump well. The flush motor assembly was found in approximately its normal position in the waste tank next to, but detached from, the flush pump and filter assembly. The motor housing was completely melted. Large concentrations of molten metal were found on the forward side of the mounting flange facing the toilet bowl, and on the aft side where the **3-phase** electrical leads enter the motor housing. A portion of the wiring harness which supplies **a.c.** power to the flush timer, flush motor, and flush button was encased in the molten metal on the aft side of the motor. The rotor section of the flush motor was encased in molten metal above the field windings; however, the rotor did not appear to have been damaged extensively by heat. (See figure 11.)

The flush pump and filter assembly found in the waste tank was partially intact. The filter and pump mechanisms, which apparently had been located below the water line in the waste tank, were in good condition. Above the water line, the plastic housing for the pump and filter was melted away. This housing also encloses the filter gear train and is part of the assembly used to mount the pump and filter to the pump well. The exposed shaft and gears showed heat damage. The gears, which make up the filter gear train that connects the motor to the pump and filter, were found lying in the waste tank. The plastic mounting ring, which mates the pump and filter housing to the pump well, was found intact among the debris in the waste tank. There was some slight melting of the top surface of the mounting ring. All of the components of the flush motor and pump assembly were removed for further examination.

Figure 11.—Lavatory pump and filter system.
