AIRCRAFT ACCIDENT REPORT

EXPLOSIVE DECOMPRESSION--
LOSS OF CARGO DOOR IN FLIGHT
UNITED AIRLINES FLIGHT 811
BOEING 747-122, N4713U
HONOLULU, HAWAII
FEBRUARY 24, 1989

**Adopted: March 18, 1992
Notation 5059C**

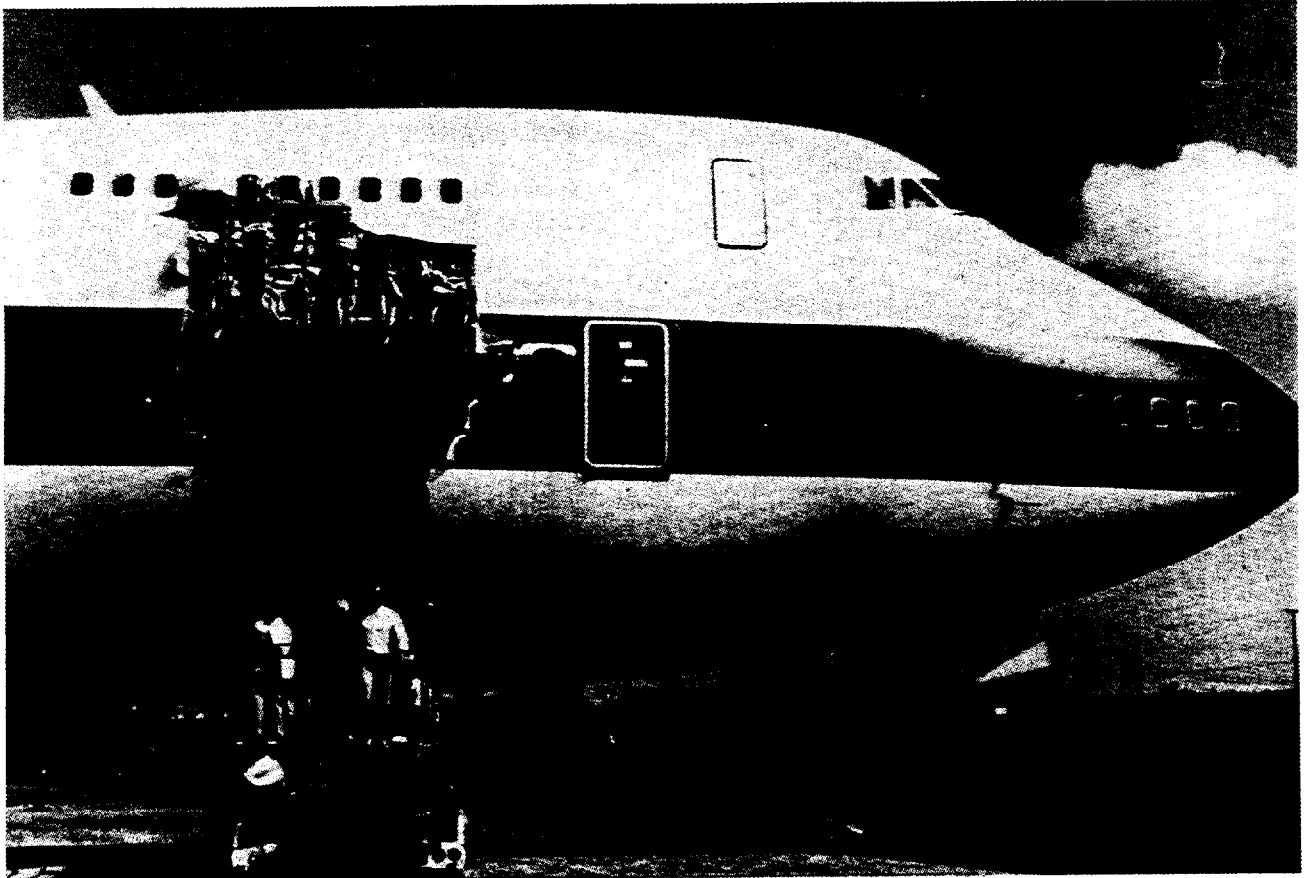
The primary damage to the airplane consisted of a hole on the right side in the area of the forward lower lobe cargo door, approximately 10 by 15 feet large. The cargo door fuselage cutout lower sill and side frames were intact but the door was missing (see figures 1 and 2). An area of fuselage skin measuring about 13 feet lengthwise by 15 feet vertically, and extending from the upper sill of the forward cargo door to the upper deck window belt, had separated from the airplane at a location above the cargo door extending to the upper deck windows. The floor beams adjacent to and inboard of the cargo door area had been fractured and buckled downward.

Examination of all structure around the area of primary damage disclosed no evidence of preexisting cracks or corrosion. All fractures were typical of fresh overstress breaks.

Figure 1 .--Overall view of forward cargo door area on the right side of the aircraft.

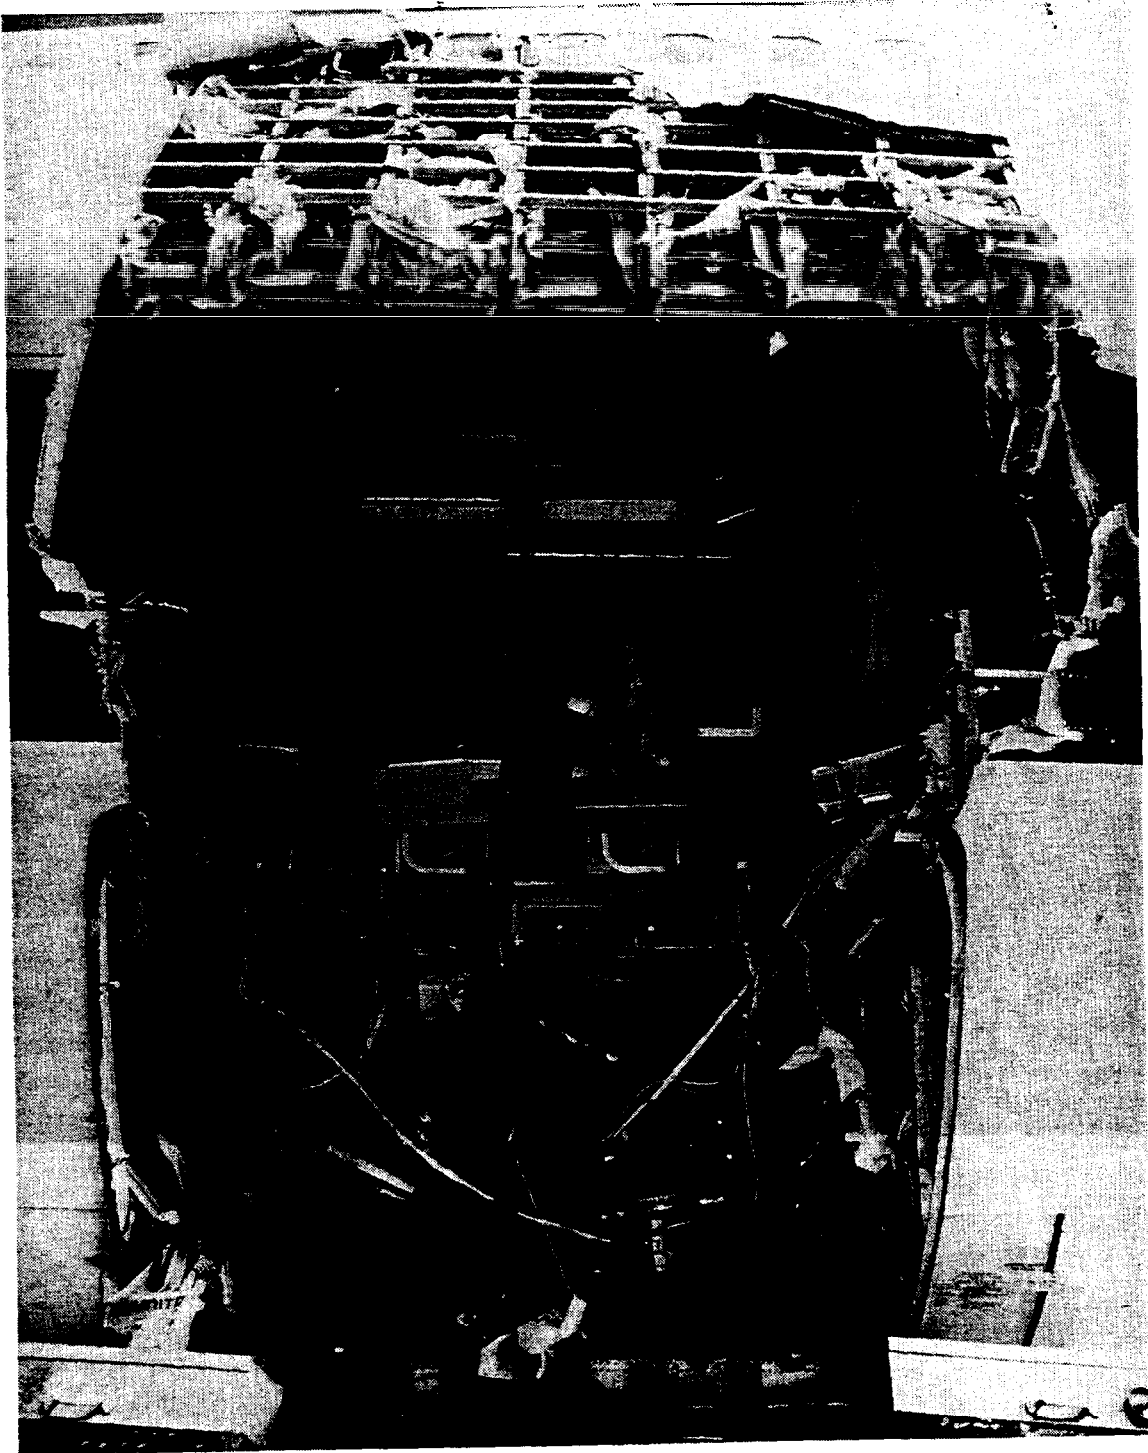
Figure 2.--Close-up view of hole and surrounding structure damage.

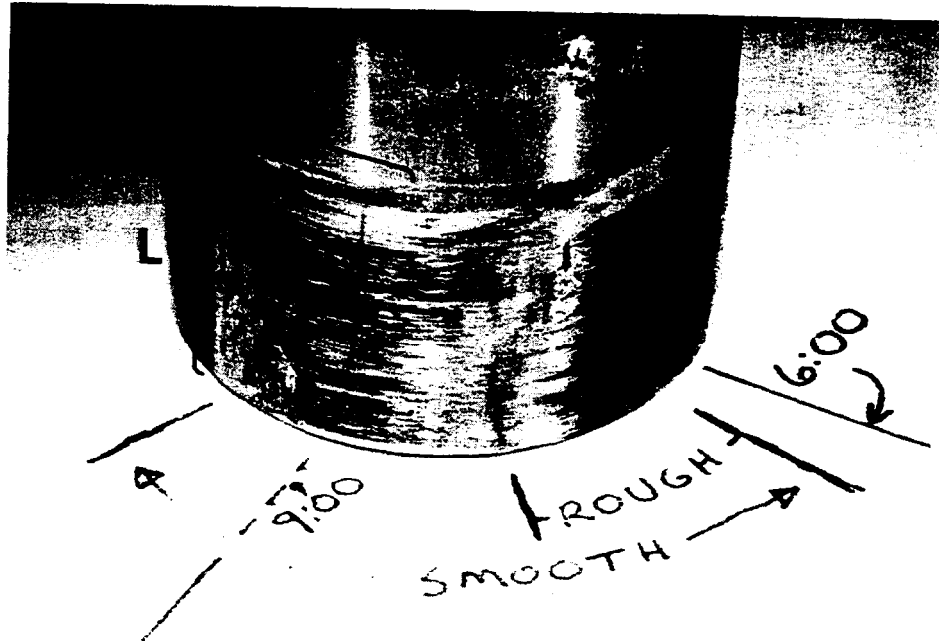
Based on the orientation of the latching mechanisms, the fully unlatched latching cams would first contact the latch pins from about the 1:15 o'clock position to the 7:15 position as the door was closed. As the cams are being latched around the pins, they would rotate approximately **80°**, making contact with the pins from about the **4:15** position to the **10:15** position (See figure 7).

Figure 7.--Latch pin number 6. Note the rough and smooth areas and the steps indicating the contact area with the latch cam.

Detailed examination of the exposed surface of the pins (the portion of the pins extending from the housings) revealed various types of wear and damage. In general, all of the forward door cargo latch pins had smooth wear over the entire portion of the pin area contacted by the cams during normal closing and opening of the door. The pins also had distinct roughened (smear) areas between the 6:15 and the 7:30 positions (See figure-8). The roughened areas had evidence of “heat tinting” and transfer of cam material to the surface of the pins. On pins 1 and 8 the roughened areas extended past the pin bottom to the 5:00 position. The 7:30 position approximately corresponds to the area on the pin where the lower surface of the cam would be relative to the pin when the latch cams are in the unlatched or nearly unlatched position.

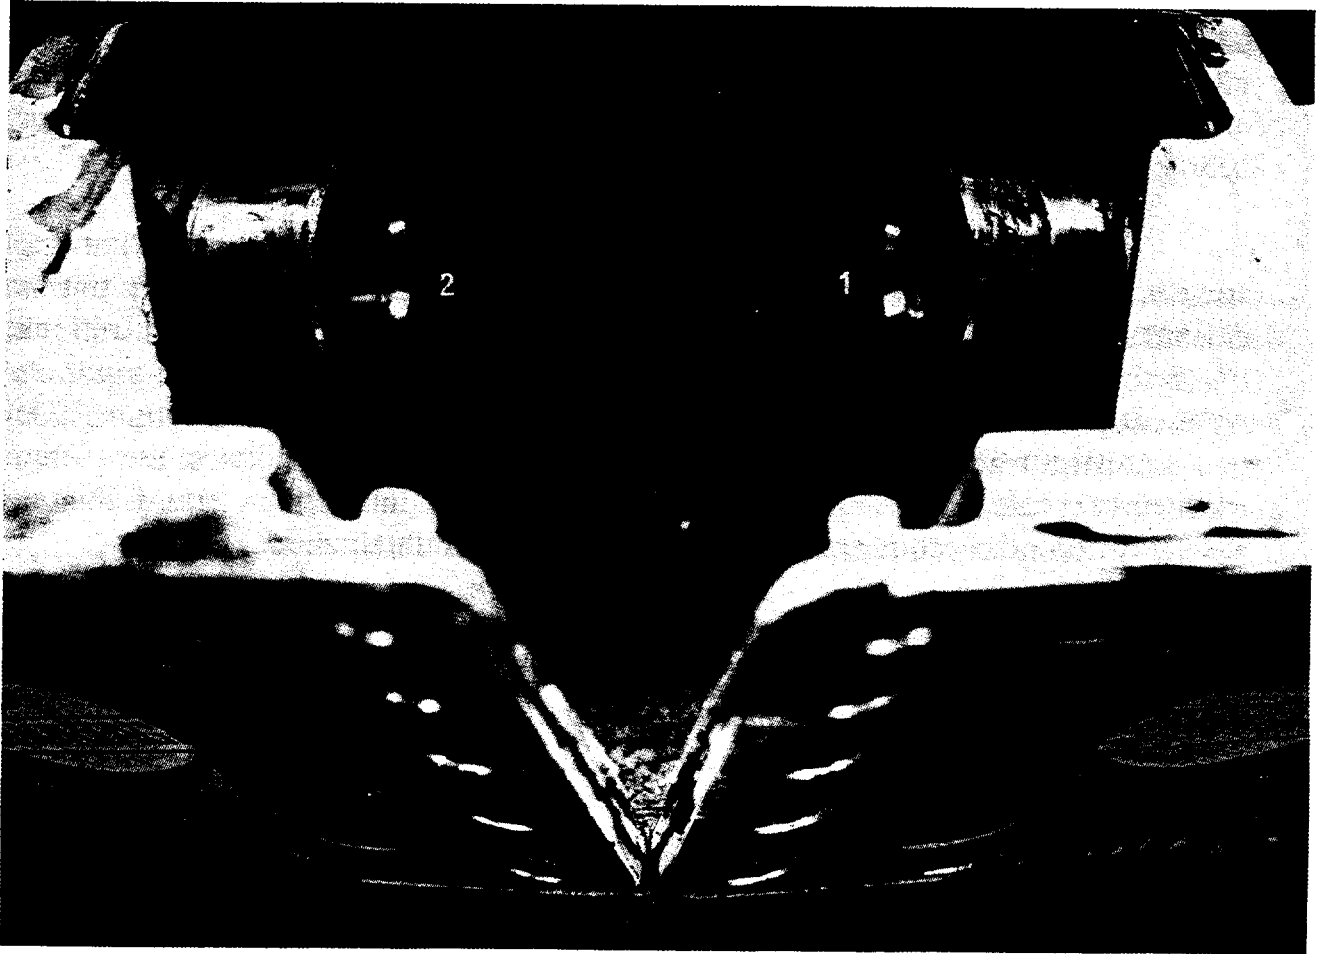
Figure 8.--Lower latch pin and housing assemblies
Nos. 1 and 2 looking up and slightly outboard.

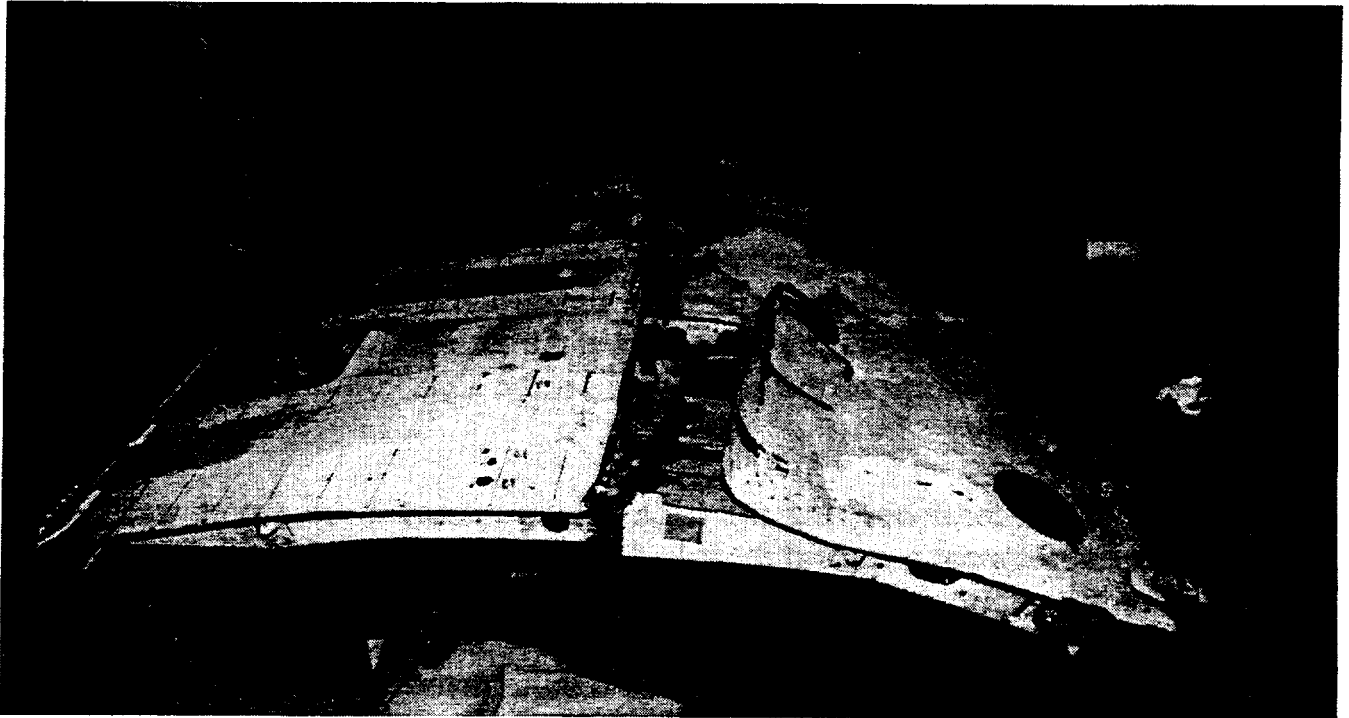
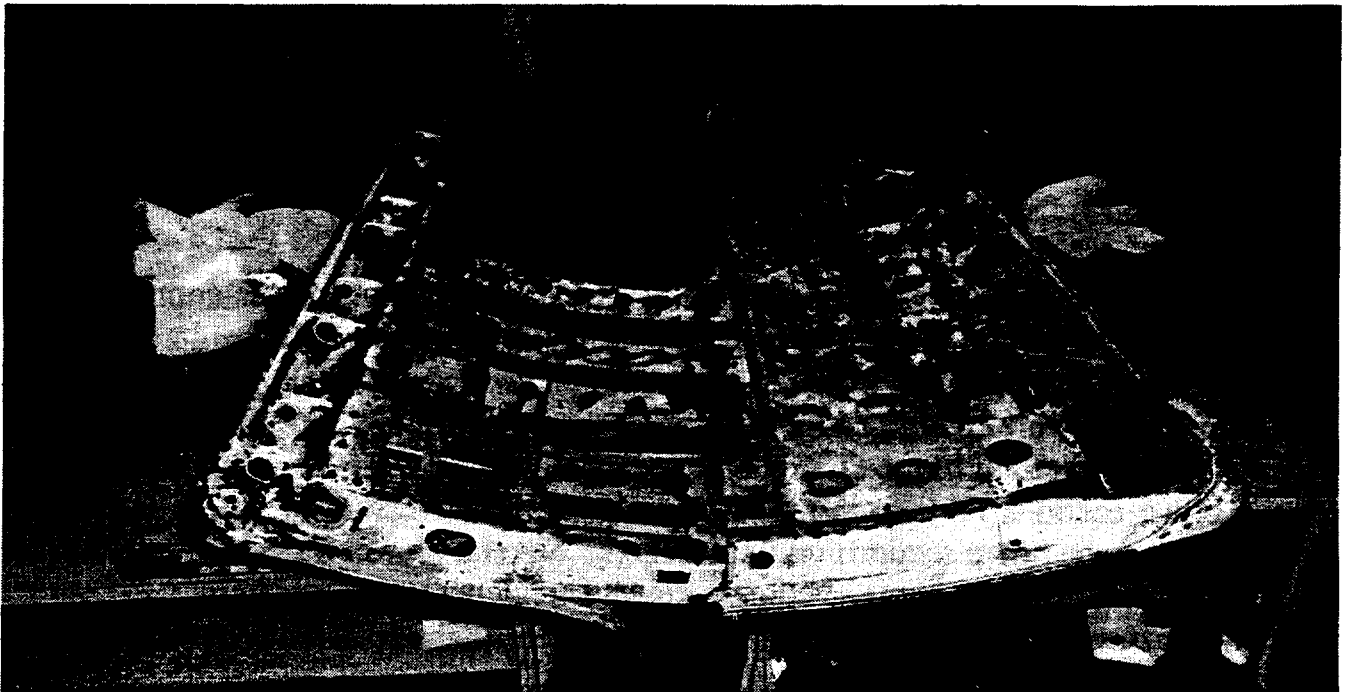
The cargo door had fractured longitudinally near the mid-span lap joint near stringer 34R, just beneath the mid-span torque tubes. Except for an area of missing skin between frames 2 and 3 and a portion of frame webs where the upper latch lock torque tube had tom out, the frames and skin of the upper door

piece mated to the lower door piece.² Several areas of the upper door skin along the longitudinal fracture were bent back. In addition, a large area of lower door skin between frame 6 and the aft door edge had peeled downward from the fracture line. The two door pieces are shown together in Figures 9 and 10. Examinations of the fracture surfaces of the skin and frames revealed no evidence of **pre-existing** cracks. All fractures were typical of overstress separation.

Figures 9 and 10.--Exterior [top photo] and interior bottom photo] views of cargo doors after removal of pull-in hooks, latch cams, lock sectors, and actuators.

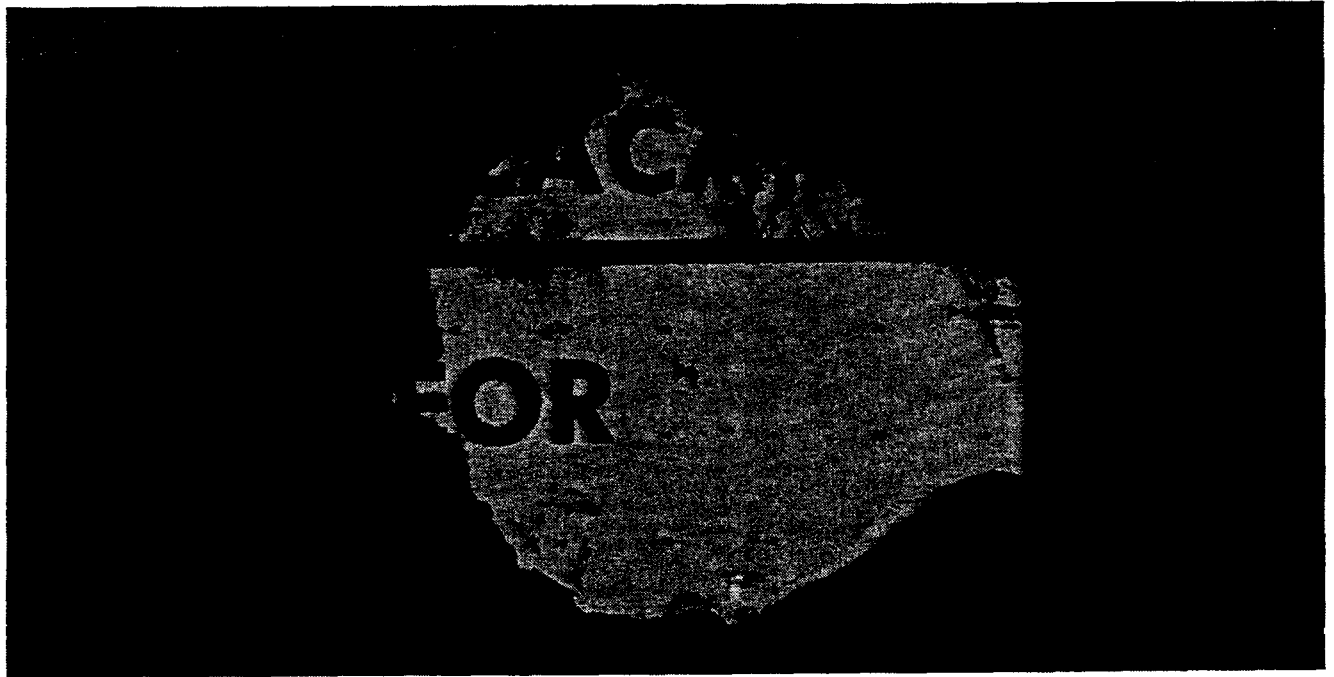
Figure 12.--Decal over latch actuator manual drive port
(2X Magnification).

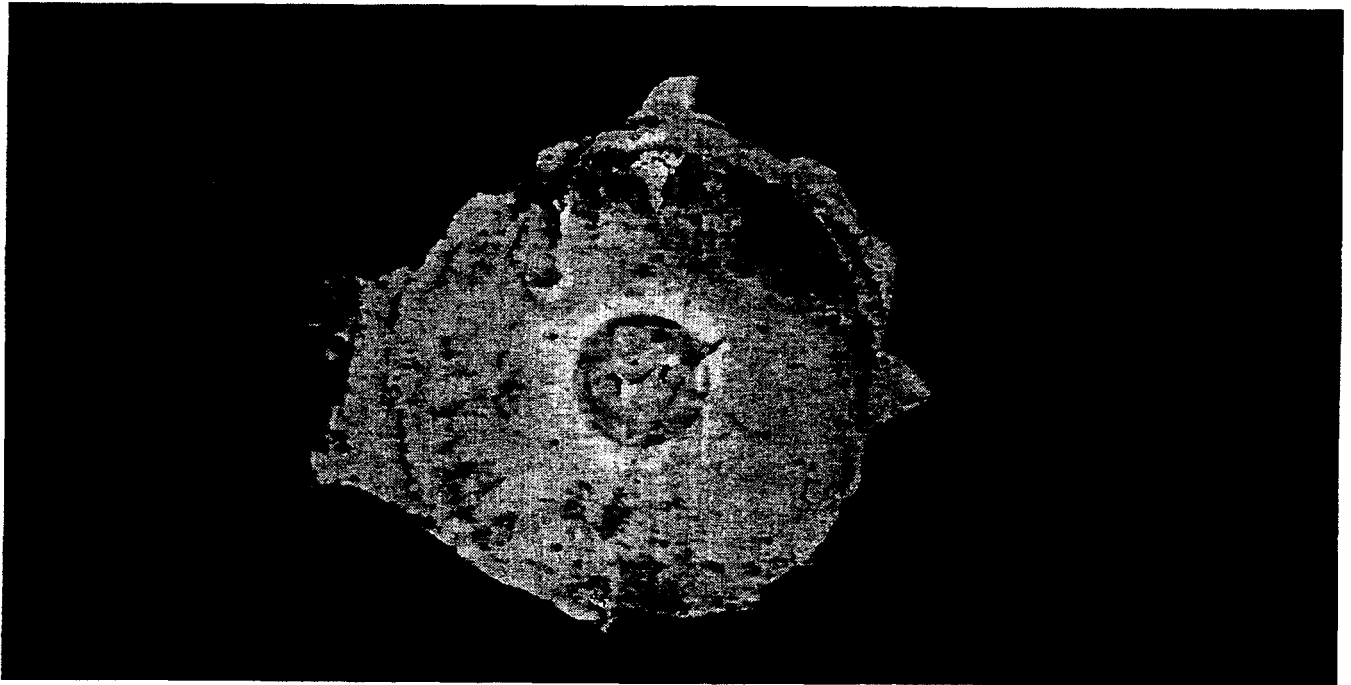
Figure 13.--**Underside** of decal piece (2X Magnification).

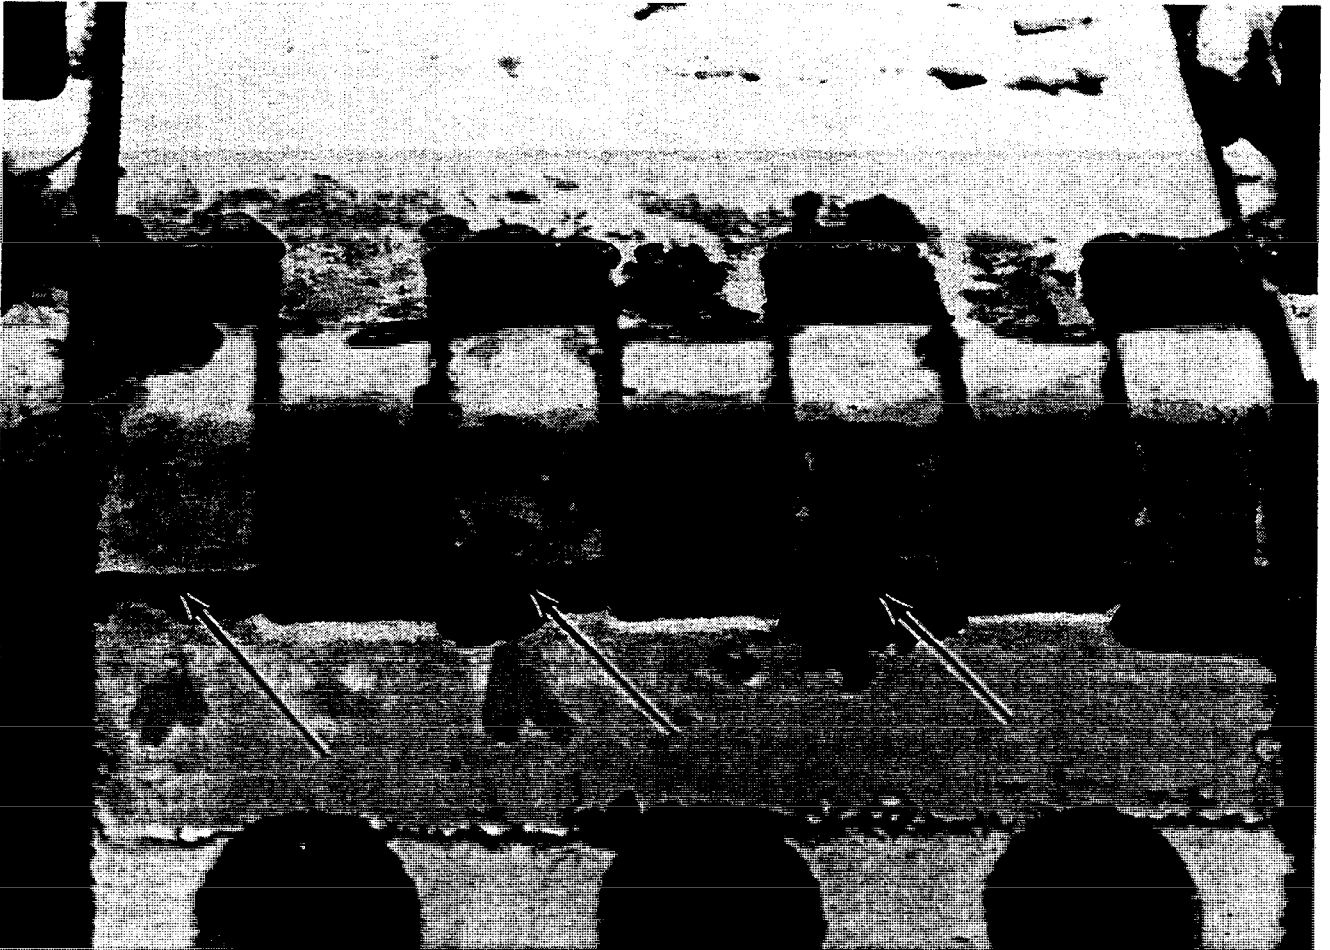
The hinge that attaches the cargo door to the fuselage is comprised of several hinge sections--those attached along the upper edge of the cargo door and those along the fuselage just above the cargo door cutout--interconnected with hinge pins. The hinge pins and all hinge sections from **N4713U's** forward cargo door were intact; all hinge sections rotated relatively easily. All attach bolts from the hinge sections on the door remained attached; conversely, no bolts remained attached to the hinge sections on the fuselage. Several areas on the hinge sections, such as the fuselage hinge sections, showed evidence of contact from the door during overtravel (See figure 14). In addition, the fuselage forward hinge sections

Figure 14.--Close-up view of cargo door hinge section.
Arrows show impressions caused by contact with opposite hinge section.

were slightly bent. The upper flange of the door, to which the door hinges are attached, was not deformed. The forward cargo door can rotate open 143 degrees before the hinge would deform, permitting the door to contact the fuselage above.

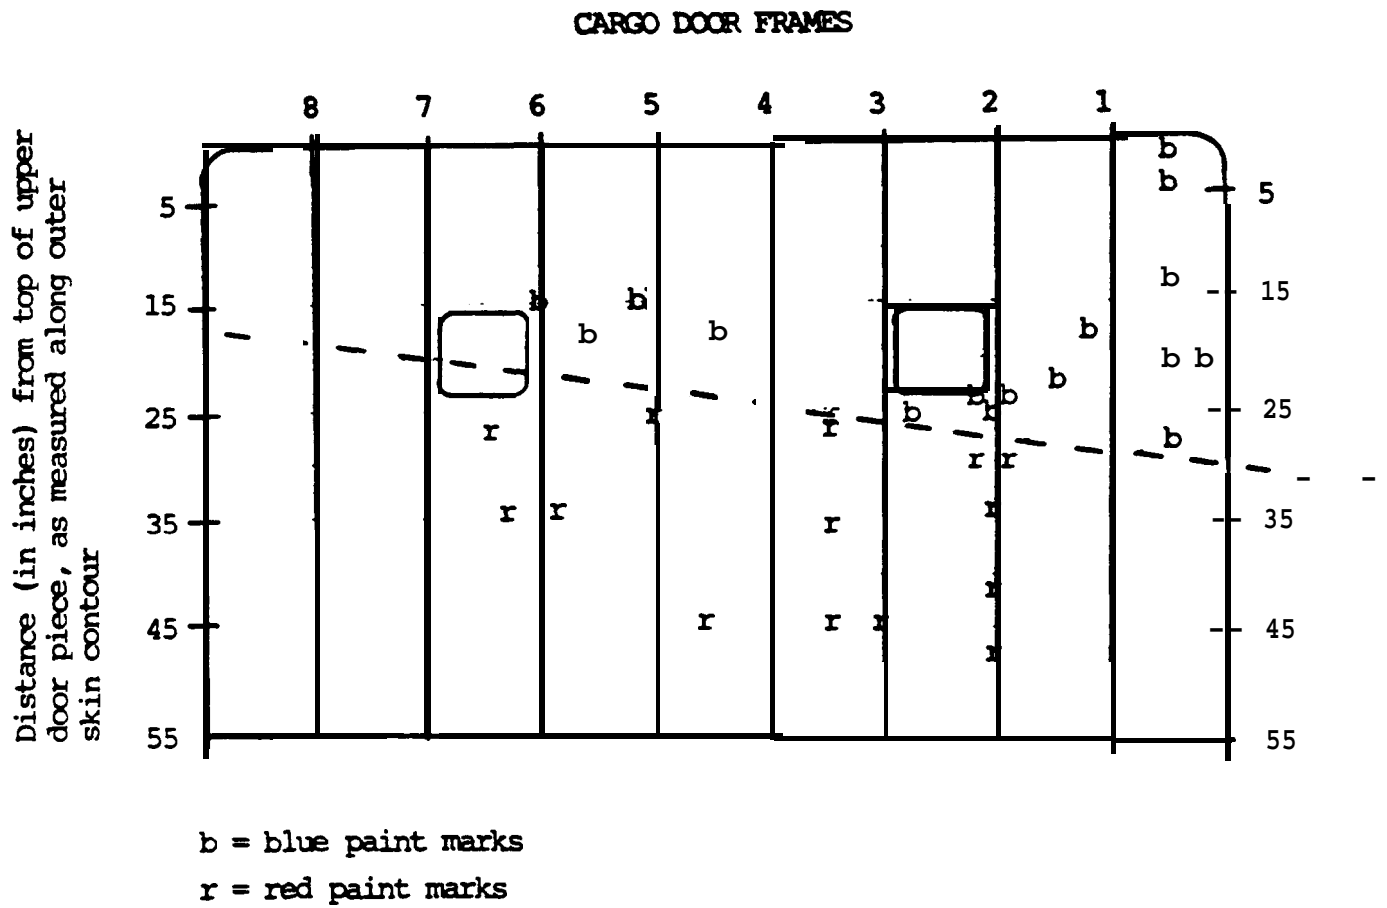
Figure 15.--Documented paint marks on outer skin of upper door piece.
Dashed line is approximately 8 degrees from horizontal.

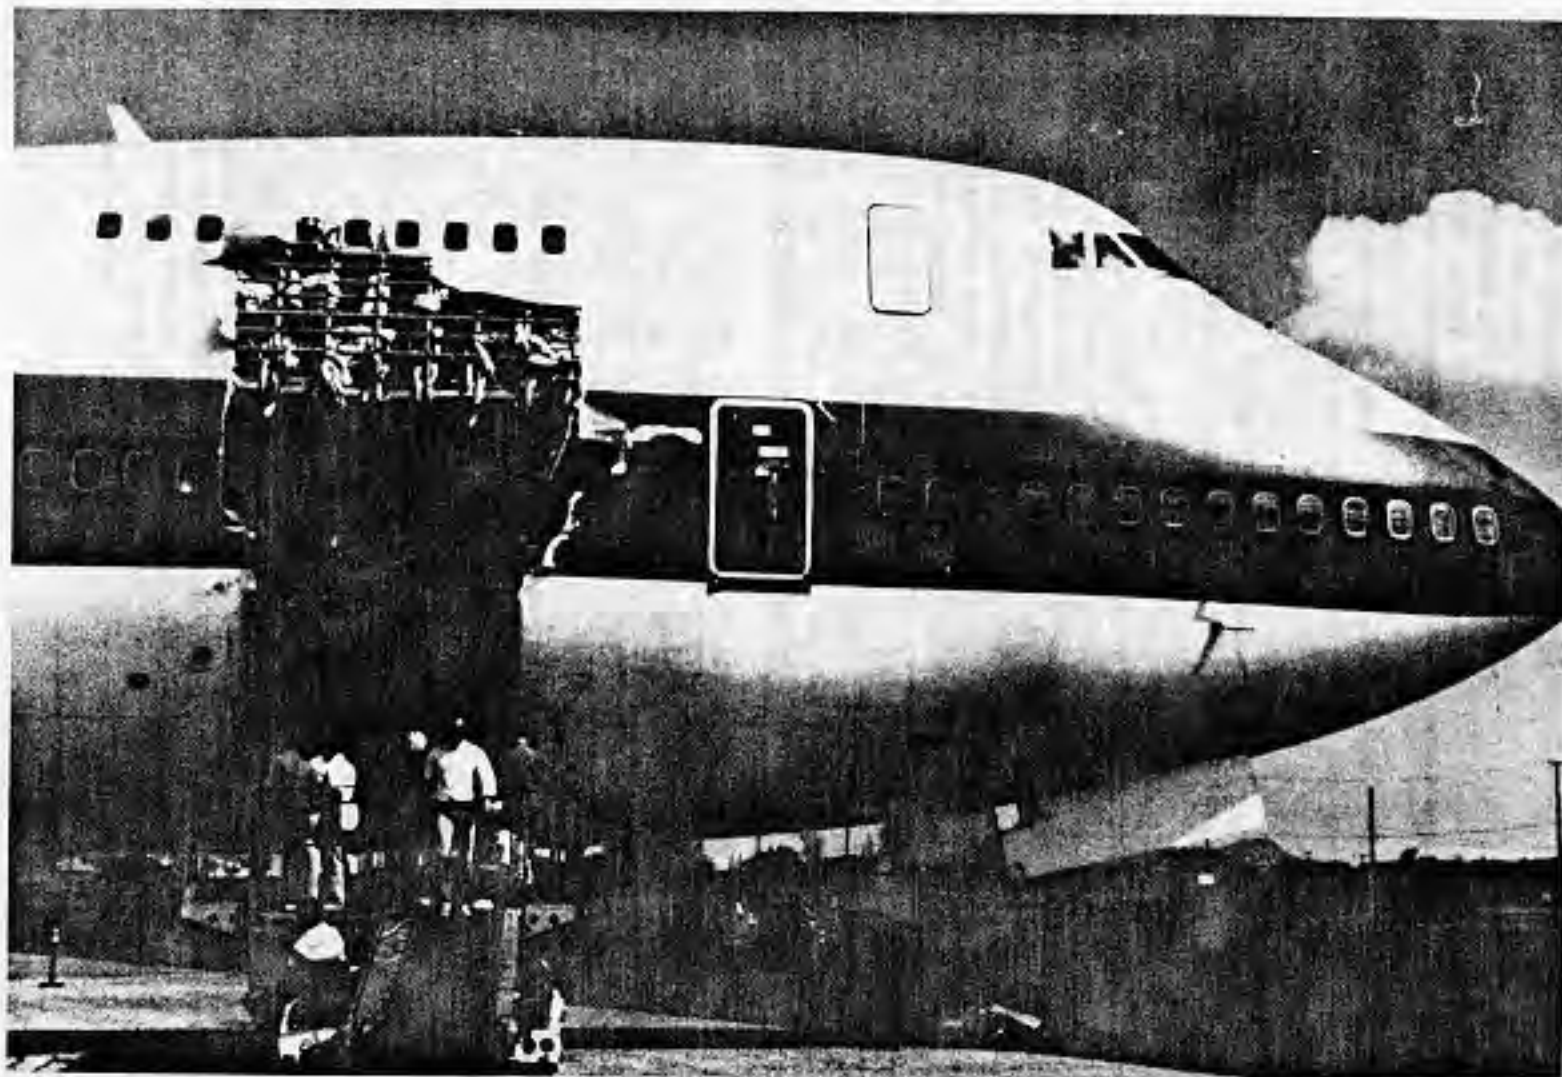
Figure 1.--Overall view of forward cargo door area
on the right side of the aircraft.

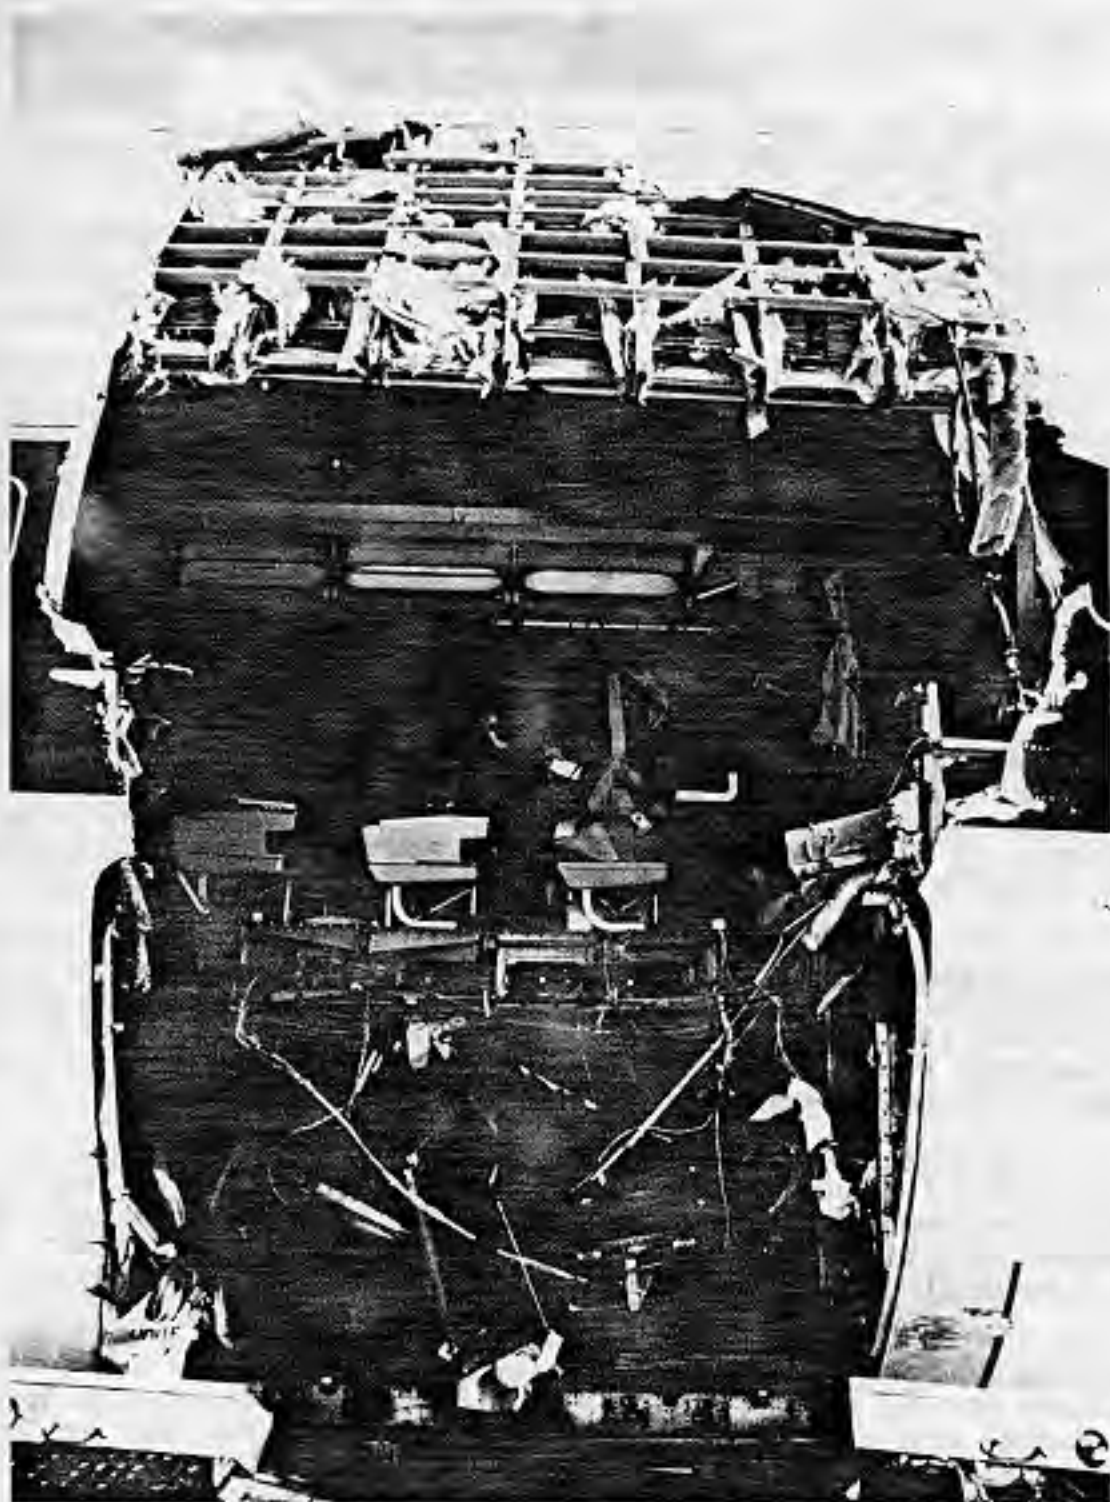
Figure 2.--Close-up view of hole and surrounding structure damage.
