PB95-910403
NTSB/AAR-95/03
DCA94MA065

NATIONAL TRANSPORTATION SAFETY BOARD

AIRCRAFT ACCIDENT REPORT

FLIGHT INTO TERRAIN DURING MISSED APPROACH
USAIR FLIGHT 1016, DC-9-31, N954VJ
CHARLOTTE/DOUGLAS INTERNATIONAL AIRPORT
CHARLOTTE, NORTH CAROLINA
JULY 2, 1994

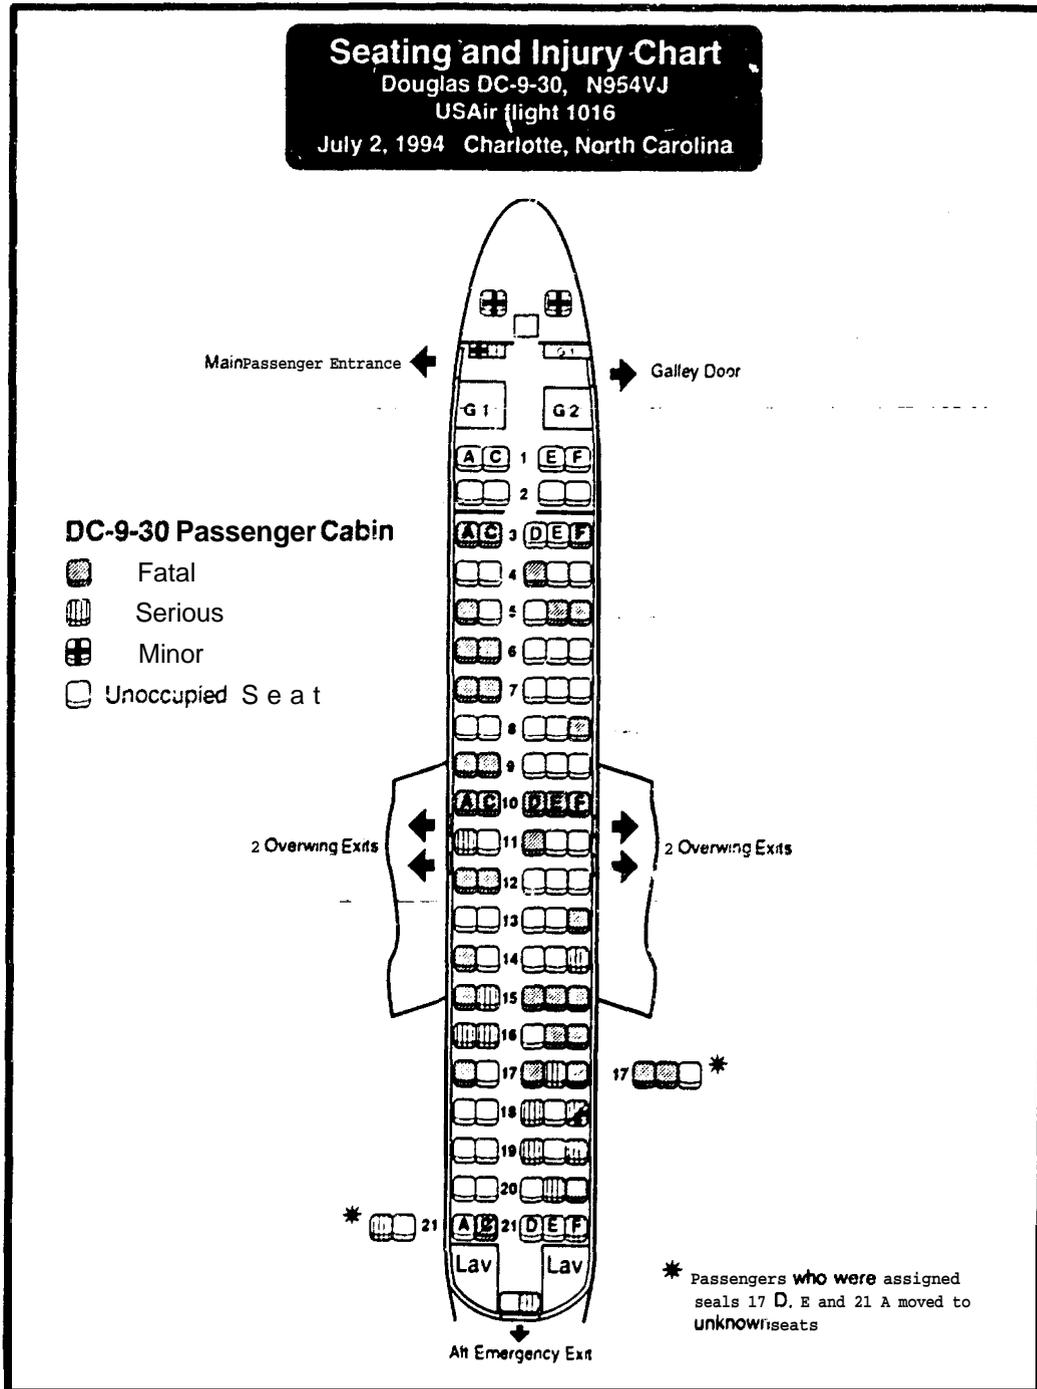
Figure 3.--Cabin diagram.

A 9-month-old infant, who was unrestrained in her mother's lap in seat 21C, sustained fatal injuries. The mother was unable to hold onto her daughter during the impact sequence. Seat 21C was intact and the surrounding cabin structure sustained minor deformation. Additionally, the impact forces in this area were calculated to have been within human tolerances. According to passengers, a flash fire swept through the inside of the cabin during the impact sequence; examination found no evidence of either fire or smoke impingement in this area of the cabin. (See figure 3.)

The two lap children were seated in 18F and 21C. The 18-month-old female infant was lying across seats 18E and 18F. This infant sustained serious injuries, and her mother sustained minor injuries. The other lap child, a 9-month-old female infant, was being held by her mother in 21C and sustained fatal injuries. According to the mother, she was unable to maintain a secure hold on her child during the impact sequence.

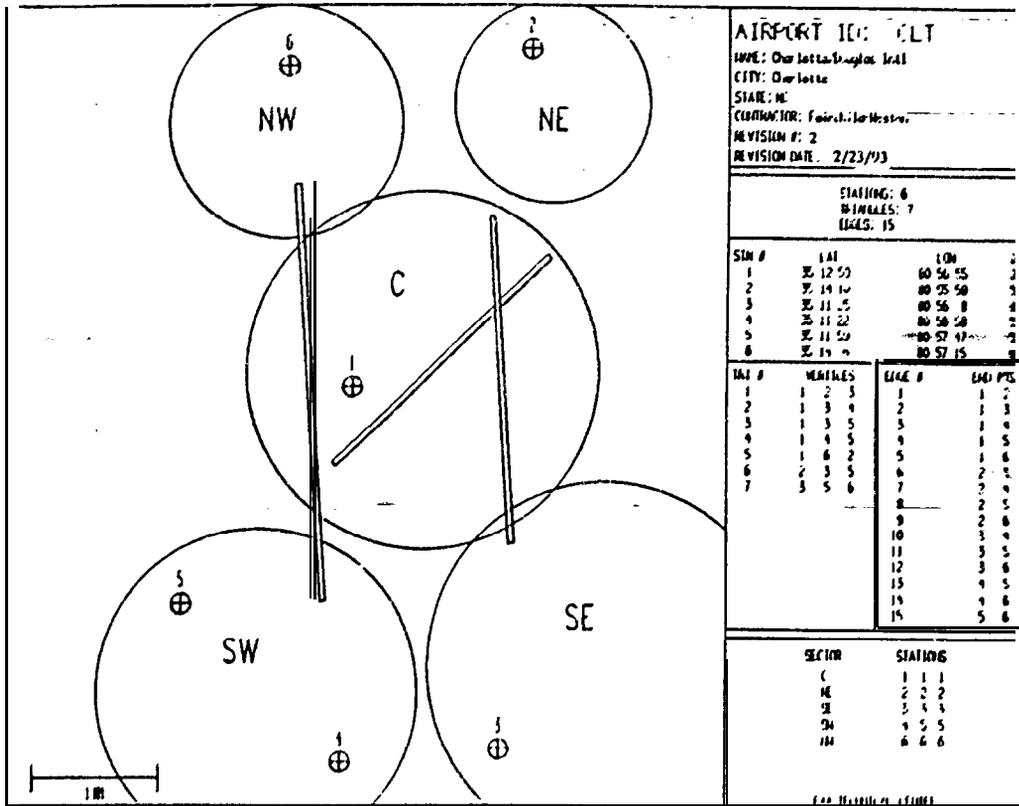
LLWAS SENSOR LOCATIONS

Although the Charlotte LLWAS system was recertified after the accident, it was the subject of several internal communications within the FAA between April and June of 1993. The system was identified as having problems, specifically, "inaccurate reporting of wind conditions." The Safety Board found that while funding requests for system upgrades were made, there had been no modifications to the system at the time of the accident. In addition, on August 4, 1994, the FAA cited in its written response to the Safety Board regarding the performance of the Charlotte LLWAS system "...at the time of the installation of the CLT LLWAS, the concern was to detect gust fronts, not microbursts" and the siting "...standards were less stringent than those now currently used." The FAA further stated that a Site Performance Evaluation Study (SPES), conducted at Charlotte after the accident, determined that sensor 2 (northeast boundary) and sensor

6 (northwest boundary) were sheltered by obstacles "...significant enough to degrade the system.."
