Final Report

On the accident on **1st June 2009**
to the **Airbus A330-203**
registered **F-GZCP**
operated by **Air France**
flight AF 447 Rio de Janeiro - Paris

BEA

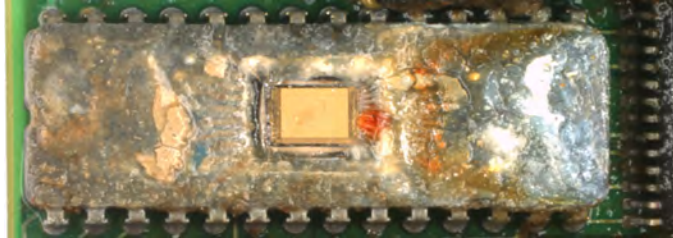
The two computers were examined. The memory components containing the data were damaged. One of the components had been torn out and the other suffered from internal short-circuits. The work was brought to a conclusion.

Figure 30: Memory component from one of the FCDC

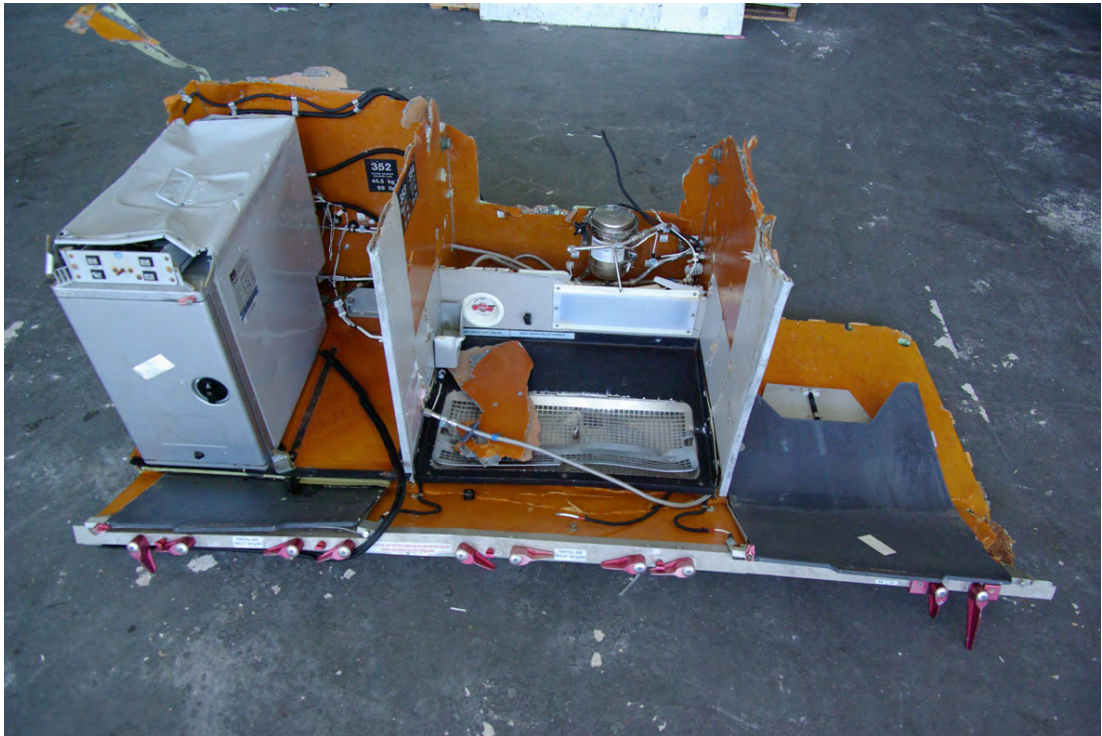
The overhead luggage rack attachment fittings had deformations that are due to vertical compression and to a forward movement of the luggage racks.

Figure 35: Part of Galley G3: downwards deformation at the level of the galley's heavy parts

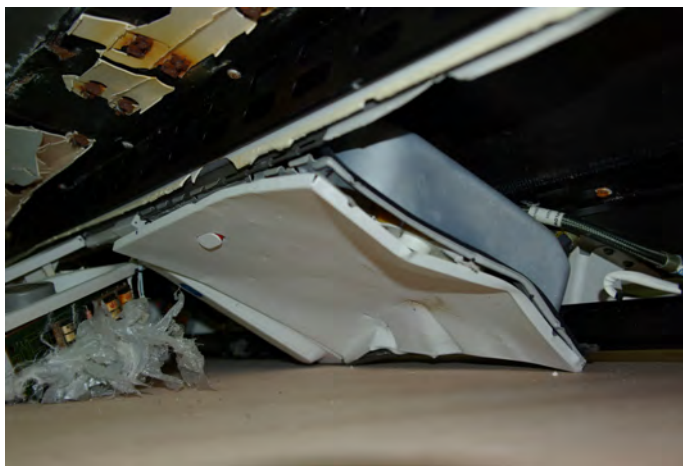
Figure 40: Passenger oxygen container recovered closed:
the deformations on the cover matched those on the box

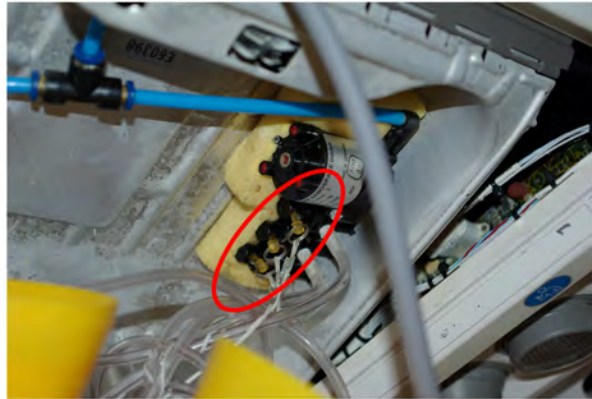
In normal operation, the oxygen is sent to the mask when the passenger releases the system's lock-pin by pulling on the mask. Several pins were found in place, closing the oxygen circuit.

Figure 41: Passenger oxygen container recovered open: the three pins are in place

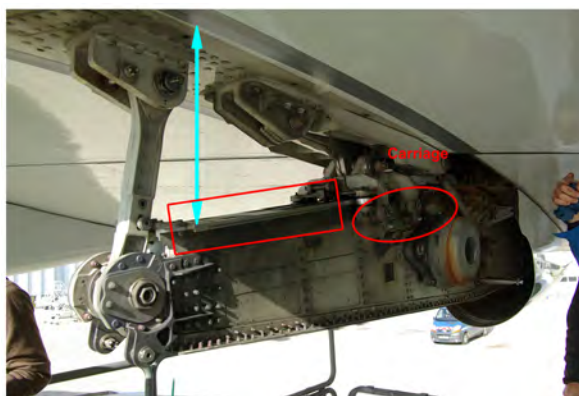
Several parts of the flap extension mechanism fairing were found. There were marks on two of them (positioned at the level of flap track N°3), made by the flap extension track on impact. Analysis of these marks (morphological and dimensional examinations) and comparison with an identical aeroplane made it possible to determine that the flaps were in the “retracted” position (see photo below) at the time of impact with the water (measurement of the distance between the track and the lower surface of the flap, position of the carriage on the track).

Figure 42: Flap extension mechanism (or flap track) No. 3 in retracted position

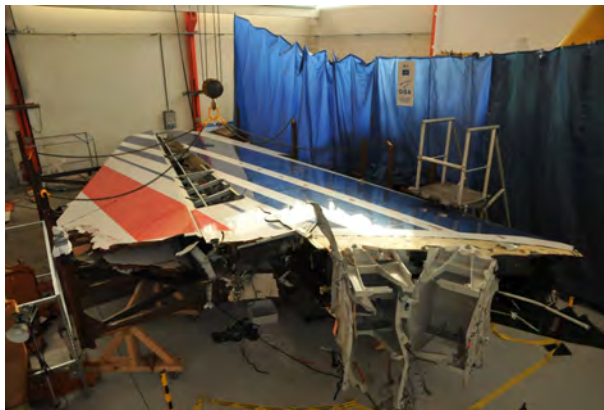
- ❑ The forward attachment (male and female lugs) and the lower part of the side panels (lug reinforcements) were missing;
- ❑ The centre and aft attachments were present: male and female lugs and parts of the fuselage frames.

Figure 44: Fin – In the foreground the base of the fin with the central and forward attachment lugs

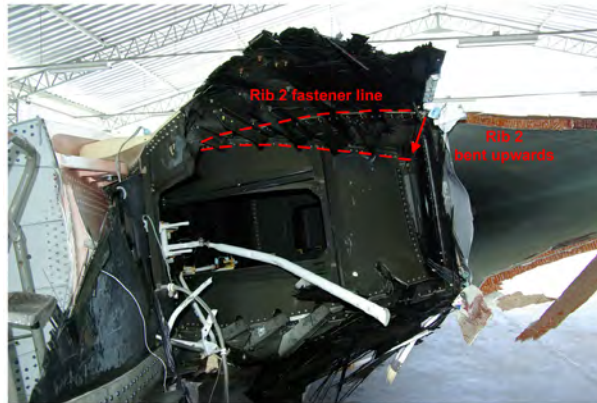
- ❑ Failure of the leading edge right- and left-hand panels
- ❑ Longitudinal cracking of the leading edge stiffener
- ❑ HF antenna support (attached to the forward spar): failure of the lower part, crumpling indicating bottom-upwards compression loads.

Figure 45: Rib 2 bent upwards as a result of bottom-upwards compression loads

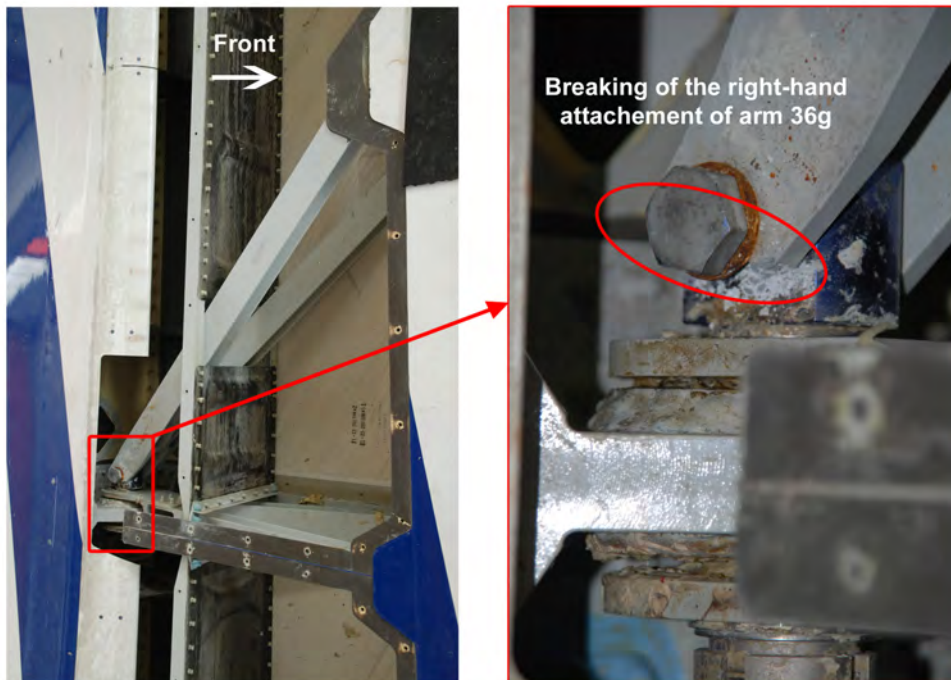
The size of this arm is calculated to withstand a maximum load of 120,000 N, corresponding to a relative acceleration of 36G of the rudder in relation to the vertical stabilizer.

Figure 47: Arm 36G, right view: failure of the rudder attachments

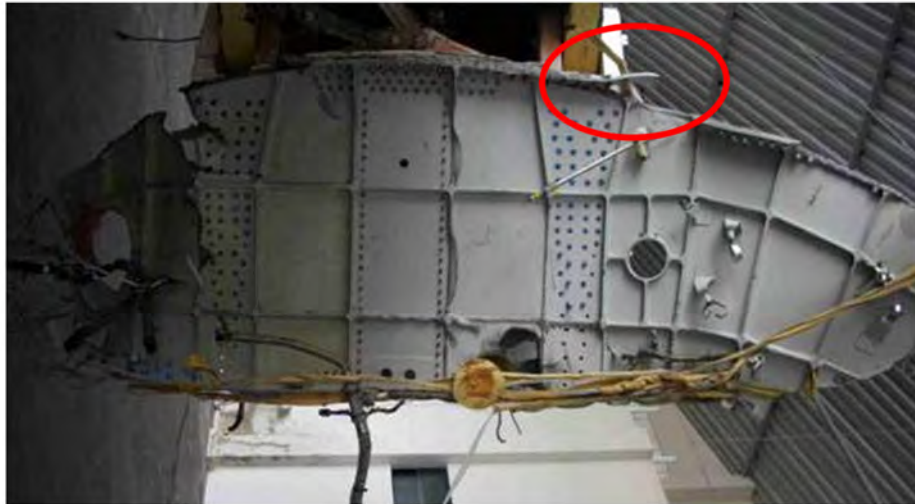
The fuselage was sheared along the frames and centre and aft attachment lugs by loads applied bottom-upwards.

Figure 48: Frame 87: shearing of the frame and fuselage skin along the frame

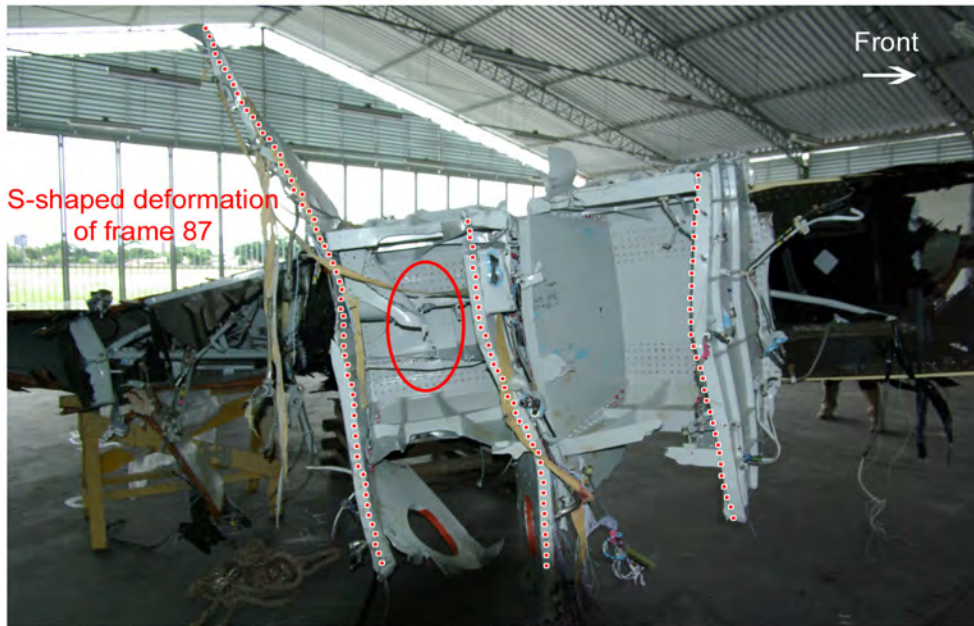
The part of frame 87 that can be seen had undergone S-shaped deformation: the left-hand side forwards, and the right-hand side backwards. The horizontal stabiliser actuator supports were deformed and broke in a backwards movement from the front. These observations indicate a backwards movement of the trimmable horizontal stabiliser.

Figure 50: Frames 84 to 87: S-shaped deformation of frame 87, with frames 84 and 85 pushed in backwards; failure of the horizontal stabiliser actuator supports between frames 86 and 87 (red circle)

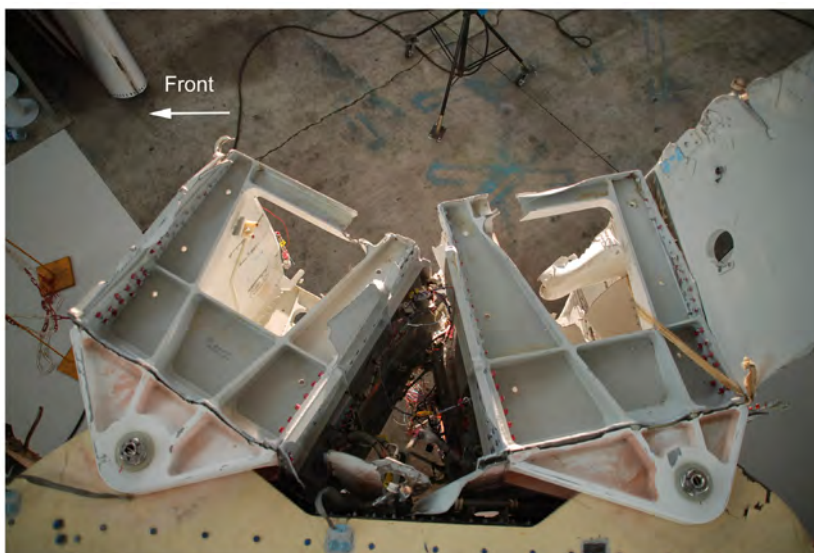
The centre attachment had pivoted backwards with the parts of the frames and web frames that were attached to it. The aft attachment had pivoted forwards with the parts of the frames and web frames that were attached to it.

Figure 51: Fin centre and aft attachments

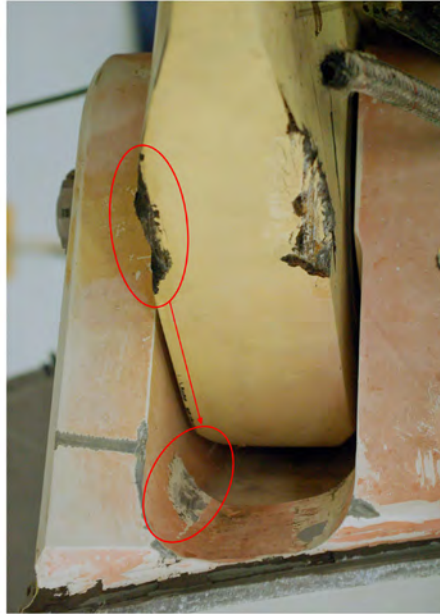
The aft attachment lugs (male on the fin and female on the airframe) had marks indicating a backwards movement of frames 86 and 87 as a whole.

Figure 52: Rear view of the left-hand aft lug: there were marks showing a backwards pivoting of frames 86 and 87

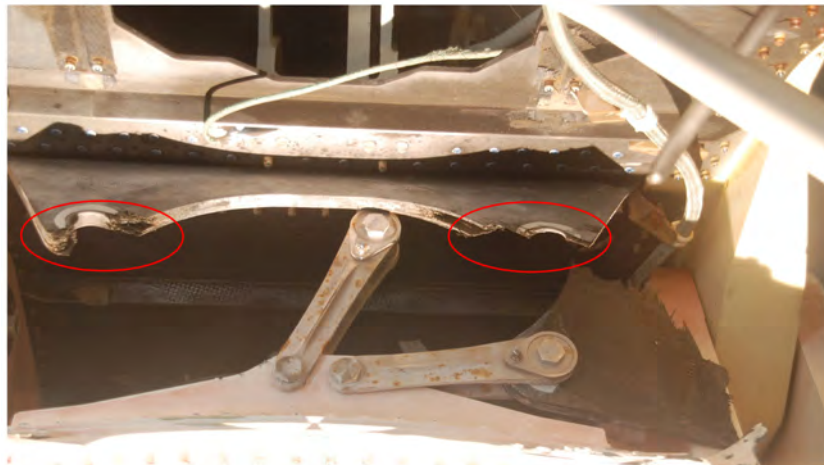
- ❑ Tensile failure of the centre spar at the level of the centre rod attachments;
- ❑ Compression failure of the aft spar at the level of the aft rod attachments and failure of the left-hand rod by buckling.

Figure 53: Tensile failure of the centre spar at the level of the attachment of the lateral load pick-up rods

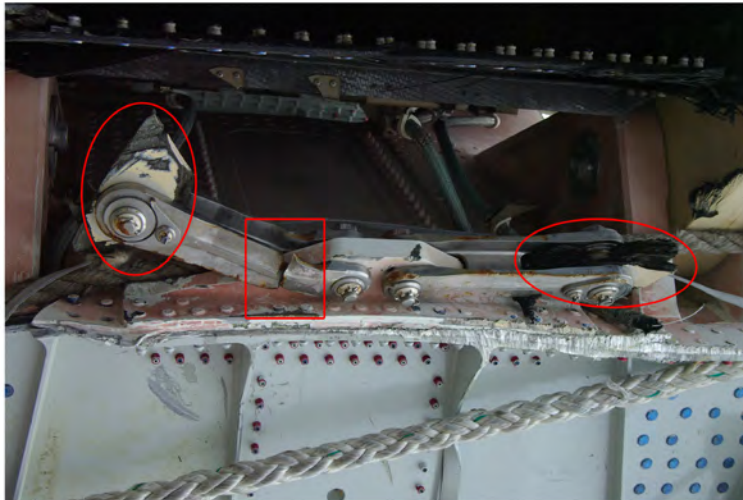
Figure 54: Compression failure of the aft spar at the level of the attachments of the lateral load pick-up rods and failure of the left-hand rod by buckling

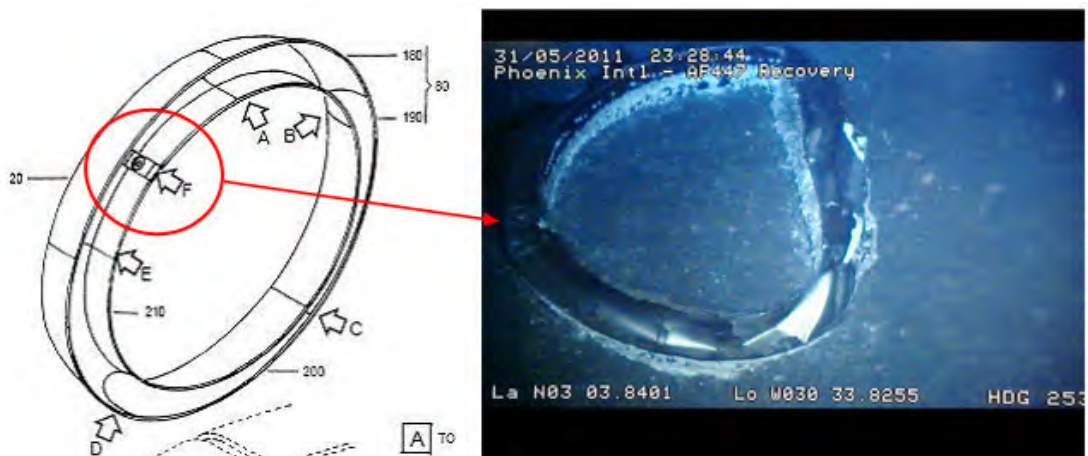
The left engine air entry leading edge had significant deformation on its lower part.

Figure 57: Left engine air intake
