Aircraft Icing

TAKE-OFF ICING ACCIDENTS

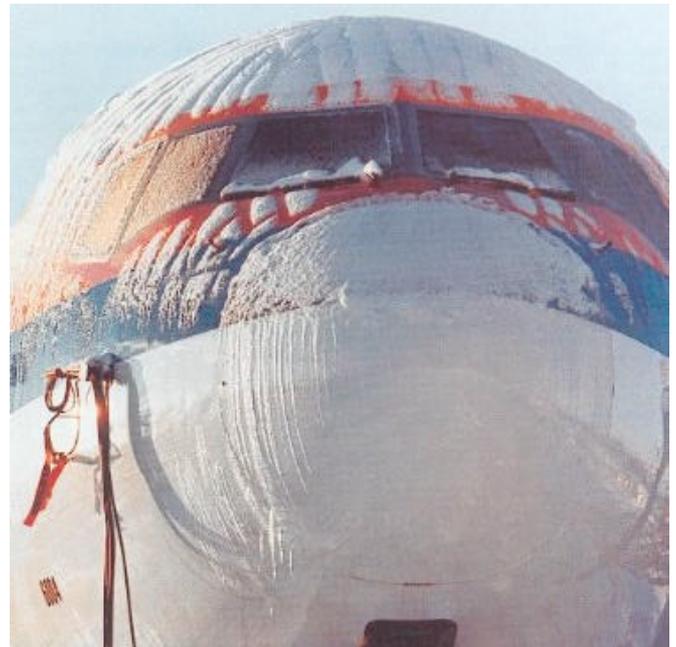
RYAN DC9-15, FEBRUARY 1991 (CLEVELAND, USA)

The aircraft was on a night mail flight with an en-route stop at Cleveland. Moderate rime icing between 7000 feet and the surface had been reported so the crew probably used anti-icing for the approach. The aircraft stood in dry blowing snow for the 35 minutes that it was on the ground. Falling snow melted on the initially hot wings before refreezing as the wings cooled to below freezing. As more snow fell onto this ice layer it was also frozen and formed a thin rough layer of "sand paper" ice which the crew were unlikely to have seen even if they had done a walk-around - they did not leave the aircraft.

On take-off, shortly after the positive rate call, sounds of compressor surges were heard on the CVR. This was followed by the stick shaker and the sound of impact with the ground.

The Tower Controller said the aircraft had reached a height of about 100 feet before it made a quick bank left, followed by a quick bank right, after which a " fireball " came out of the rear of the aircraft. The aircraft banked right to 900, increased pitch attitude and continued to roll past 900 before impacting the runway inverted. The NTSB noted that this combination of events was consistent with an abrupt and asymmetrical stall as the aircraft left ground effect. Tests by the manufacturer showed that compressor surges occur due to the disruption of the airflow aft of the wing when it is stalled. The stall occurred 27 knots above the theoretical stall speed. The 30 percent reduction in lift was due to a snow / ice accumulation that may have been less than 0.5 mm thick and barely perceptible by visual examination.

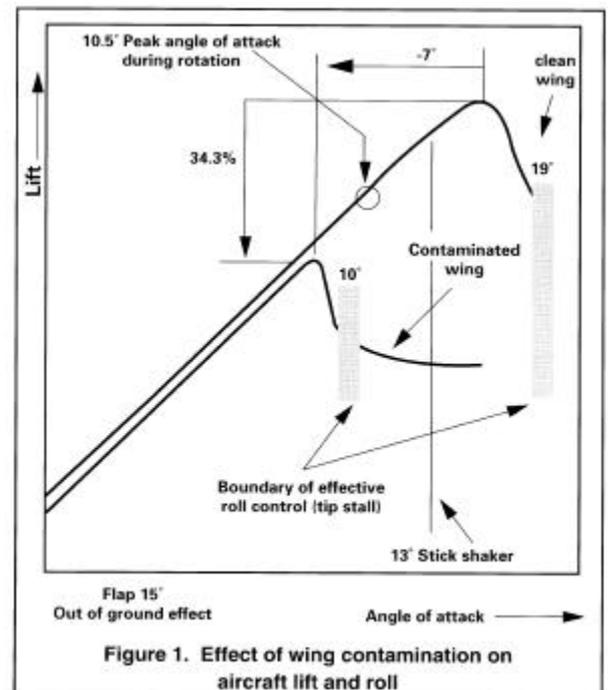
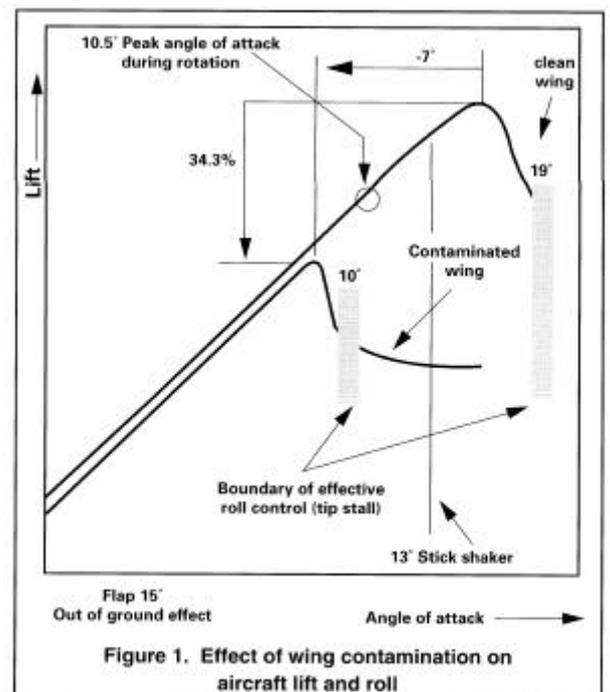
The combination of reduced thrust, increased drag due to the airframe icing, subsequent stall and ensuing crash into the river are perhaps best explained by the two graphs (figures 1 and 2) obtained from flight and wind tunnel tests on a Fokker F100. The data was obtained from wind tunnel tests on models with various sizes of uniformly distributed roughness over the entire wing upper surface, as well as from flight tests with simulated rime ice and sandpaper roughness on the leading edge.

As with all aircraft types, wing contamination can reduce the maximum lift by up to 34 percent and, simultaneously, reduce the angle of attack for maximum lift by up to 7°.

When the clean aircraft is rotated smoothly at V_r with a pitch rate of $3^\circ/\text{sec}$ the peak angle of attack will be approximately 10.5° . An uncontaminated wing will still have a 25° margin before activation of the stick shaker and a 5.5° margin before maximum lift is reached. With a contaminated wing, however, the stall will occur at about 9° , which is about 1.5° lower than the angle of attack already achieved by the aircraft and well below the 13° at which stick shaker activation will occur. Aggravating the situation is the fact that the stalling of a contaminated swept wing is usually accompanied by a pitch-up tendency which pitches the aircraft deeper into the stall.

As can be seen in Figure 1, the boundary of effective roll control for a clean wing is 19° compared to only 10° for the contaminated wing. Aggravated by the probable asymmetric contamination of the wings, an asymmetric stall may be accompanied by a violent, uncontrollable roll.

In Figure 2 the drag of the aircraft with clean wings is such that the climb capability is ensured at the required climb angle at V_2 with one engine inoperative. However, with a stalled contaminated wing the drag may be more than doubled to the point where even with both engines at take-off thrust, climb capability may be lost.

The study concluded that, with no means of relating the amount of ground icing contamination to its effect on the aerodynamics of an aircraft, no take-off should be attempted unless it is first ascertained that all critical surfaces are free of ice snow or frost deposits. A further simulator study done by Fokker on alternative take off methods such as reduced rotation rate, lower pitch angle, increased rotation speed and combinations of these three methods showed a considerable increase of up to 43 percent in runway distance required to the screen height of 35 feet. Furthermore, the simulator trials only considered the symmetrical wing contamination case. The more severe case of non-symmetrically contaminated wings was not even considered. Perhaps the following extract from a letter by Douglas to the NTSB best sums the situation up :

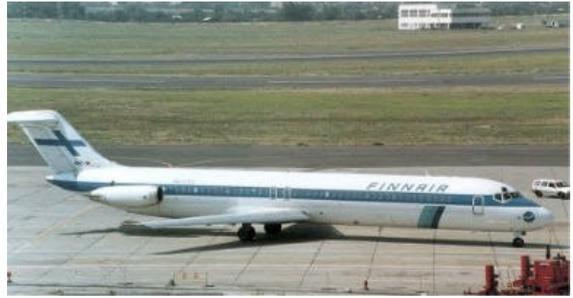
If the aircraft then lands at an airport with a readily available source of moisture such as rain, drizzle, heavy fog, high humidity, etc. and an ambient temperature between -40 and +10° Celsius (even up to +15°C), the moisture will freeze on contact with the top surface of the cold soaked wing and form ice. The ice formed is usually clear ice, and because the entire surface of the wing, icy and non icy areas alike, is often wet and shiny, the ice is very difficult to see.

If the ice is not detected and removed prior to departure, then the flexing of the wing during the taxi for take-off may loosen some of the ice which can be ingested by the engines during take-off causing ice foreign object damage. This damage often manifests itself as a buzz or vibration in the aft cabin, and in extreme cases may cause compressor stalls/ surges, significant power losses or even flame-outs.

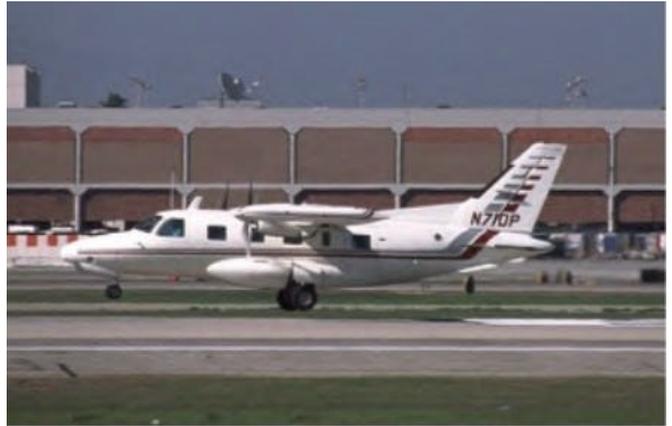
MU-2s have had at least 15 icing related accidents and 46 incidents, mainly involving heavy aircraft above FL150. The most frequent type of incident involved a rapid speed loss caused by icing. However, many of the incidents and all of the accidents involved a rapid speed loss due to icing followed by a stall and loss of control. A typical example was an MU-2 cruising-at FL210 at night. The pilot gave ATC a routine position report one minute before radioing, *"Mike Uniform Alpha's out of control, going down"*. Thirty seconds later, apparently under high physical stress the pilot made his last call: *"we are in ice and spinning down through 8000 feet"* :

No Recovery, No Survivors !
