### Accident Investigation Final Report

All Engines-out Landing Due to Fuel Exhaustion

Air Transat  
Airbus A330-243 marks C-GITS  
Lajes, Azores, Portugal  
24 August 2001

22 / ACCID / GPIAA / 2001

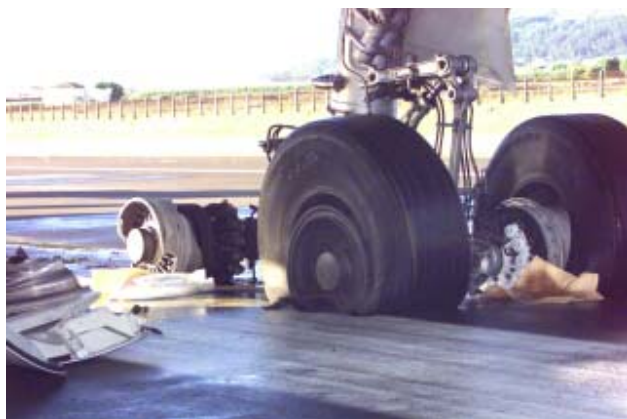
**Figure 2 - Left-main Boogie**

Due to the engines-out condition, the landing was conducted without the brake anti-skid and normal braking systems. Because the emergency brake accumulator only provides for a limited amount of brake applications, full braking was applied and retained at the second touch down, resulting in the main wheels locking up. The tires quickly abraded and deflated at a point between about 300 and 450 feet beyond the second and final touch down. The segments of the main wheels contacting the pavement were worn down to the bearing journals, the left, rear, inboard wheel detached from the axle. Both left and right brake anti-torque links attachment horns on the bottom segments of the main oleos also contacted the pavement; the horns were abraded to the point that some of the links separated from the oleo resulting in the rotation of at least one brake carrier.

Shedding of brake and wheel components during the landing run also resulted in a combination of punctures and impact damage to the airframe and left engine nacelle.

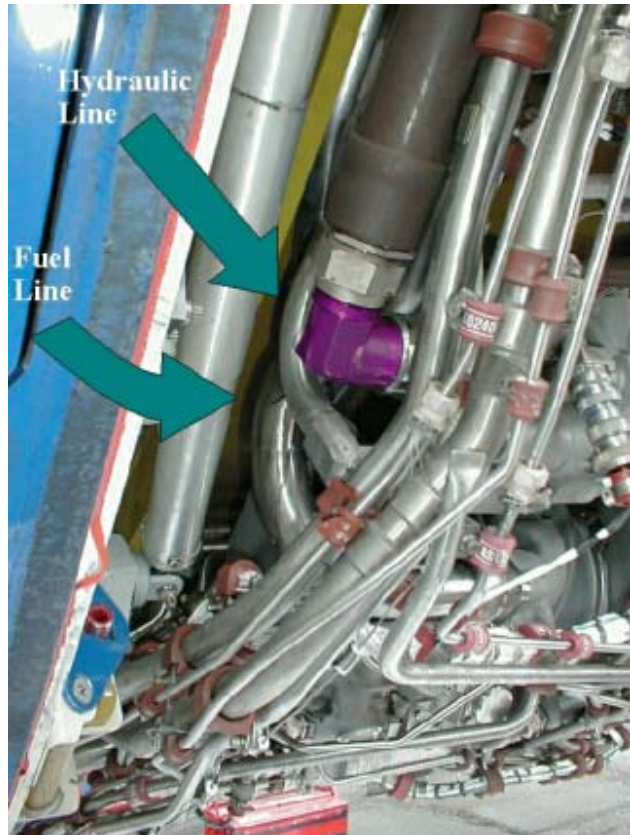
Figure 3 - Right Engine Pipe Contact

Both reports concluded that the fuel and hydraulic tubes fully matched the drawing characteristics for material, form and shape. The fuel tube wall section was measured and showed that the wear had reduced the wall thickness by 0.005 inches, and that the hard contact had resulted in a dent measuring 0.044 inches deep. The examination concluded that the fuel tube fractured in high cycle fatigue at multiple initiation sites in the bore and the outside diameter, due to a combination of vibratory stresses being superimposed on the tube deformation. Also noted were some scratches and deep scores around the chafed location on both tubes. Report MFR 41281 stated that these marks are believed to have been made at the time of installation of the engine because this was the only time the post-SB fuel line and pre-SB hydraulic lines were mounted adjacent to one another. The report con-

cluded that the scratches and scores were directionally aligned and that they could have been caused from repeated contact from a blunt instrument, such as a screwdriver being inserted between the tubes in order to force a clearance between them. There were no cracks initiated from the score or scratch marks.

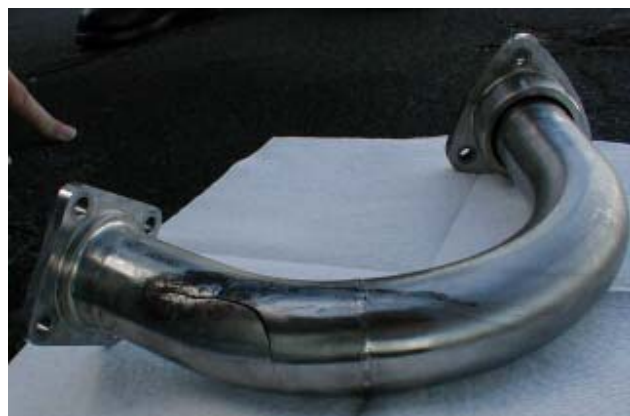
Figure 4 Fuel Pipe Crack & Scratches

The initial inspection of the right engine following the occurrence uncovered the presence of an L-shaped crack on the inlet fuel tube wall (Part No FK30383). The crack was approximately 3.0 inches (80mm) long, and was spread to a width of about 1/8 inches (2.5mm). In addition, the hydraulic outlet tube (pressure) for the rear hydraulic pump was found to be in hard contact with the fuel tube. The cracking on the fuel tube extended to both sides of a mechanically worn (chafed) area where the tubes came into contact. It was evident that the interference and chafing occurred due to the mismatched installation of the post-mod fuel tube (P/N: FK30383) and pre-mod hydraulic tube (P/N: LJ51006). Based on the DFDR data, it was determined that the fuel leak rate through this cracked reached a maximum of about 13.0 metric tons per hour.

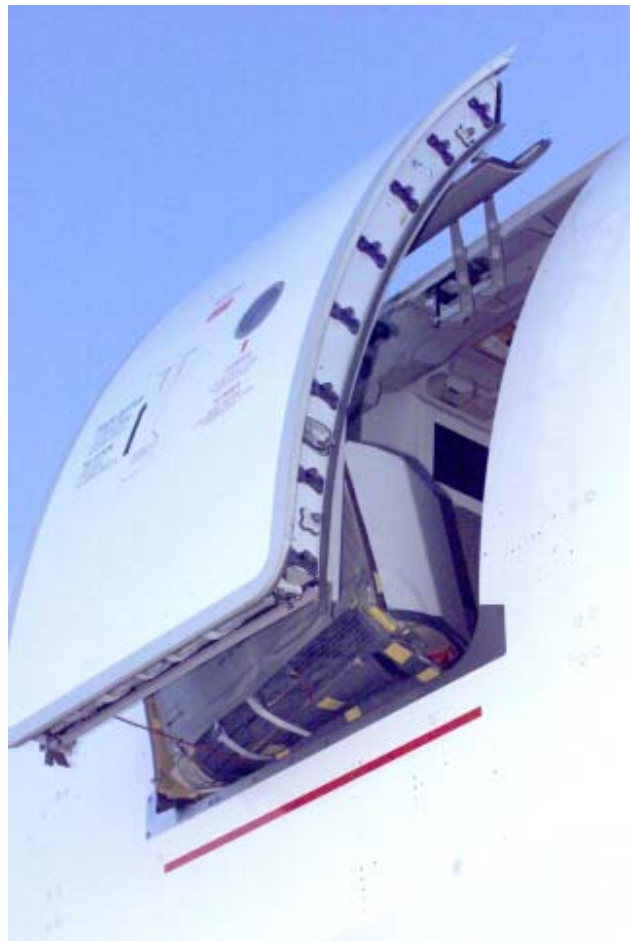
Figure 6 - Door L3 Jammed

The L3 flight attendant reported that, prior to departure, door L3 had been armed and that the indicator at the door indicated that the door was properly armed. The indicator at the FD's panel also indicated that the door was armed. Following the evacuation, the L-3 attendant examined the door and the slide appeared to be partially attached to the exit door. A photo taken of the door from outside the aircraft showed the L3 door partially opened and the escape slide slightly askew and apparently connected to both the floor and the door.

Sometime after the landing, fire-rescue crews, in attempting to eliminate the hazard of the escape slide inflating within the cabin, used a pry-tool to release the slide and open the door. Reportedly, when the door was opened, the slide fell out the door and only inflated partially.

Inspection of the L3 exit did not reveal any damage to the door or frame, other than minor scratches and minor damage to the plastic panel in the area where the pry bar was used. When operated by investigators, the door opened and closed without any restriction and no mechanical distortion or malfunction was found either with the arming system or with the locking/unlocking of the girt bar. An examination of the power-assist unit indicated that it had been activated.

Conclusive finding as to the cause of the door jam could not be made, primarily because of the missing components. Notwithstanding, interviews and photos confirm that the slide had not released completely from the door, and that the bustle rails/rail adapters may have jammed.
