USAir Flight 1016

USAir 1016

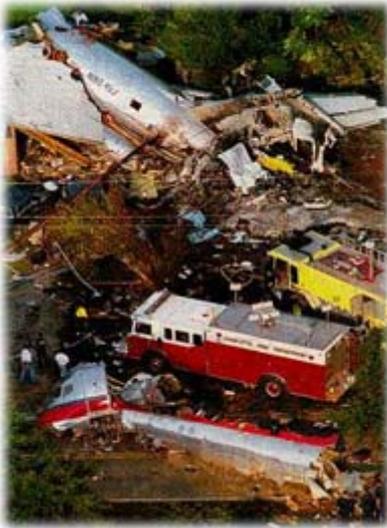
It was a stormy evening July 2, 1994 as USAir flight 1016 approached Charlotte/Douglas International Airport. There were 57 people aboard the DC-9 as it began its ILS approach to runway 18R. A windshear alert was issued as 1016 began its descent down the glideslope. As the crew neared the airport, they encountered the windshear and decided to execute a missed approach. As they rotated the aircraft to go around, they turned slightly to the right. Passing the airport, the aircraft continued to descend. It struck trees and telephone poles before impacting the ground. 37 people were killed.

It was clear that 1016 had encountered thunderstorm and microburst activity. Severe weather lay over the airport and along the approach path at the time of the accident. The airport was scheduled to have terminal Doppler radar installed, but it was behind schedule and not functional the the time of the accident. Had it been, more pertinent information would have been available to the crew concerning the existing conditions. Another indicator of the lack of significant weather information being disseminated to the crew was their decision to turn right during the execution of the missed approach. The airport's Doppler radar showed that the weather was actually worse on that side of the runway. Throughout the last moments of the flight, 1016 encountered a windshear of an incredible 61kts. The aircraft's onboard software was not advanced enough to recognize windshear in a timely manner, preventing the crew from being able to make a more pertinent decision. The airport did have surveillance radar, but ATC procedures did not require the controllers to alert crews as to developing weather, including two other windshear alerts which had occurred prior to the accident. The crew's go-around procedure was begun

correctly, the aircraft's nose rotated up, but the power was not advanced. That, together with the increasing tailwind, caused the aircraft to approach a stalled condition. The crew then lowered the nose to avoid the stall but their descent rate increased, causing them to impact the ground. Investigators cited USAir's inconsistent training procedures regarding windshear penetration and missed approach procedures which were not resolved by the FAA.
