Preventing HARD Nosegear Touchdowns

FLIGHT OPERATIONS

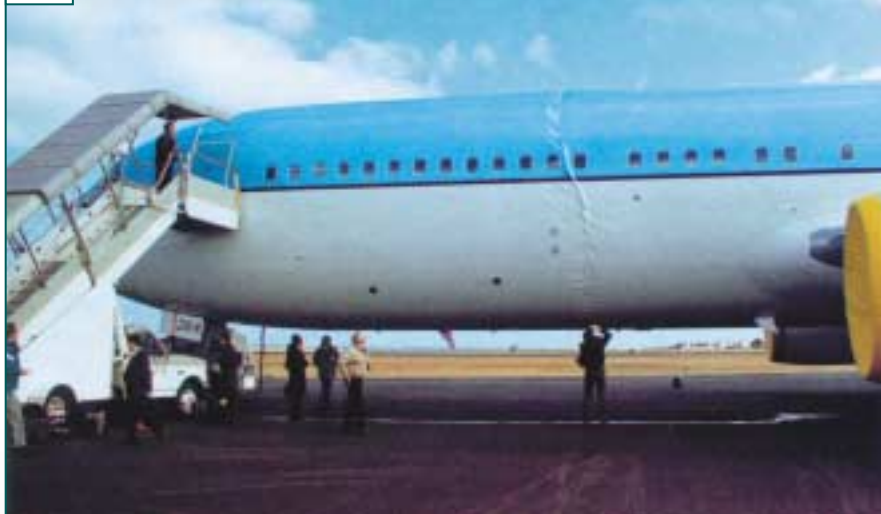
1 DAMAGE TO FORWARD FUSELAGE

Hard nosegear landings can produce heavy loads on the nosegear and its support structure. The resulting high stresses in the forward-fuselage upper crown and between the flight deck and wing front spar can cause the fuselage structure to buckle. Appropriate actions by the flight crew can help prevent such incidents. Understanding which actions are appropriate requires a discussion of the following:

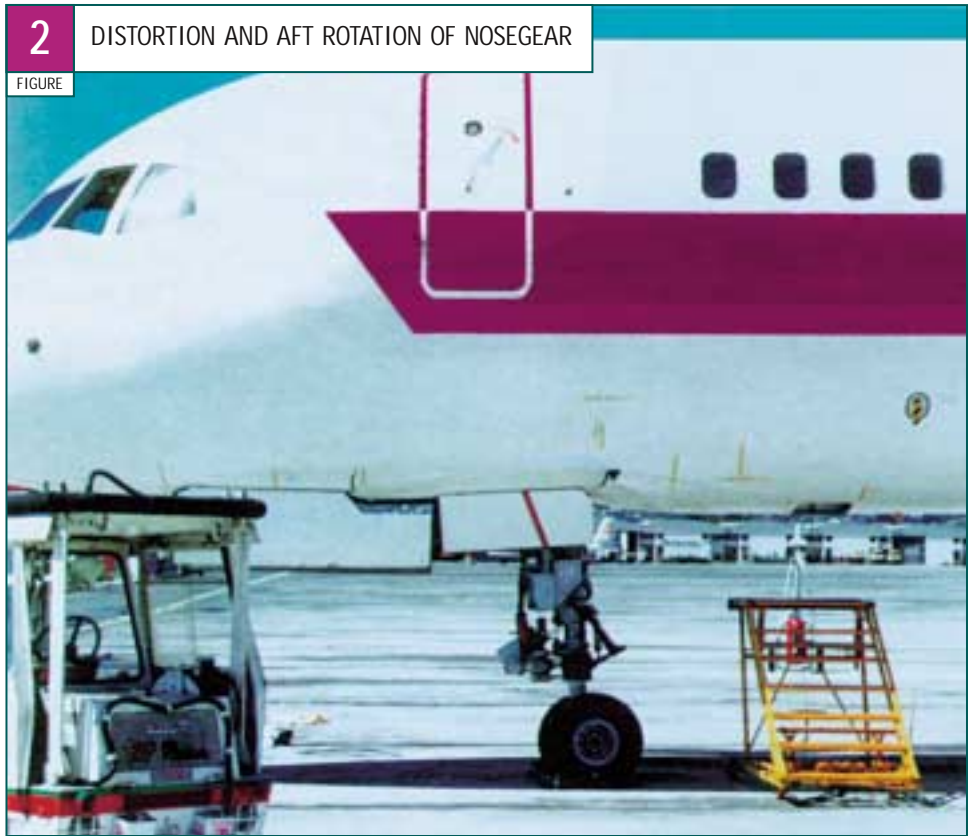
2 DISTORTION AND AFT ROTATION OF NOSEGEAR

An airplane returned to the departure airport following an in-flight engine shutdown. The airplane landed firmly on the main gear. Recordings

by the digital flight data recorder ended abruptly because of damage from the nosegear contact; however, the last data point showed that considerable forward control column movement had been applied. The nosegear was rotated aft and to the left of its normal position, resulting in damage to the lower fuselage and nosegear wheel well area (fig. 2).

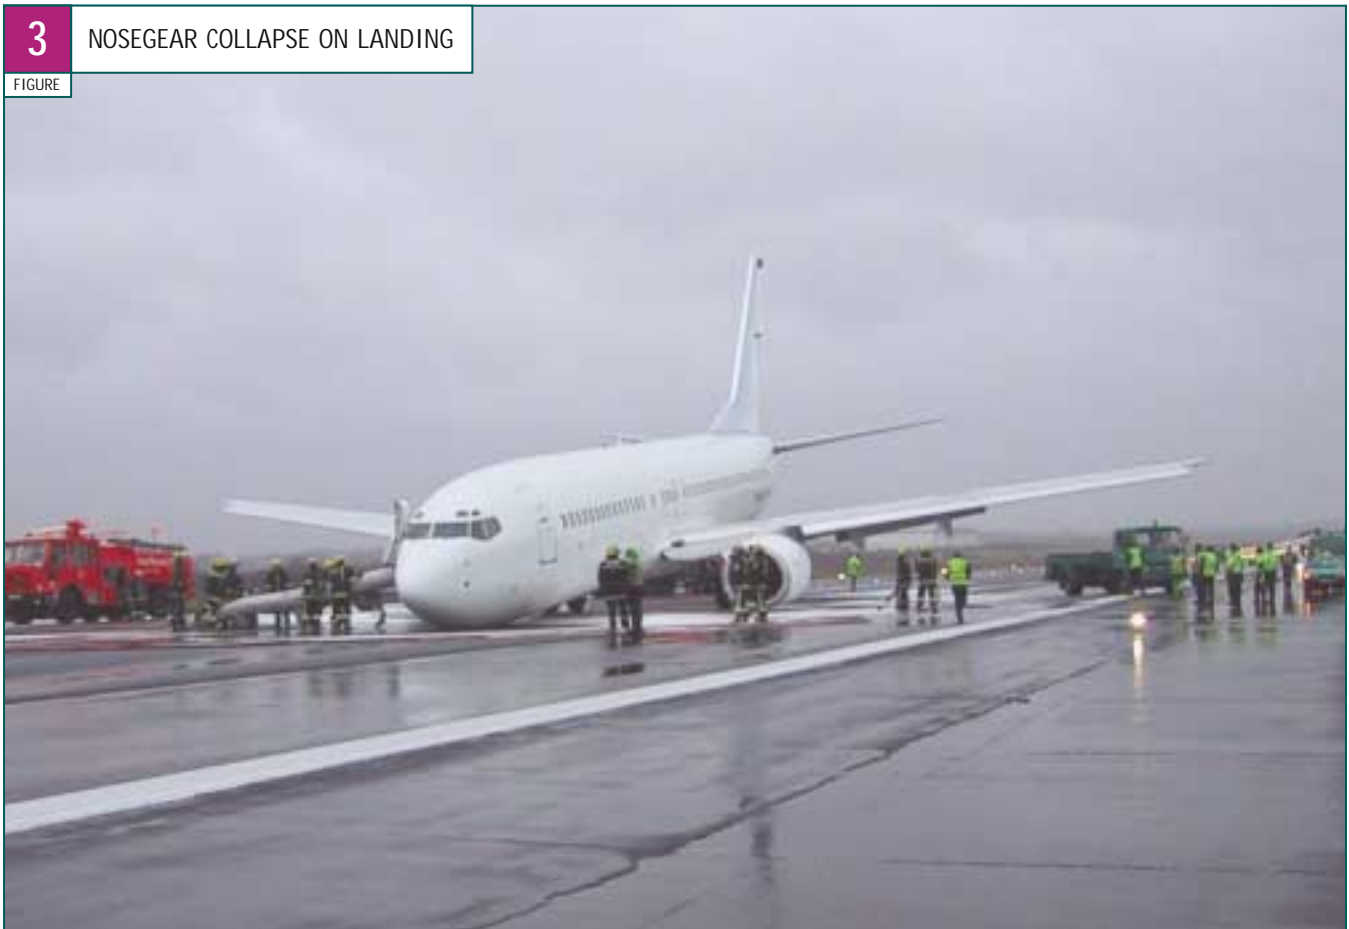
3 NOSEGEAR COLLAPSE ON LANDING

An airplane landing in strong crosswinds and turbulent conditions touched down on the main gear firmly, but not abnormally for the conditions. The airplane bounced, full forward column movement was applied, and the nosegear contacted the runway very hard, causing the nosegear to fail and rotate upward in the aft direction. The nosegear wheel assembly penetrated the electronics bay and caused considerable damage (fig. 3).

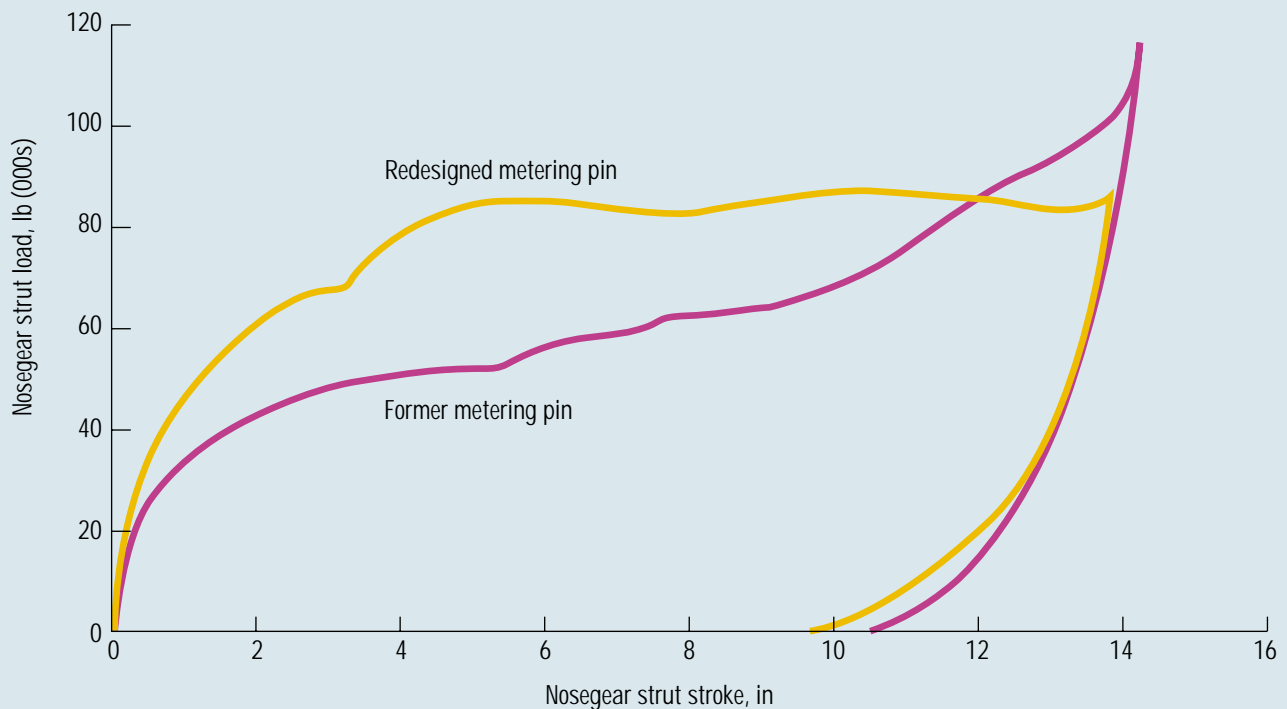
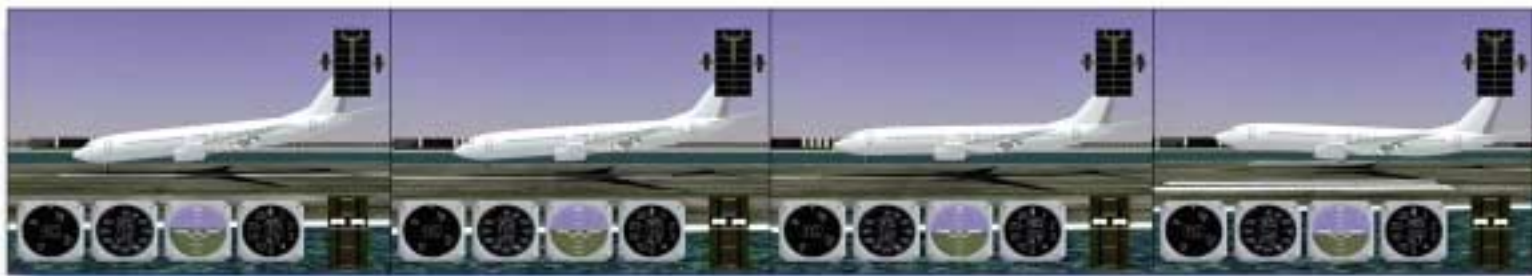
4 NOSEGEAR LOAD VERSUS STROKE FOR PITCHOVER

The most recent design enhancements involve the 767. The 767-300 nosegear metering pin has been further optimized to absorb the energy produced during overderotation events, thereby lowering the load on the nosegear (fig. 4). The metering pin device controls the flow of hydraulic fluid within the nosegear oleo strut. The design enhancement was incorporated into production airplanes in August 1994 and is available for retrofit on earlier 767-300s.

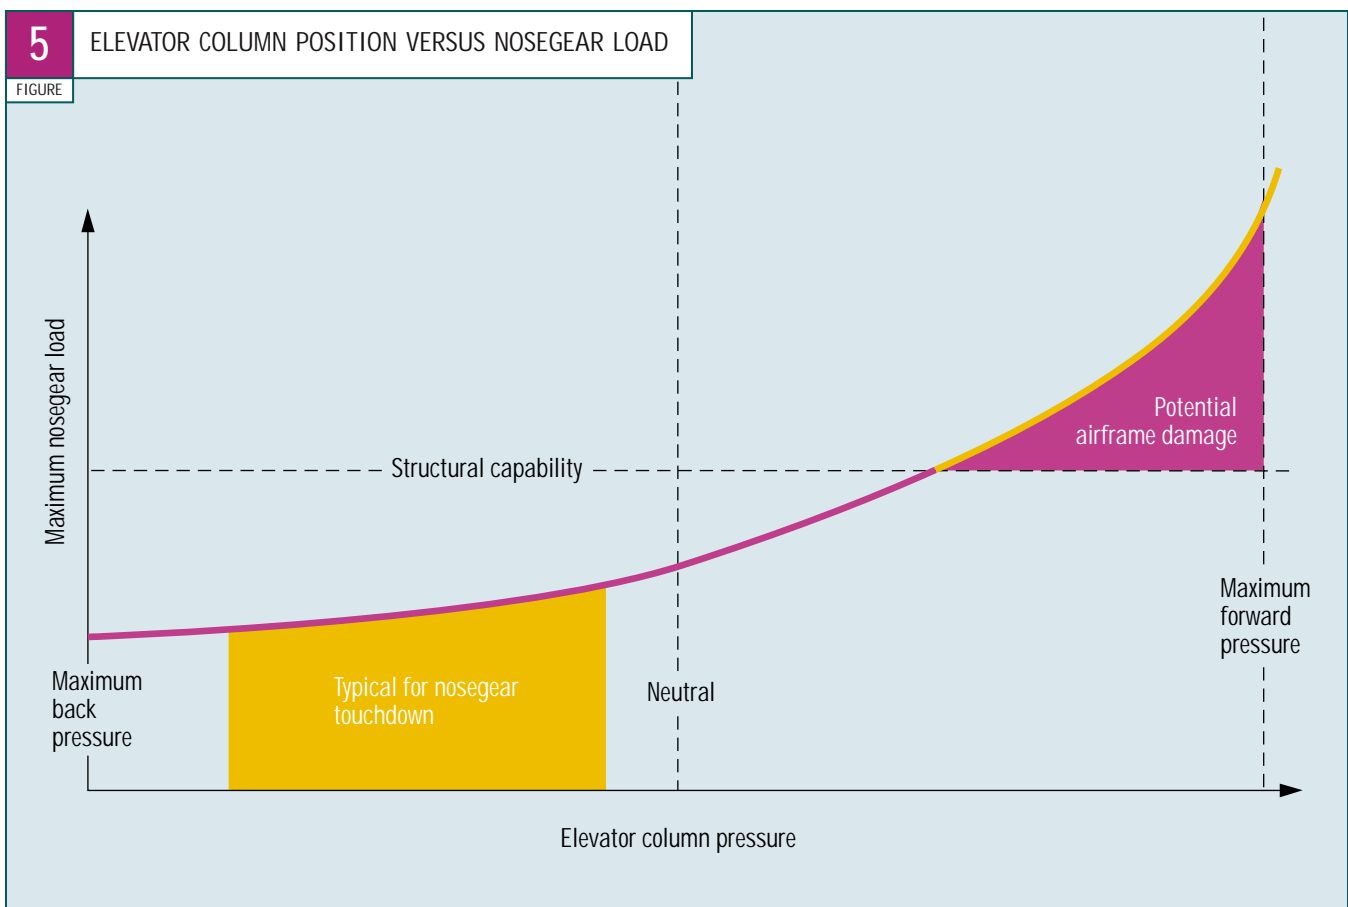
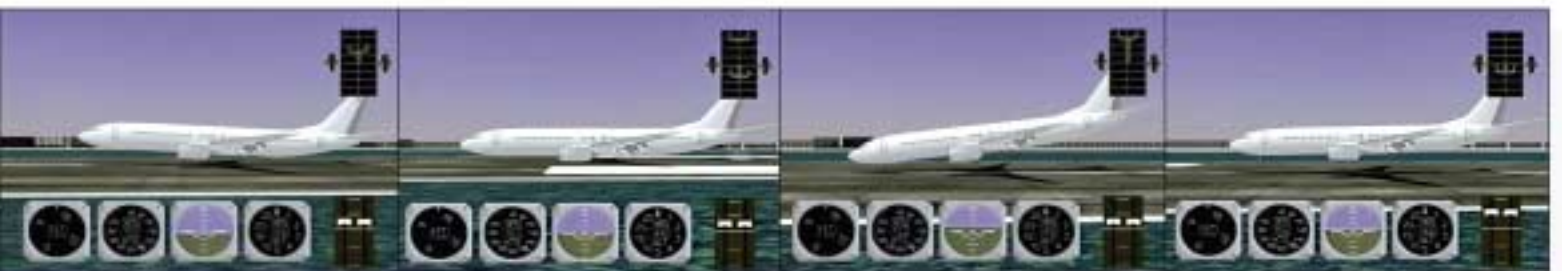
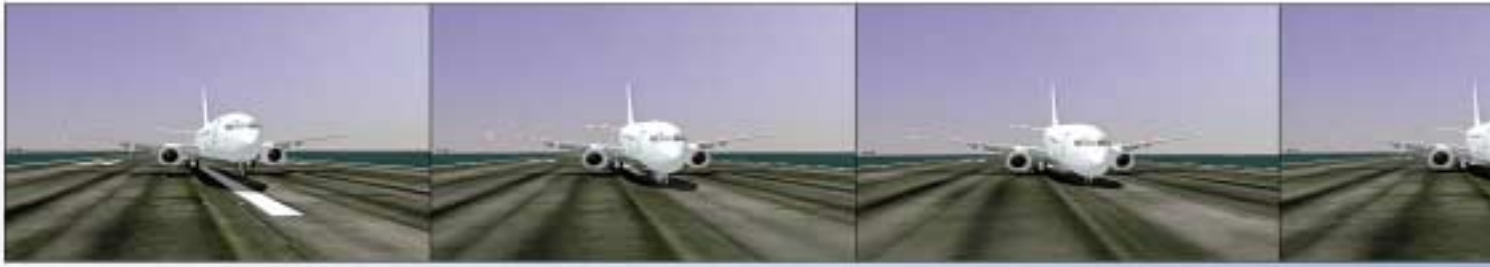
damage from hard nosegear contacts. Examination of airplane flight recorder data from these incidents revealed that, in each case, full or nearly full forward column movement was applied between the time of main gear contact and nosegear touchdown. Figure 5 shows that enough nose-down elevator authority exists to damage the airframe structure if the airplane is rapidly derotated following main gear touchdown. This is possible because the maximum nose-down elevator authority is designed to control go-arounds, which require

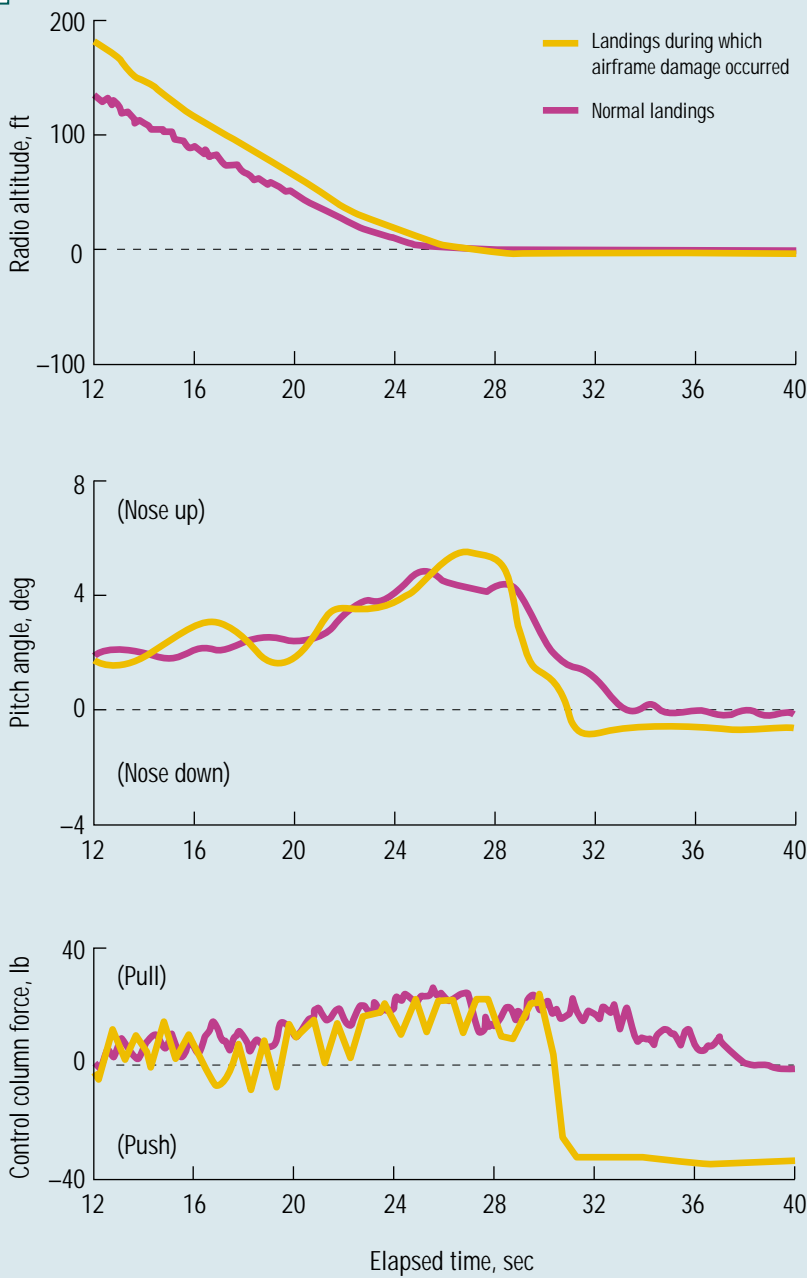
6 RADIO ALTITUDE, PITCH ANGLE, AND CONTROL COLUMN FORCES—NORMAL AND HARD LANDINGS

relaxing aft column pressure. When heavy brake applications are needed, with and without autobrakes, increased aft column pressure may be required to slow the derotation rate. Flight crews should not hold the nose up in the touchdown attitude or allow the nose to rise because either could result in a tail strike. Control column movement forward of the neutral position should not be needed. Figure 6 illustrates this smooth relaxation of column force as the nose is lowered. The figure compares the radio altitude, pitch angle, and control column forces for both normal landings and landings during which airframe damage occurred.
