HAZARDS of ERRONEOUS GLIDESLOPE INDICATIONS

All airplanes equipped with instrument landing systems are vulnerable to capturing erroneous glideslope signals. Boeing, the International Civil Aviation Organization, and the U.S. Federal Aviation Administration are working together to improve awareness and prevent such errors. Flight crews can help manage the risk by understanding the problem and performing glideslope confidence checks.

SAFETY

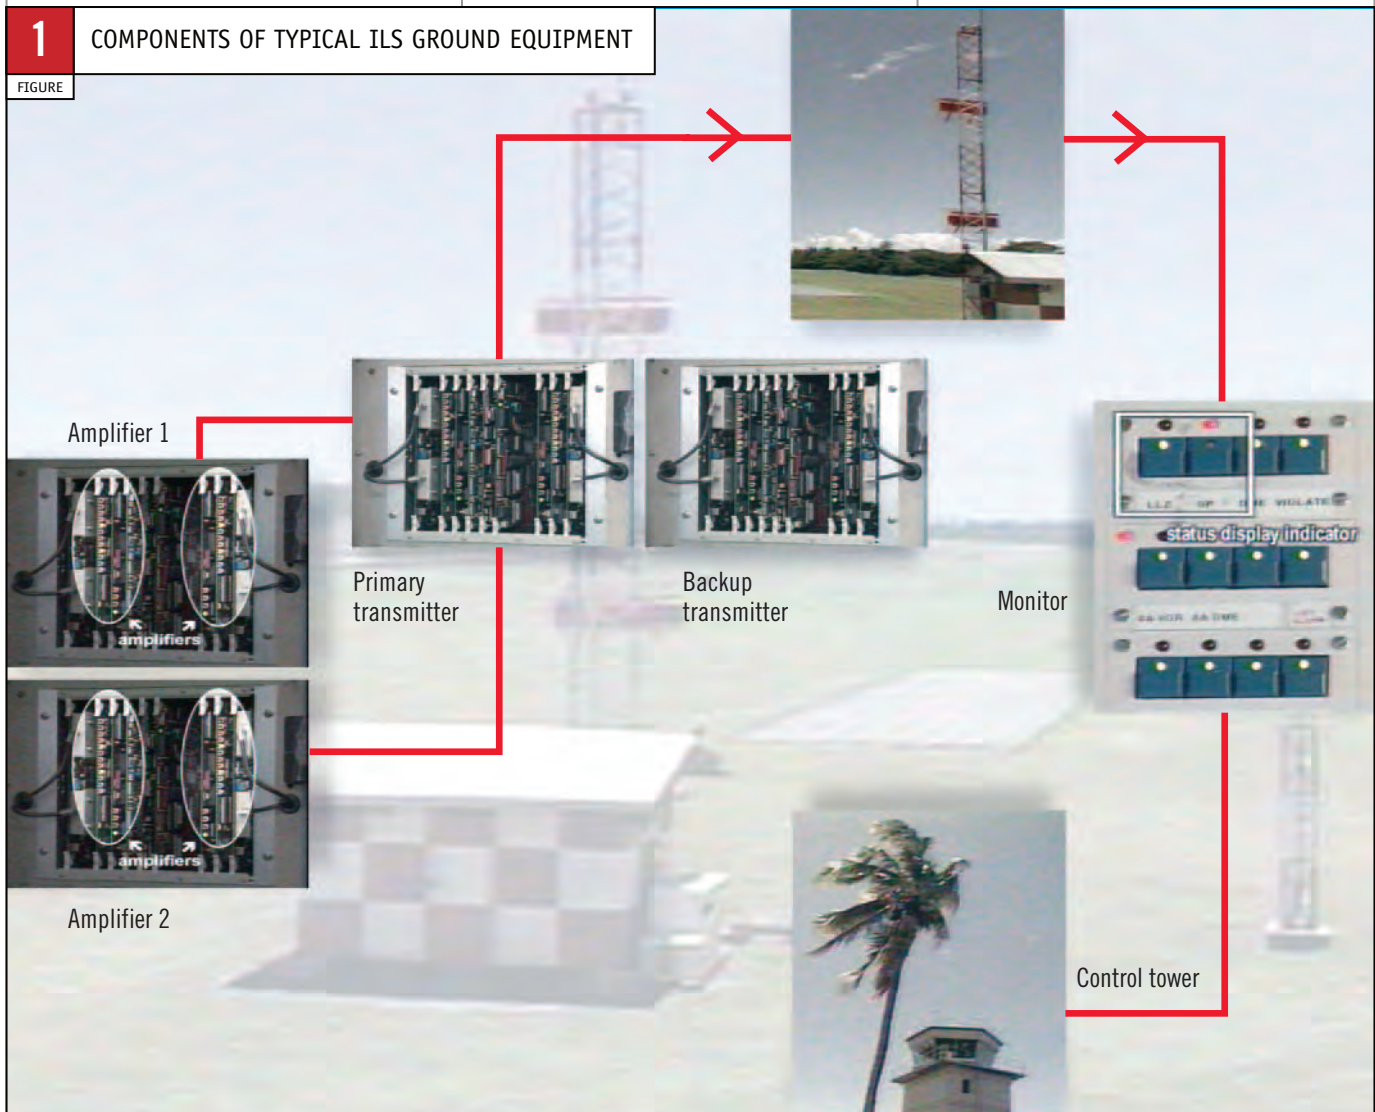
1

ILS ground equipment provides horizontal and vertical guidance information to airplane instrumentation. The equipment typically comprises five components: a localizer transmission system, a glideslope transmission system, a DME or marker system, a standby transmitter, and a remote control and indicator system (fig. 1).

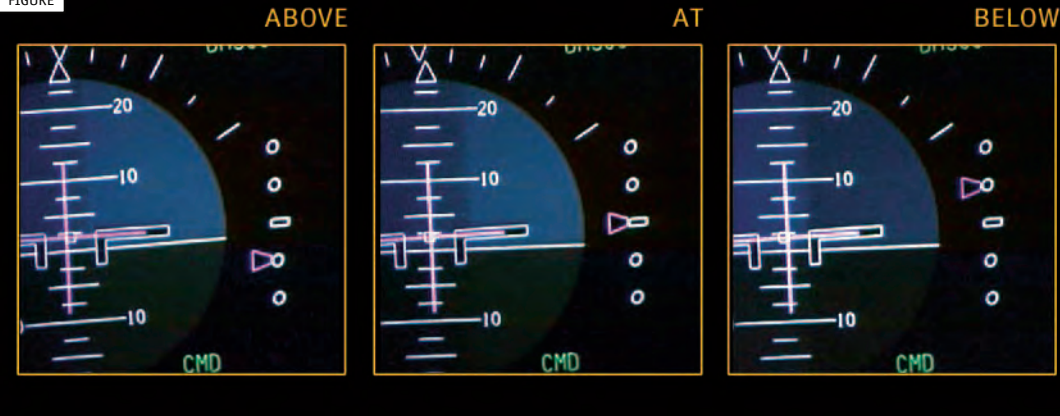
2

During normal ILS operation, the localizer and glideslope transmitters each radiate a carrier wave of 90- and 150-Hz signals of equal amplitude. These signals alone do not provide guidance but are compared with separate 90- and 150-Hz sidelobe signals radiated by the localizer and glideslope to create complex interference patterns. The patterns are designed so that when an airplane is below the desired glideslope, the instruments will sense a predominance of 150-Hz signals; when the airplane is above the desired glideslope, the instruments will sense a predominance of 90-Hz signals; and when the airplane is on the glideslope, the instruments will sense equal amounts of 90- and 150-Hz signals (fig. 2).

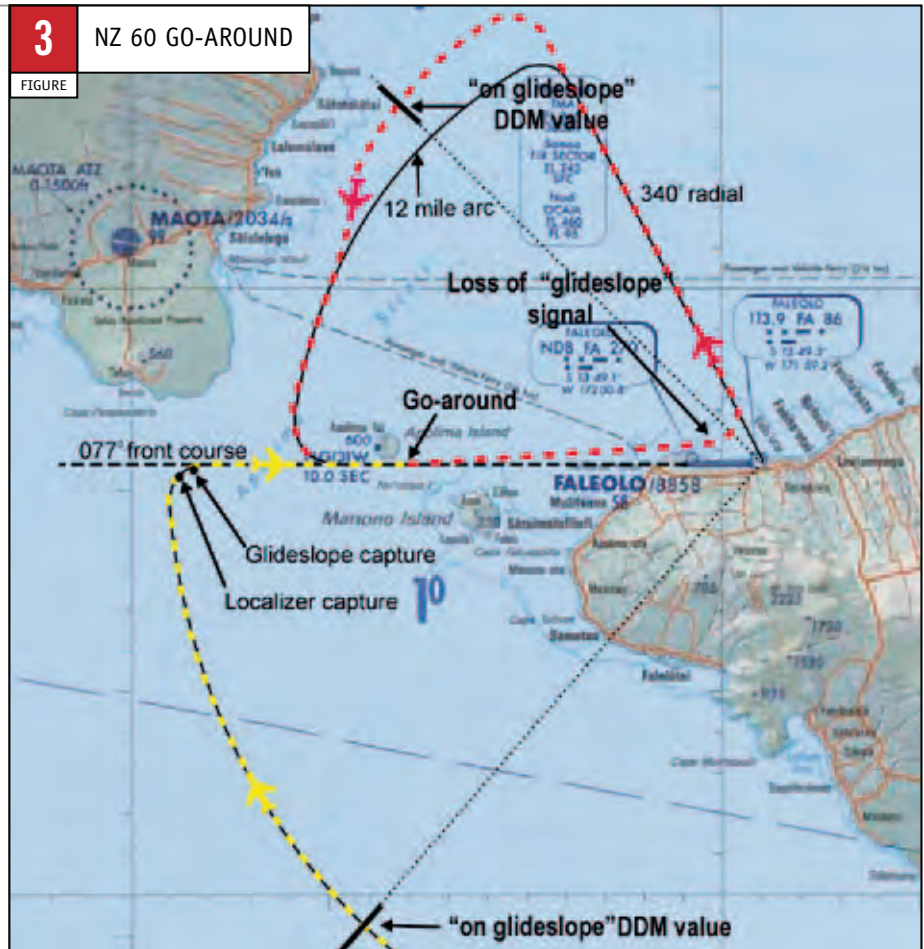
3 NZ 60 GO-AROUND

The captain executed a timely go-around 5.5 mi from the runway at an altitude of less than 400 ft. The crew successfully executed a second approach by using the localizer and ignoring the on-glideslope indications.

notice to airmen (NOTAM) bulletins had informed them that the ILS was unmonitored, and they discussed this during their approach briefings. They also paid attention to subtle cues that something might be wrong, even though the automatic flight system was indicating normally. Last, the crewmembers were willing to execute a go-around to give them more time to sort through the conflicting information (fig. 3).
