Wind helped pool fuel fire engulf

At 0612hr on August 22, 1985, British Airtours Boeing 737 G-BGJL, carrying 131 passengers and six crew on a charter flight to Corfu, began its takeoff from runway 24 at Manchester Airport.

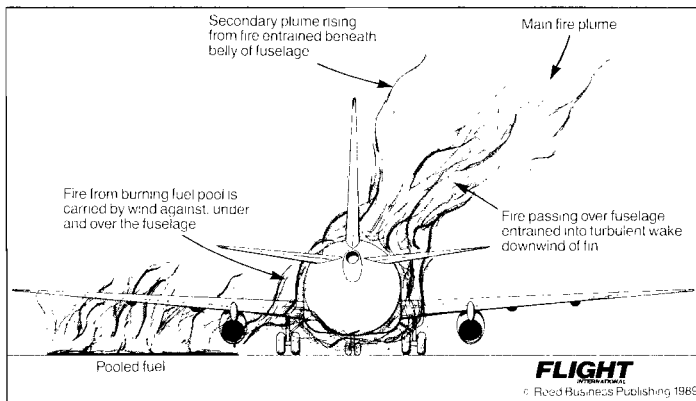
737's fuselage

The initial fire penetration of the fuselage occurred within 20 seconds of the aircraft stopping, when the lower skin panels on the left side adjacent to the aft cargo hold were burned through, followed shortly afterwards by penetration of the glassfibre acoustic insulation blanket. This gave the fire access to a cavity surrounding the cargo hold, from which it entered the aft cabin via floor air-conditioning grilles on each side of the aircraft.

Within one minute of the aircraft stopping, the fire penetrated the cabin side walls just above floor level adjacent to seats 17A to 19A, giving the fire direct access to the cabin interior. The windows resisted the fire for 40 or 50 seconds after the aircraft stopped, but visible signs of damage, including cracking and apparent melting, were evident to passengers much earlier.

The fire was entrained by the wind beneath the rear fuselage, creating a large area of fire contact with a high rate of heat transfer into the hull, resulting

in the rear fuselage and tail collapsing on to the ground.
