**NATIONAL
TRANSPORTATION
SAFETY
BOARD**

AIRCRAFT ACCIDENT REPORT

**DELTA AIR LINES, INC.,
LOCKHEED L-101 1-385-1, N726DA
DALLAS/FORT WORTH -
INTERNATIONAL AIRPORT, TEXAS
AUGUST 2, 1985**

NTSB/AAR-86/05

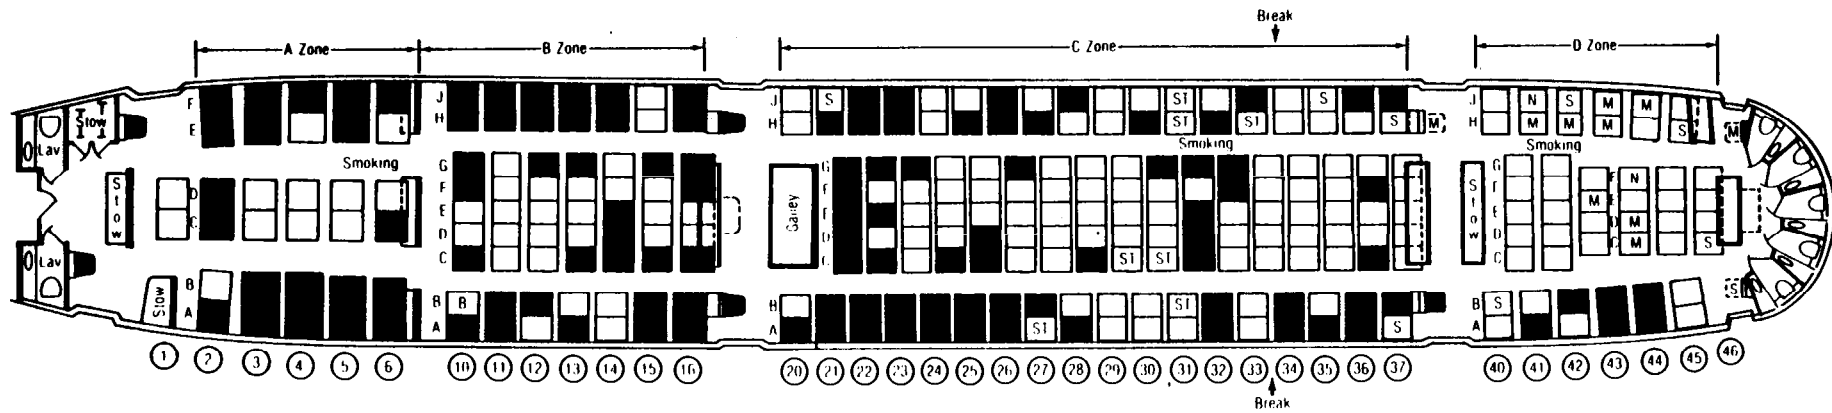
Figure 3.--L-1011 cabin seat diagram.
