PB2002-910401
NTSB/AAB-02/01
DCA00MA006

Aircraft Accident Brief

**EgyptAir Flight 990
Boeing 767-366ER, SU-GAP
60 Miles South of Nantucket, Massachusetts
October 31, 1999**

**NTSB/AAB-02/01
PB2002-910401
Adopted March 13, 2002**

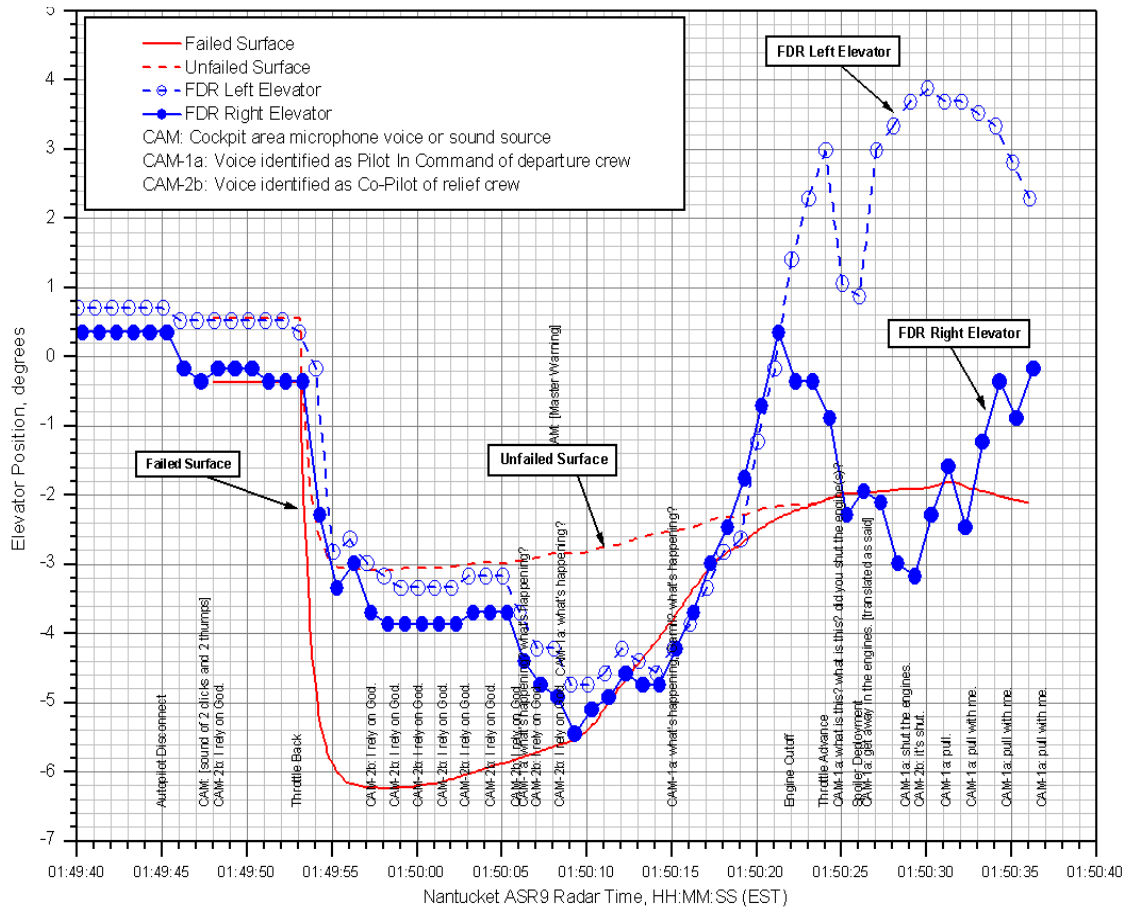
the forces produced by the two failed PCAs would overpower the opposing force produced by the one nonfailed PCA. The resultant initial force on the elevator surface in the failed direction would be equivalent to a single functioning PCA operating at 100 percent of its maximum force. The failed PCAs would resist the backdriving force³¹ with a force equivalent to about 130 percent of a single functioning PCA. The high internal pressures required for activation of the PCAs' pressure relief valves allow the PCAs' pistons to resist the aerodynamic backdriving movement with more force than normal operating pressures would allow. Therefore, if a dual PCA failure occurred in flight, the elevator would initially move to a position consistent with a single functioning PCA operating at 100 percent of its maximum force, balanced against the aerodynamic forces affecting the elevator surface. As the airspeed increases, the failed elevator surface would remain at this initial position until the backdriving forces exceeded those of a single PCA operating at 130 percent of its normal capability, at which point the deflection of the failed elevator surface would decrease.³² (Figure 2 is a comparison of the elevator positions recorded by the accident airplane's FDR with failed and nonfailed elevator positions following a dual PCA failure.)

Figure 2. Comparison of the elevator positions recorded by the accident airplane’s FDR with failed and nonfailed elevator positions following a dual PCA failure.

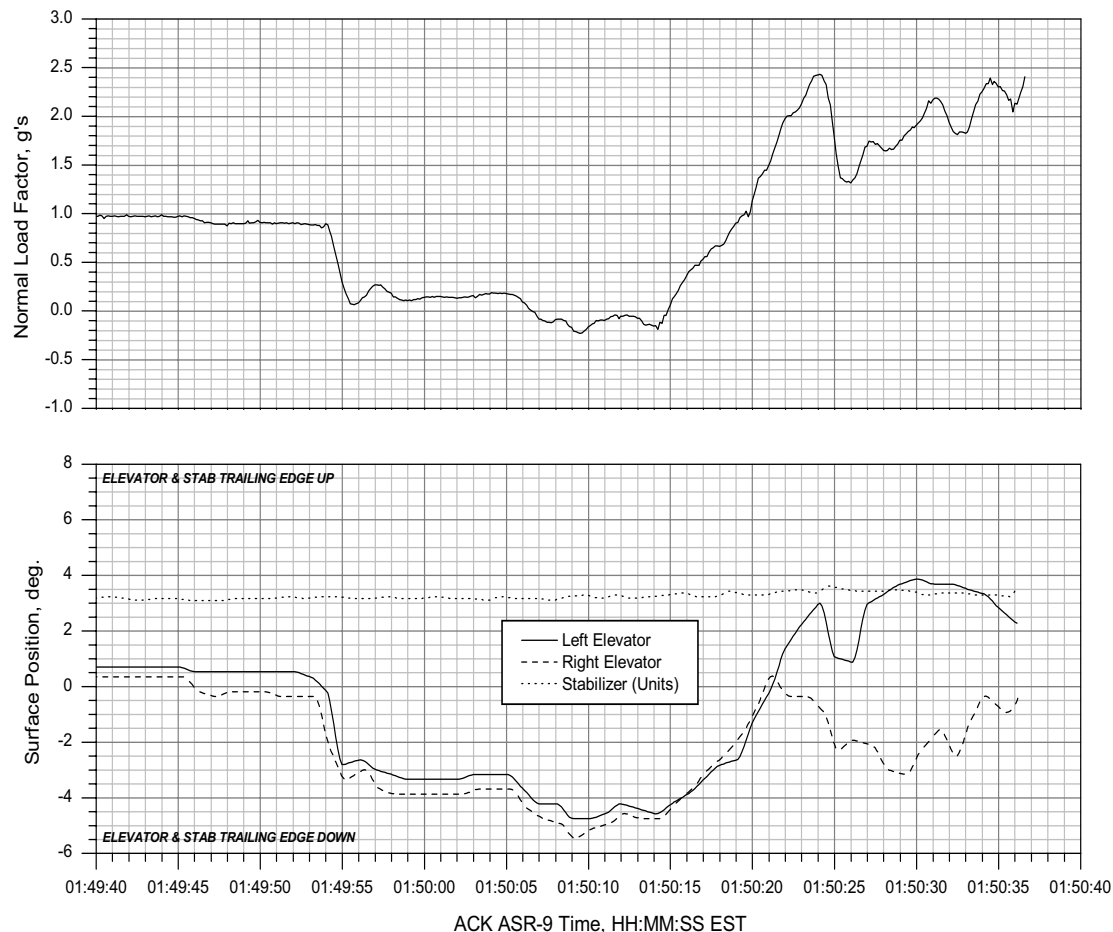
Figure 4. Graphs depicting the accident airplane's normal load factor response to elevator and stabilizer movement.
