AIRCRAFT ACCIDENT REPORT

**CONTROLLED FLIGHT INTO TERRAIN
AIR CHINA INTERNATIONAL FLIGHT 129
B767-200ER, B2552
MOUNTAIN DOTDAE, GIMHAE
APRIL 15, 2002**

**KOREA MINISTRY OF CONSTRUCTION AND TRANSPORTATION
KOREA AVIATION-ACCIDENT INVESTIGATION BOARD**

KAIB/AAR F0201
Adopted March 4, 2005

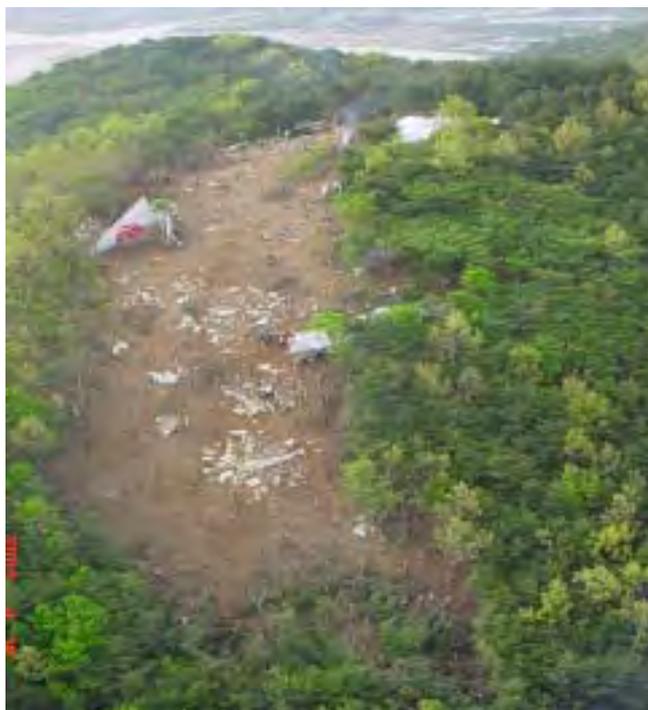
Figure 1-3 Site of Forest Damage

Damage to the forest on Mt. Dotdae of some 8,000 m², including 12 grave sites, was caused by the aircraft’s impact with trees and the ground, along with the spread of the wreckage.¹⁴

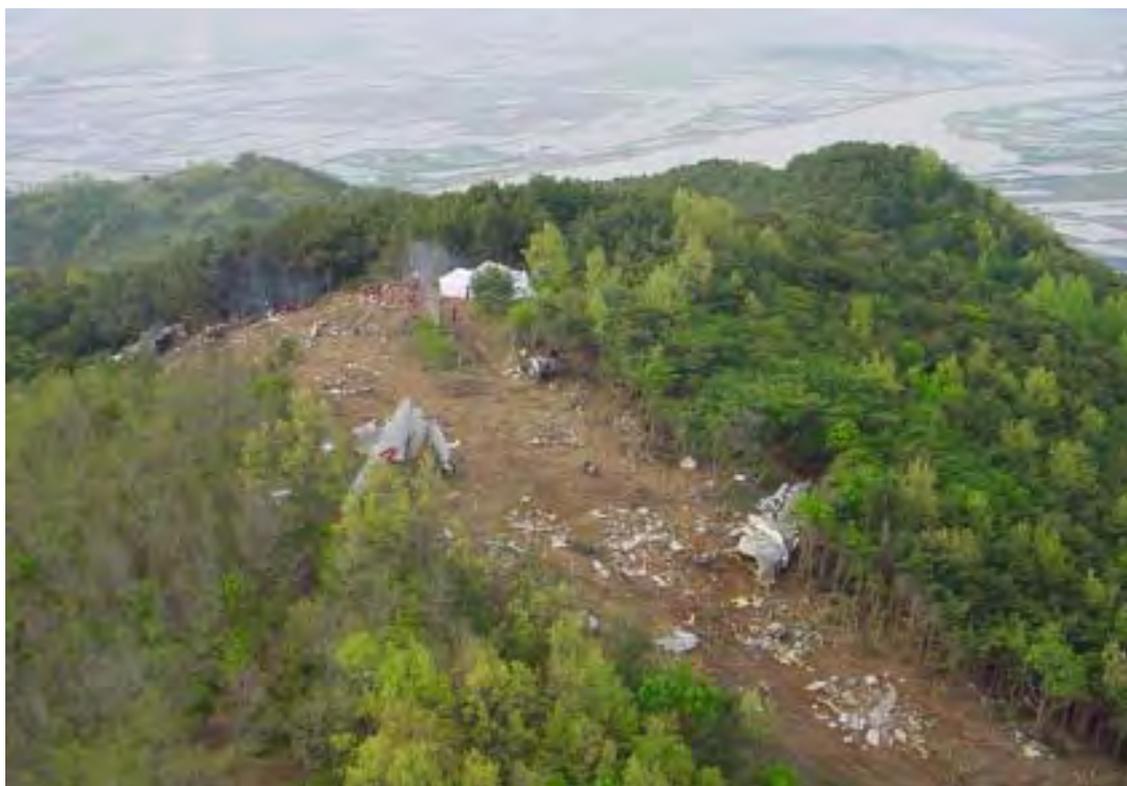
Figure 1-13 Photograph of the Accident Site

After the aircraft's impact with the ground, the right wing, empennage, left wing including parts of the fuselage, and two engines were separated respectively. The forward fuselage including the cockpit was totally consumed by a post impact ground fire.

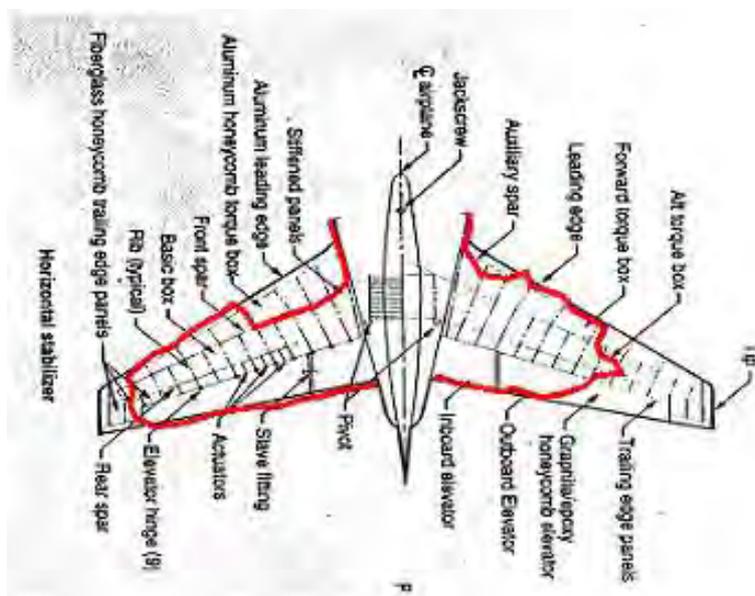
Figure 1-16 The Remaining Portion of the Wreckage (inner area of red line)

Both elevator tips were sheared off, with the elevators lying flat on the ground supporting the tail section upright.

The horizontal stabilizer's jackscrew extension was measured to be 14 inches between the lower gimbal assembly and the lower stop.

The front surface of the left horizontal stabilizer (as shown on Figure 1-16) was damaged and the tip was sheared off by an impact with the trees. While there were signs of the impact with trees on the front inner part of the left stabilizer, there was no sign of the preimpact skin corrosion or damage.

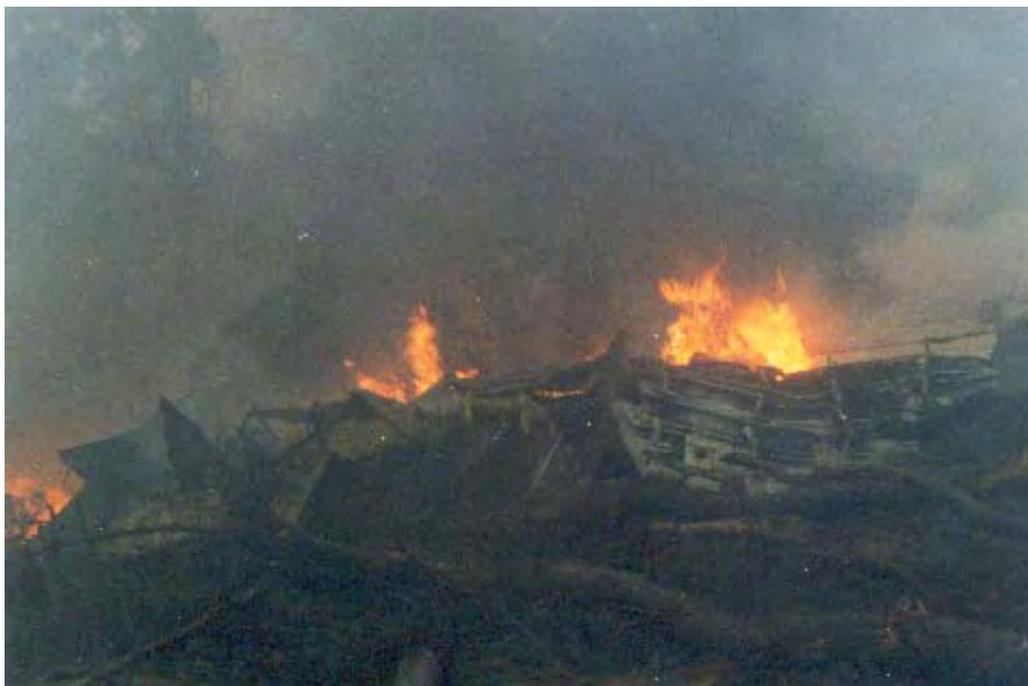
Figure 1-17 Photograph of the Aircraft on Fire after Crash

The on-scene investigation revealed no signs of fire on board the aircraft prior to crash. After the ground impact, the right wing and the empennage were separated from the fuselage. These items had no fire damage. The first sign of fire damage was found approximately 150 m from the initial point of impact.

At the accident site, it was raining with heavy fog. Fire fighters, soldiers and police struggled to apply dry chemical and halon fire extinguishing agents, and dirt to put out the fire, but the interiors of the cabin and flight deck were burnt completely, as shown on Figure 1-17. The fuselage fire, accompanied with exploding sounds and heavy smoke, was extinguished about 15:00 on the day of the accident.

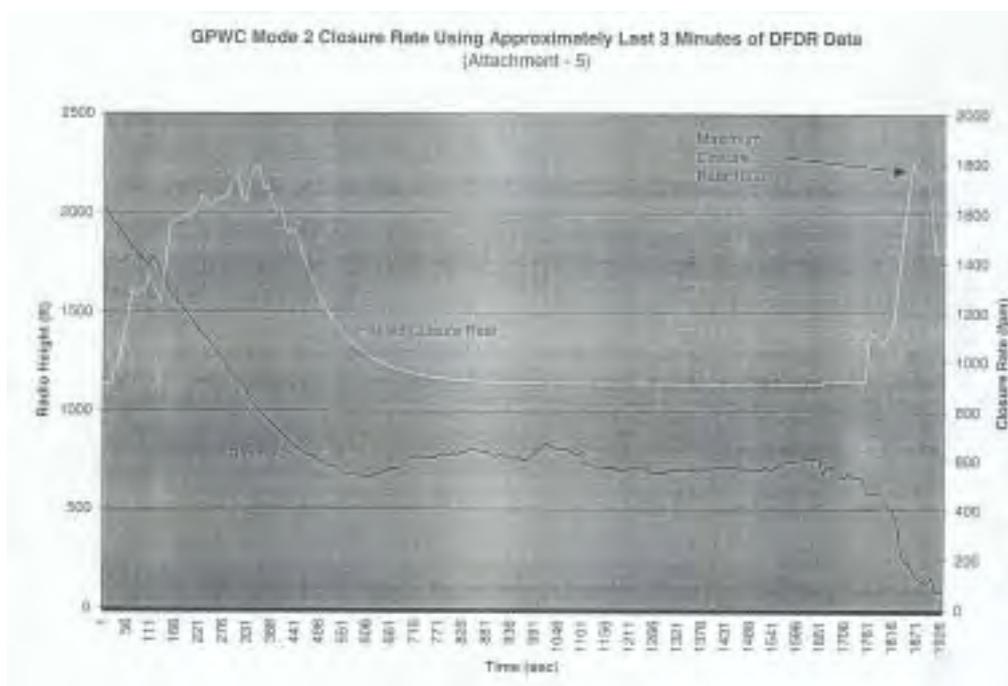
Figure 2-1: During the Last 3 Minutes of DFDR Data, GPWC Mode 2 Closure Rate

According to a close examination¹⁷⁷ by Boeing of the radio altitude data of the FDR, the descent rate for the last 3 minutes from an altitude of 2000 ft until the ground impact increased from about 900 fpm to 1800 fpm, and at 700ft on the circling approach, it decreased to 900 fpm. It again increased to 1800 fpm just before the impact, as shown in the figure 2-1.

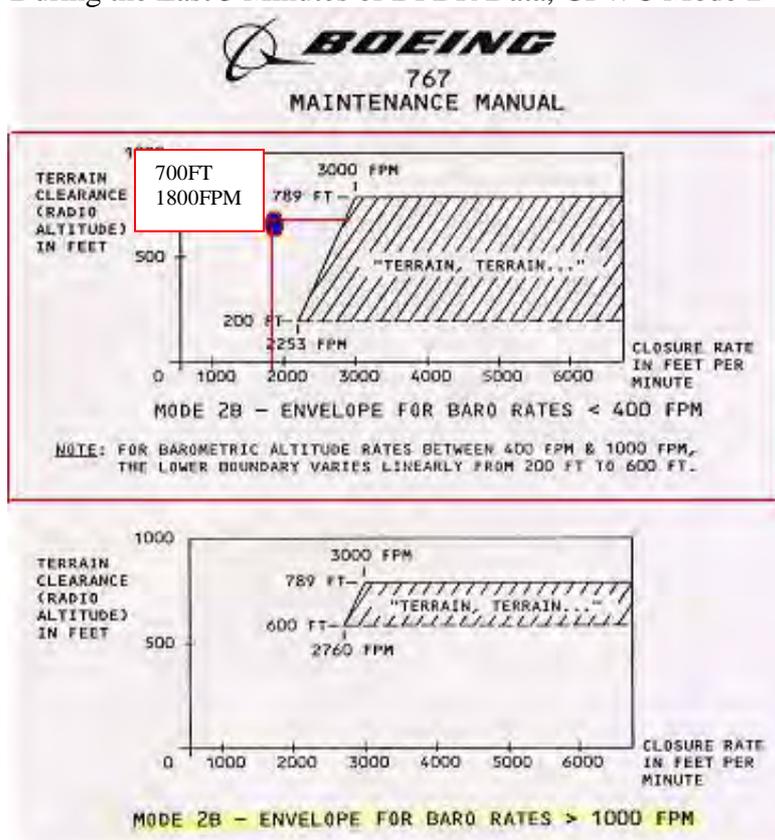
Figure 2-2 : Mode 2B Envelope for Barometric Rates < 400 FPM (Indication part)

The aircraft was in level flight and the baro rate was zero at the impact with Mt. Dotdae, which, as marked on the upper part of Figure 2-2, is applicable to Mode 2B-envelope for baro rate < 400fpm. According to the Figure, when the closure rate is 2, 253 fpm~3,000 fpm, Mode 2 warning will be generated per design. In the case of flight 129, the maximum closure rate was 1,800fpm, which was outside the Mode 2B-envelope to generate the warning. Therefore, it was confirmed to be normal that the MK- III GPWC installed in the aircraft did not generate any warning.
