AGENZIA NAZIONALE PER LA SICUREZZA DEL VOLO

FINAL REPORT

**SERIOUS INCIDENT
occurred to FOKKER 70, registration marks PH-KZH
Torino Caselle airport
16th of February 2002**

N. I/2/04

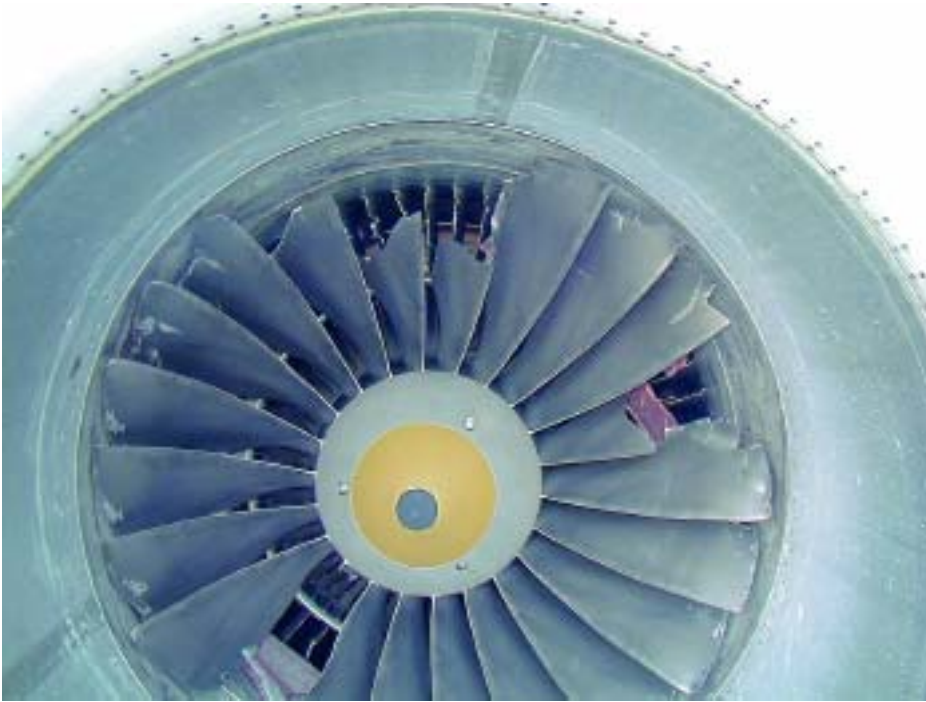
Photo 1

One fan blade was completely broken off near the root of the blade (see photograph 1 Appendix G). Three fan blades were broken off at approximately 50% of the fan blade length. One fan blade was broken at approximately 80% of the fan blade length, with 20% of the blade missing. Almost all leading edge tips of the remaining blades were damaged. There was also damage to the trailing edge of the fan blades. Some remains of the broken fan blades were found behind the fan. The accessory gearbox and the hydraulic pump housing were cracked. The PLA (Power Lever Angle) transducer was hanging on its wiring. The throttle linkage was detached from the fan case. The upper and lower cowling door opening rods were found loose with impact marks from the forward opening rod in the lower cowling door.

RH Engine.

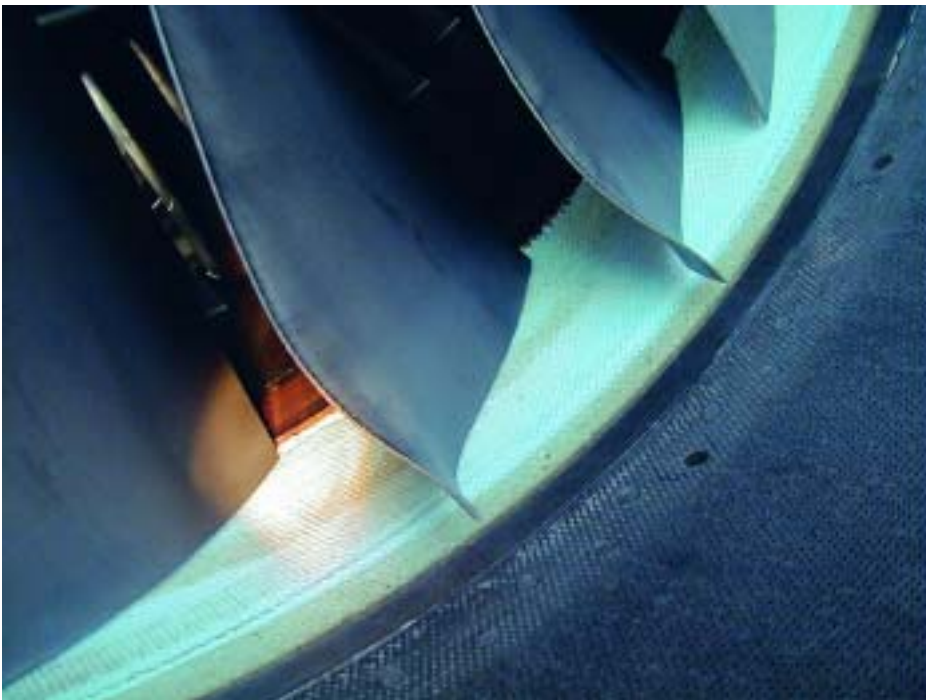
Photo 2

Five of the fan blade leading edge tips were bent forward. No damage was found on the remaining fan blades (see photograph 2 Appendix G). There was no evidence of bird ingestion.

LH Engine.

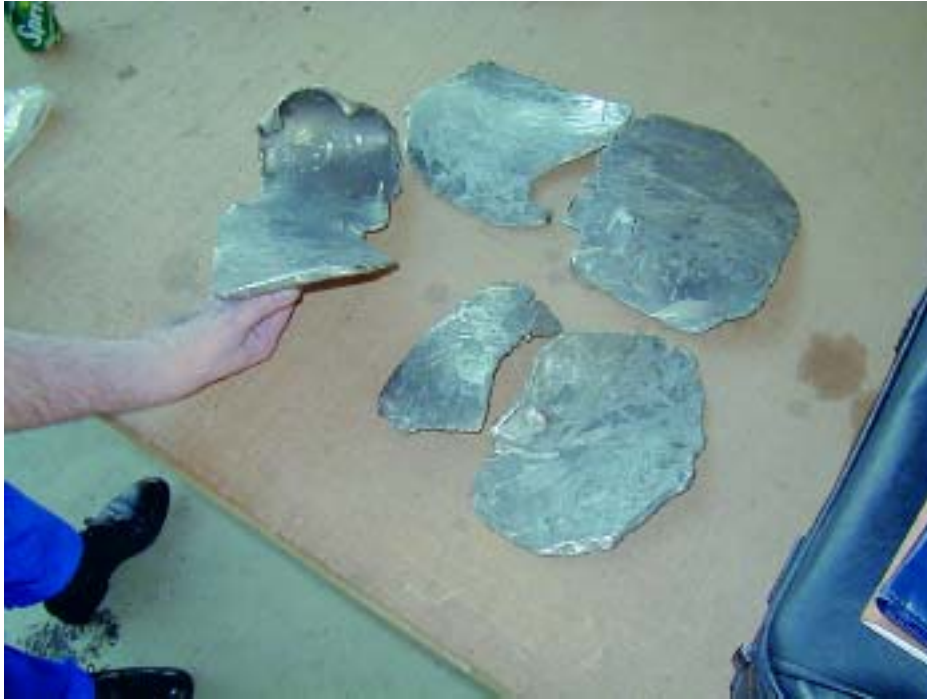
Photo 3

RH Engine debris.
