Flight Safety

AUGUST 2004

Stabilized Approach And Flare Are Keys to Avoiding Hard Landings

Vol. 23 No. 8

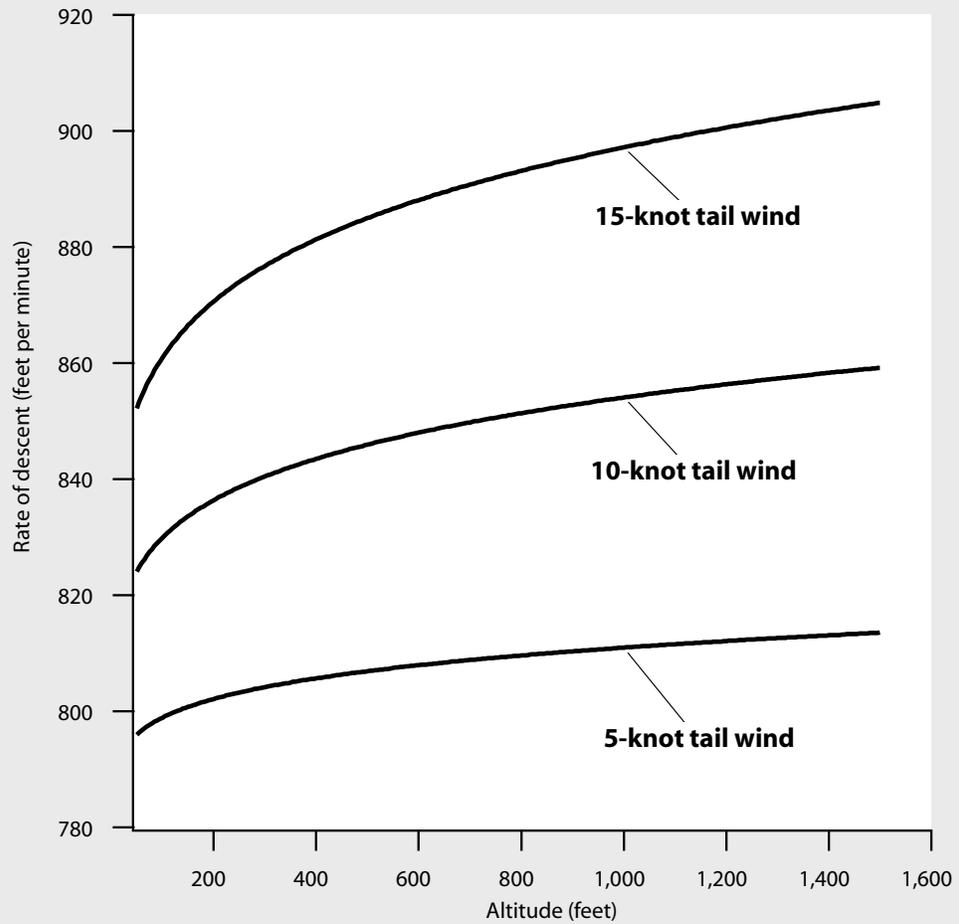
Figure 2
Examples of Descent Rates Required to Maintain Glideslope With a Tail Wind*

Tail winds are especially challenging for conducting a stabilized approach. Neither Airbus nor Boeing publish V_{REF} correction factors for tail winds. Because of the increased groundspeed caused by a tail wind, rate of descent must be increased to maintain the proper glide path.³⁸

* Examples assume a constant approach speed of 145 knots, a three-degree glideslope and tail wind velocities measured at 33 feet (10 meters) above ground level.

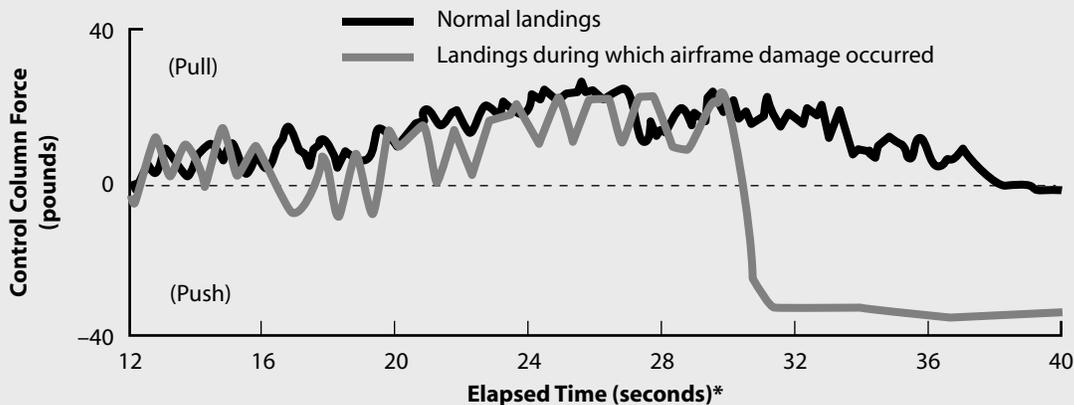
Figure 3
Control-column Movements Recorded During Normal Landings and Landings Involving Airframe Damage

Data recorded by Boeing during normal landings and during landings in which structural damage was caused by hard nose-landing-gear touchdowns show that the latter involved application of nose-down pitch control (Figure 3).

* Landings are positioned so that all reach zero feet radio altitude at the same elapsed time (28.5 seconds).
