# Investigation Report

5X004-0/01  
April 2003

Kind of occurrence: Serious Incident  
Date: 20. March 2001  
Location: Frankfurt / Main  
Type of aircraft: Transport category aeroplane  
Manufacturer / Model: Airbus Industrie / A 320-200  
Injuries to persons: no Injuries  
Damage to aircraft: A/C not damaged  
Other damage: none  
Source of Information: BFU Investigation

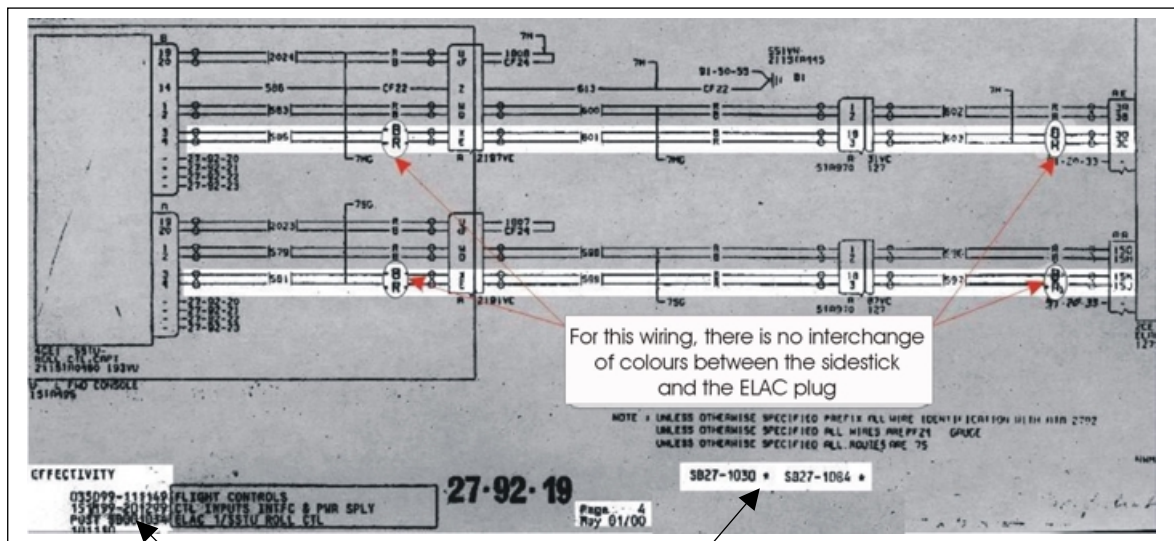
This page is applicable among other things to aeroplanes within an effectivity range POST SB from 001 to 034, provided the SBs listed on the right-hand side have been accomplished.

Page 4 shows the effectivity range from **001 to 034** following the designation **POST SB**, this means that this range applies only to aeroplanes on which the SBs indicated on this page on the bottom right have been accomplished. Although the aeroplane concerned was within this range, only the **SB27-1084** had been accomplished, but not the **SB27-1030**, thus the page was not applicable to this aeroplane. Erroneously the mechanics thought page 4 to be applicable as the SB 27-1084 had been accomplished on this aeroplane.

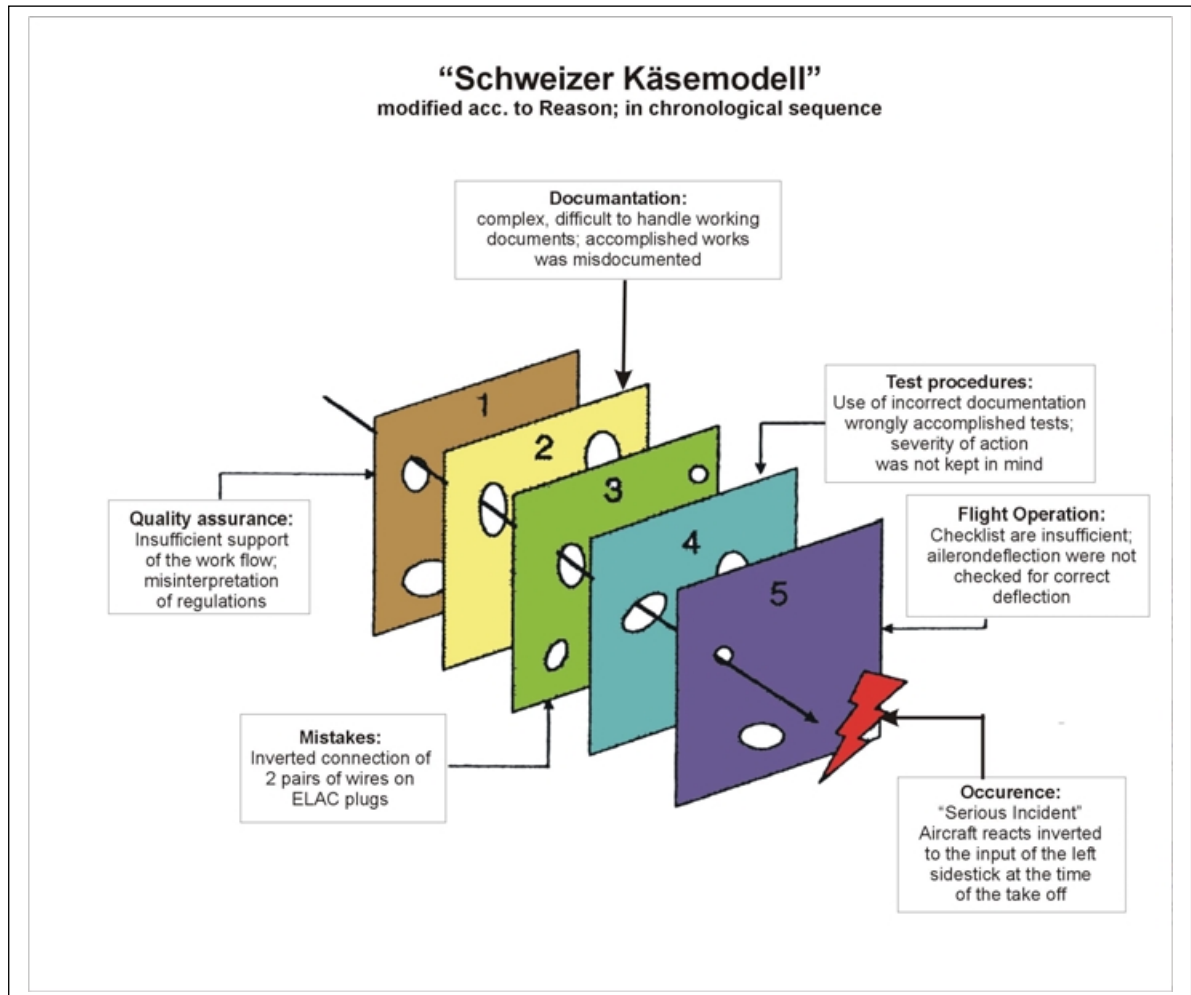
The investigation has revealed that numerous factors have contributed to this occurrence. The causal chain was never interrupted. In order to illustrate this the Swiss Cheese Model according to Reason was modified in to a chronological sequence.
