**AIRCRAFT SERIOUS INCIDENT REPORT
OCCURRENCE NUMBER 00/2518
B767-319ER
ZK-NCJ**

**NZ 60
'ERRONEOUS' GLIDESLOPE CAPTURE,
AUTOCOUPLED APPROACH,
AND GO-AROUND**

**FALEOLO AIRPORT, SAMOA
29 JULY 2000**

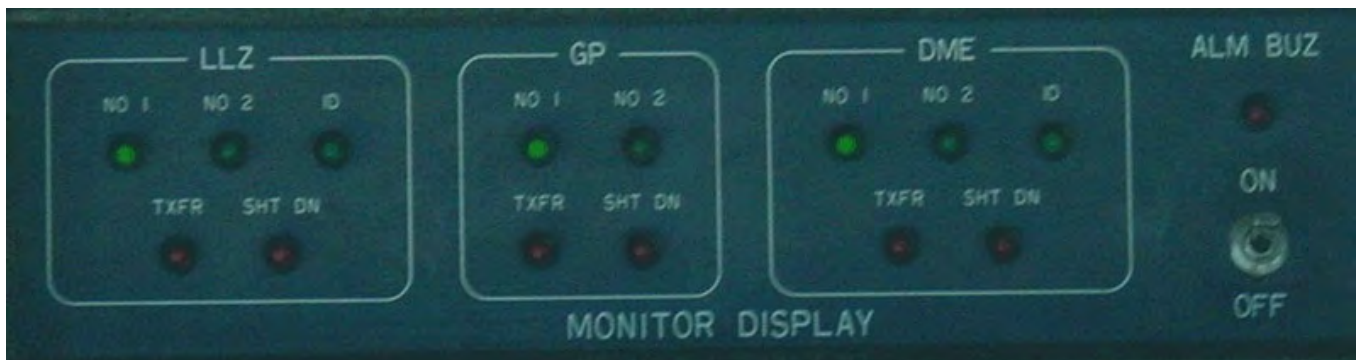
Tower Remote Status Indicator Panel at Faleolo

A tower ‘monitor’, as it is often referred to, is specified in ICAO Annex 10 as a remote control and indicator and indicates the operational status of the respective navigation aid to the controller. The remote indicator is usually simple, e.g. a green light for a normally operating system and a red light for a failed system. To reset the ILS system (in the case of Auckland) the tower staff selects the other runway and then reselects the ILS to the desired runway. Once the equipment is transmitting, the equipment (field) monitors are the sole arbiters of determining whether the equipment should remain transmitting. In the Faleolo tower only the status of the ILS is displayed and no selections are possible other than to silence the audible alarm. At the base of the Faleolo tower is the ILS remote control. This panel is the communication point for the LLZ and GP. It shows the transmitters selected, remotely (at this panel) or local (at the LLZ or GP hut on the field), any maintenance or executive alarms, transmitter transfer or shut downs, and if the equipment is in control bypass, i.e. the executive monitor is **NOT** in control.

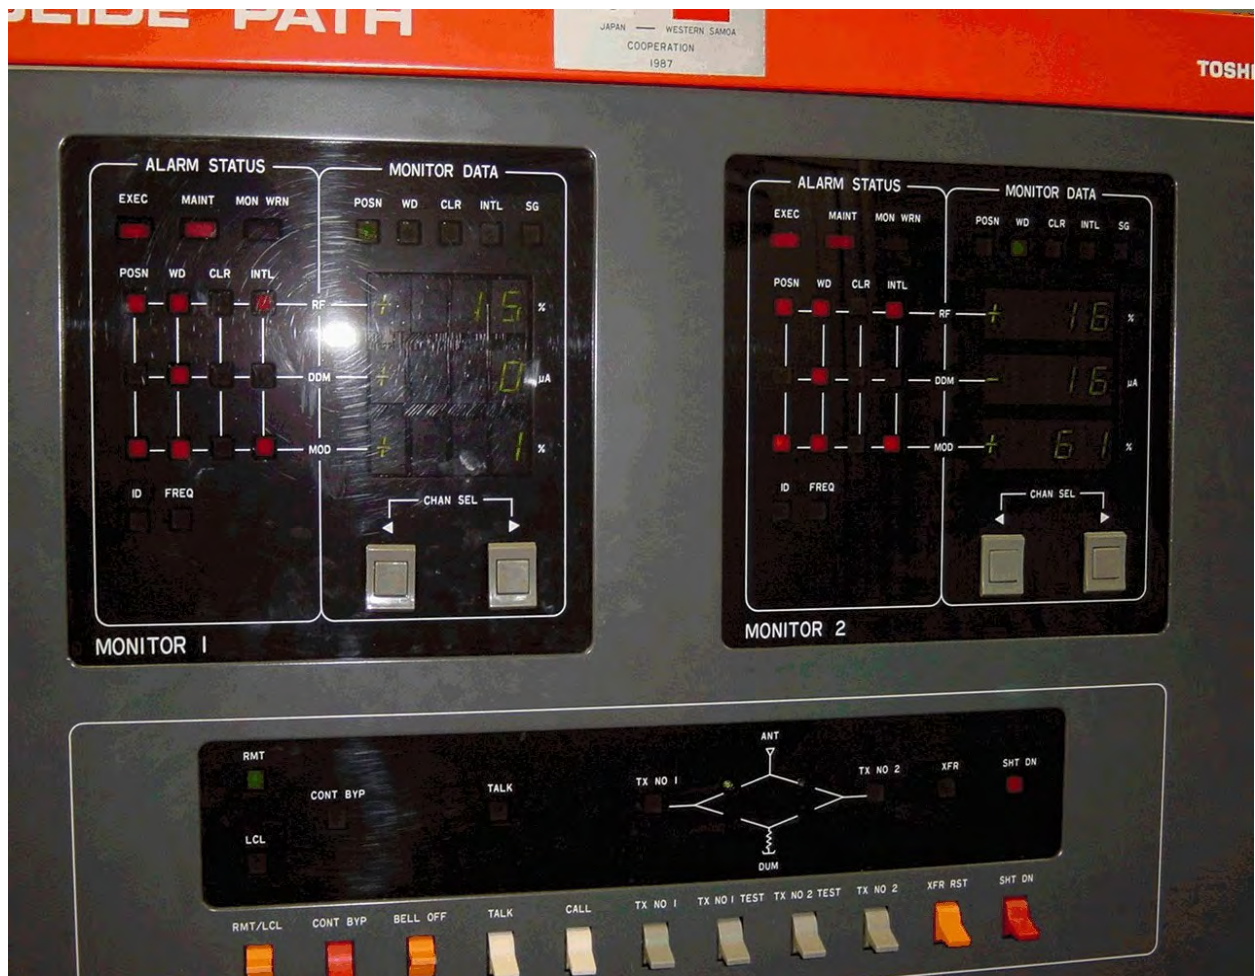
Glide Path monitors and control panel in the GP equipment shelter on the field at Faleolo

Airfields are required to have a comprehensive training and certification process for ground navigation radio aid technicians, and adequate procedures in place to ensure no incorrect parameter is accidentally transmitted.

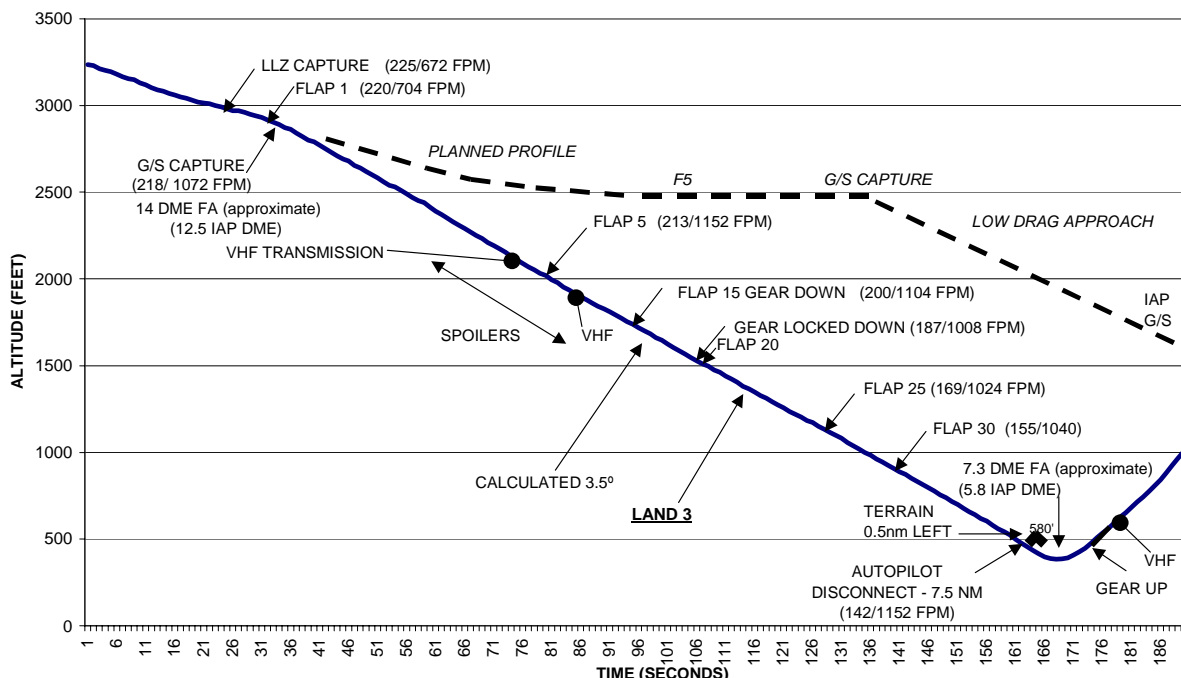
NZ 60 Profile - First Approach Apia

Analysis of the profile for the first approach revealed a subtle steepening of the approach angle from approximately 3.3°, at ‘glideslope’ capture, to 4.3° prior to the commencement of the missed approach. This would account for the steady rate-of-descent despite the reducing ground speed.

NOTE: Distances shown on the above profile are approximate. The FDR fitted to ZK-NCJ does not record DME. Distances were computed using IRS longitudinal information adjusted for latitude and corrected for the residual error.

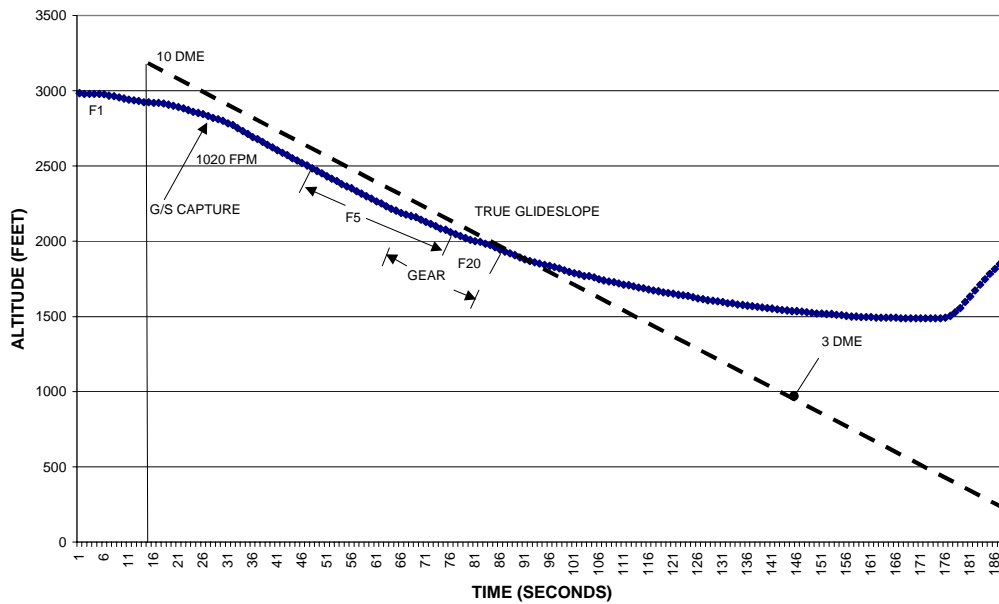
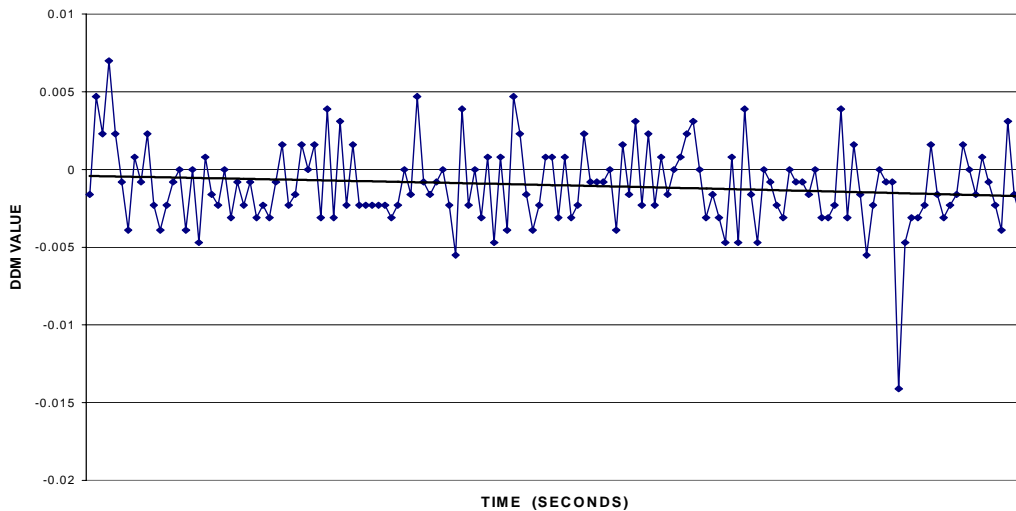
Proving Flight One – Profile One

The transition to glideslope capture occurred from the Vertical Speed mode with the left autopilot engaged in CMD. From glideslope capture the aircraft assumed a ROD of 1000 fpm which decreased throughout the profile to a point 7.8 track miles after glideslope capture where the aircraft was at 1480 ft altitude and in level flight.

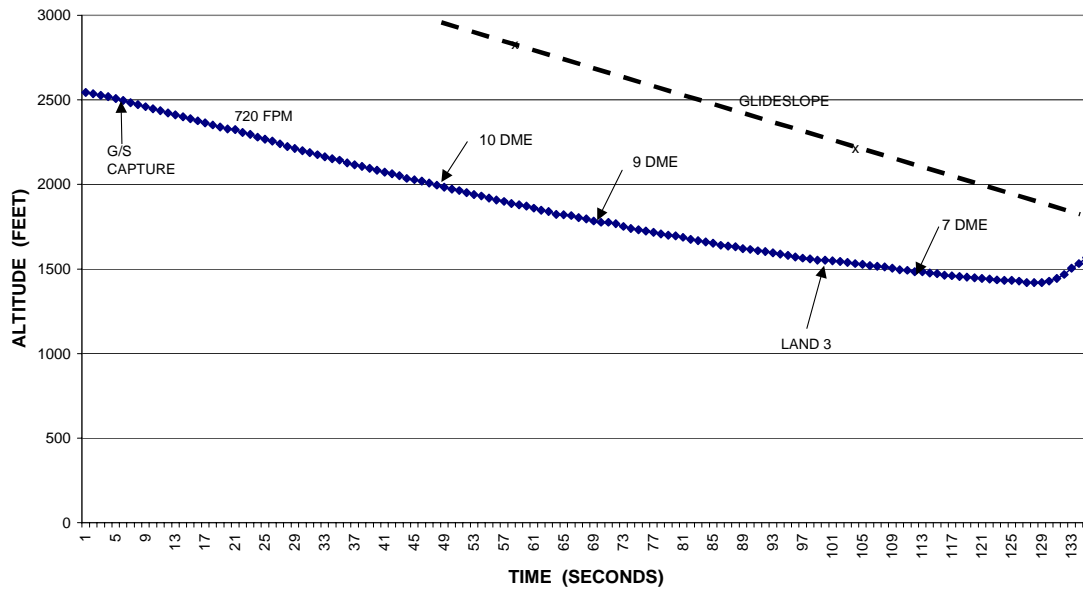
Proving Flight One – Profile Two

Glideslope capture occurred some 1000 ft below the actual glideslope. The aircraft remained on a ‘below glideslope’ profile, and ‘LAND 3’ was annunciated on the Autoland Status Annunciator panel at 1500 ft RA. The aircraft descended on a shallow profile, losing approximately 1100 ft in 5.5 track miles.

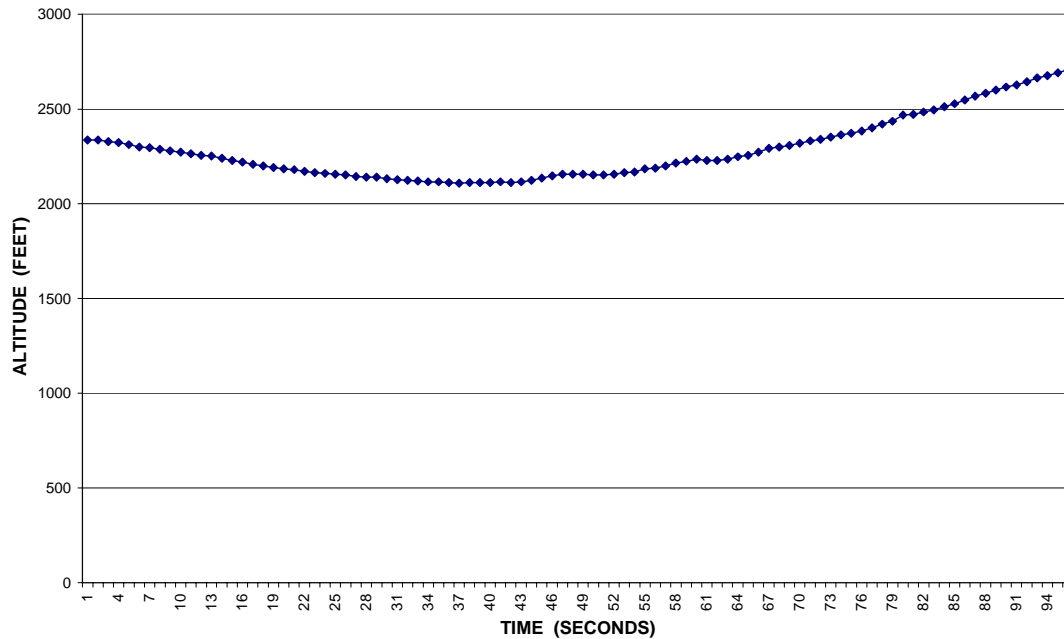
Proving Flight One – Profile Three

For the third approach the aircraft was positioned to intercept the glideslope from the altitude capture mode to ascertain whether the aircraft would pitch down at the glideslope capture point. The aircraft was positioned at the glideslope capture point at flap up, 240 KIAS. At glideslope capture the ROD was 200 fpm in a level-off manoeuvre. After glideslope capture the aircraft slowly drifted down initially then commenced a gentle climb.

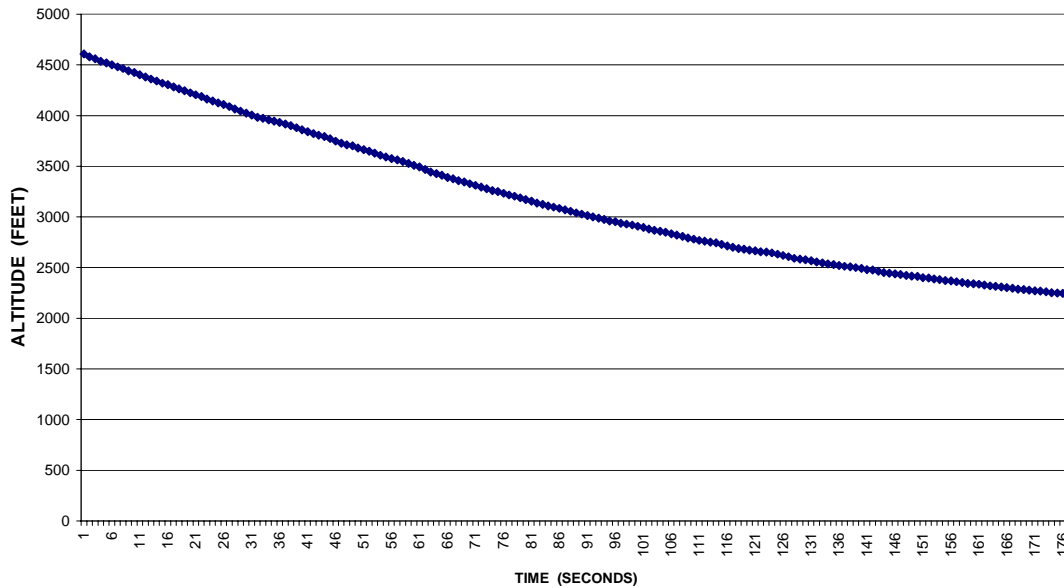
Proving Flight One – Profile Four

For the fourth approach the aircraft was positioned above the true glideslope in the Vertical Speed mode and with a ROD of 1500 fpm selected. At the glideslope capture point the ROD decreased to 1200 fpm. During descent the ROD slowly bled back to 1000 fpm until the go around point.

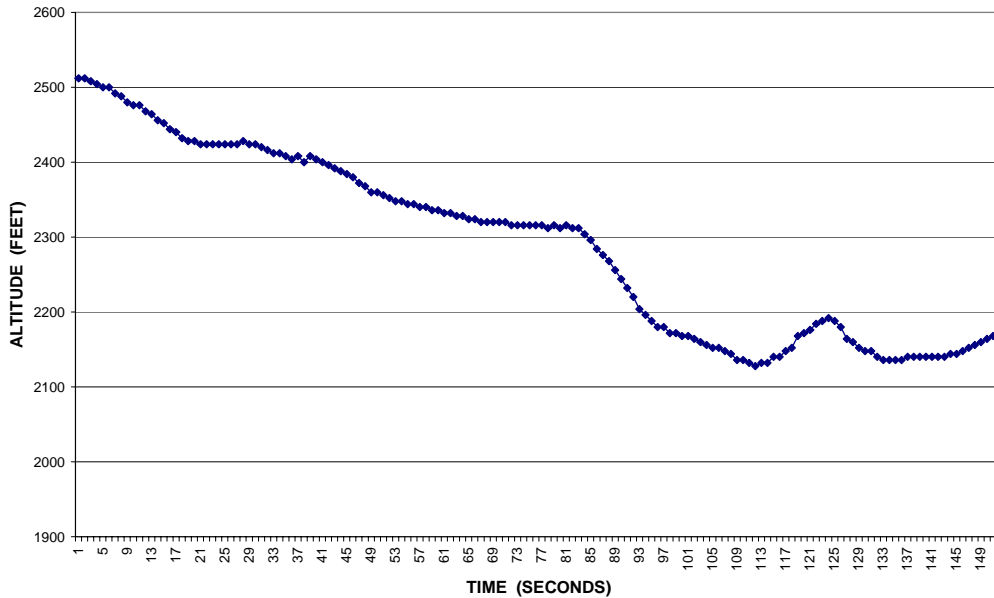
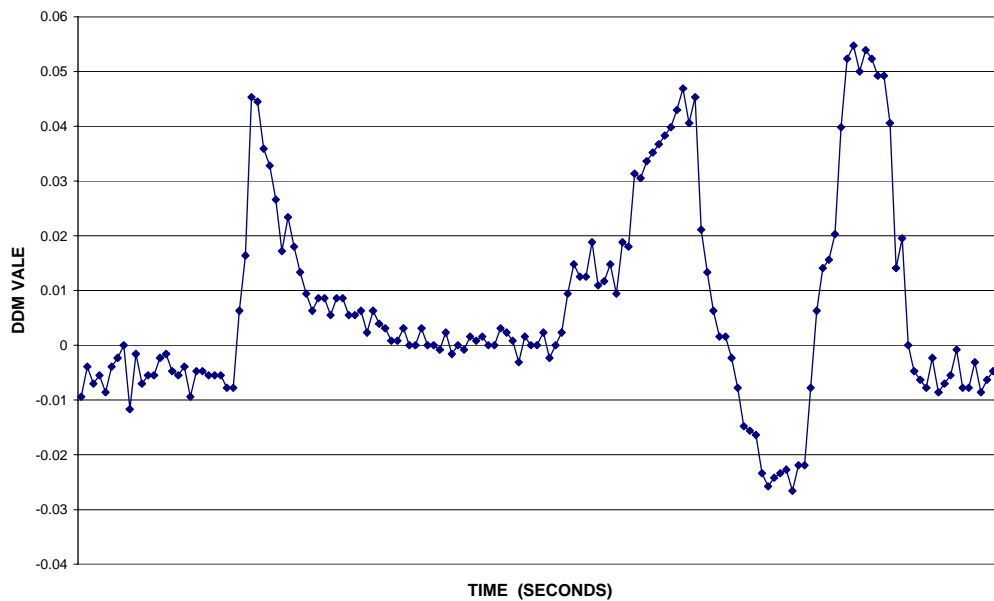
Proving Flight One – Profile Five

For the fifth approach the DDM value was varied from the ground to establish whether the residual DDM value could affect the aircraft flight path. Transition to glideslope capture occurred from Altitude Hold mode. Glideslope capture occurred with the aircraft in level flight at 160 knots and with the flaps at 20. Subsequent to glideslope capture there was no change in flap position and little change in airspeed or thrust setting. It was noted that varying the DDM value would vary the aircraft profile.

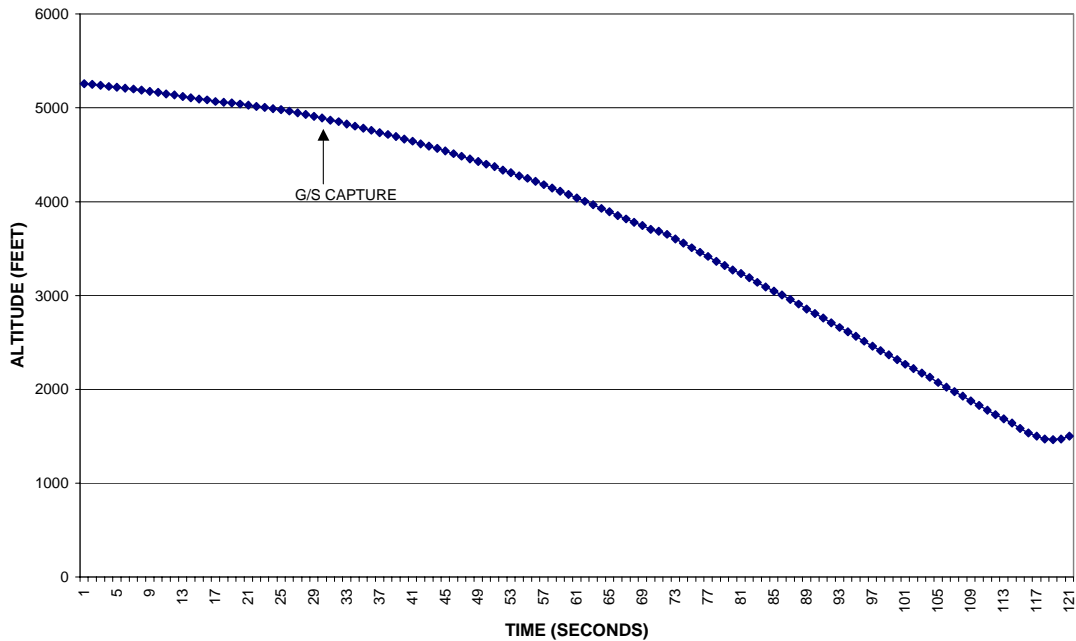
Proving Flight Two – Profile One

The automatics captured the ‘glideslope’ as expected. In apparent response to the fly down signal, the aircraft continuously pitched down on a steepening approach that commenced at approximately 3.5° and reached 8.5° toward the end. ROD increased throughout the approach from 1200 fpm to 3000 fpm. Despite the deployment of speedbrakes and extension of landing gear, the aircraft could not be slowed and configured for landing.

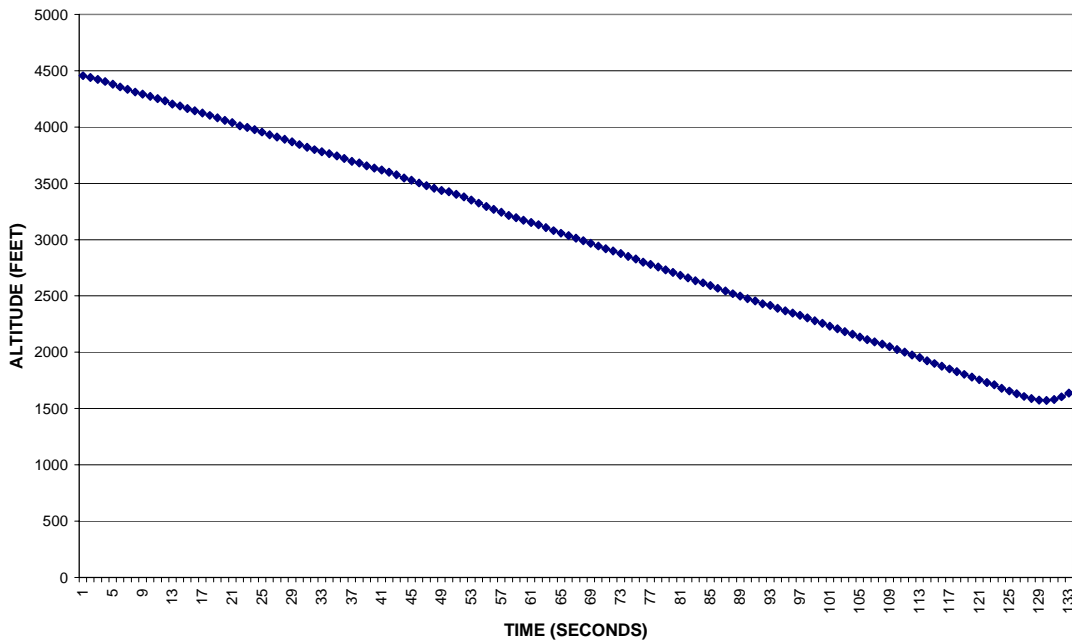
Proving Flight Two – Profile Two

Having verified the hypothesis with respect to the plus and minus DDM values, this profile was expected to closely replicate the profile encountered by the crew at Faleolo. This was achieved with a reasonably constant ROD of 1200 fpm. Speedbrakes were deployed and landing gear extended early to slow the aircraft, with landing configuration being reached some 2700 ft after glideslope capture. Analysis of the glideslope angle revealed an angle of 3° at glideslope capture increasing to over 6.5° at the bottom. The steeper angle of this approach was most likely attributable to the fly down signal being slightly greater than that encountered at Faleolo.

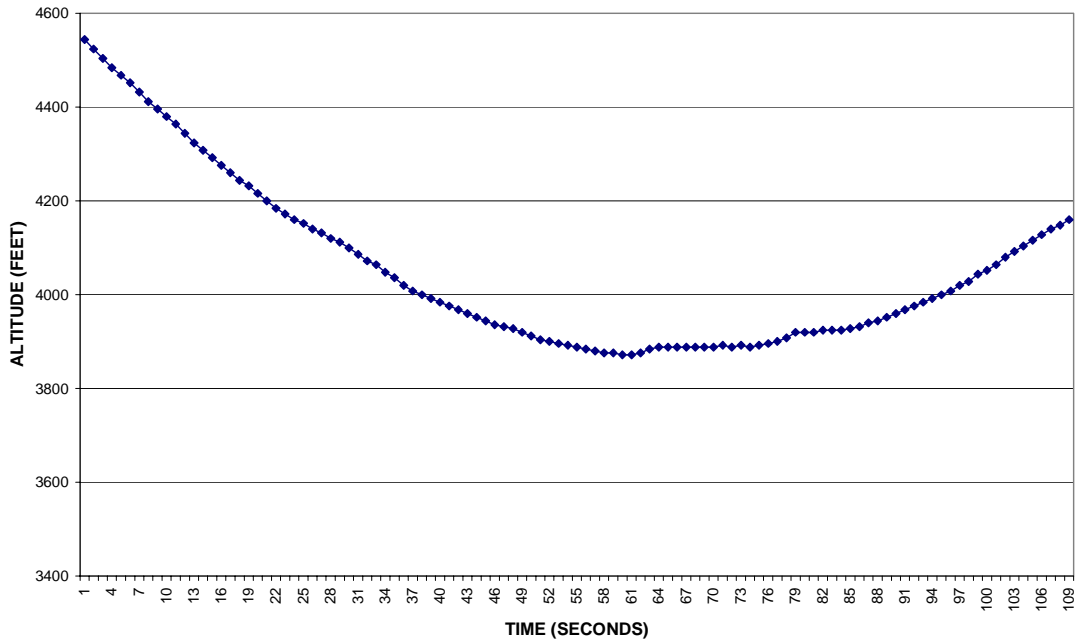
Proving Flight Two – Profile Three

As experienced on proving flight one, the aircraft commenced an approach and gently flattened out. The aircraft descended some 1600 ft before reaching straight and level flight, subsequently climbing away as the landing configuration was reached.

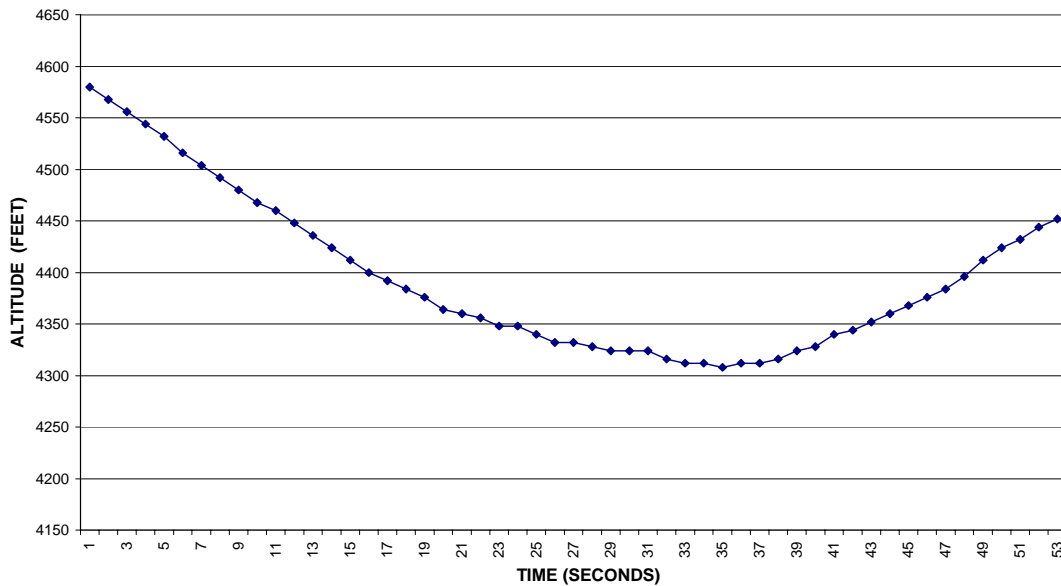
Proving Flight Two – Profile Four

The Auckland runway 05 ILS glideslope CSB signal is biased with a ‘fly up’ DDM of approximately -0.0016 to ‘trim’ the cumulative signal and generate the required glideslope angle. As expected, the approach flattened and the aircraft subsequently flew away. In this case, only 250 ft of altitude was lost prior to the aircraft climbing.

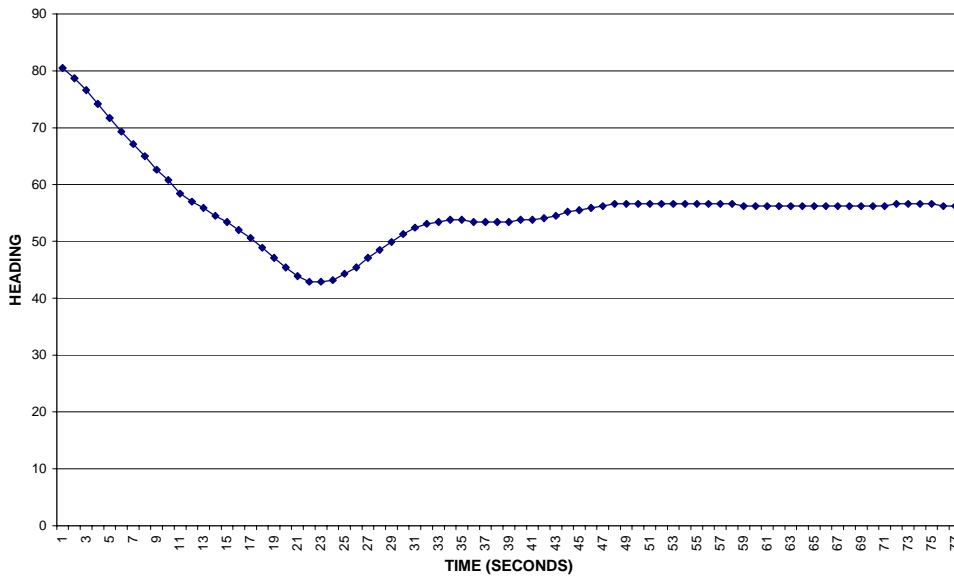
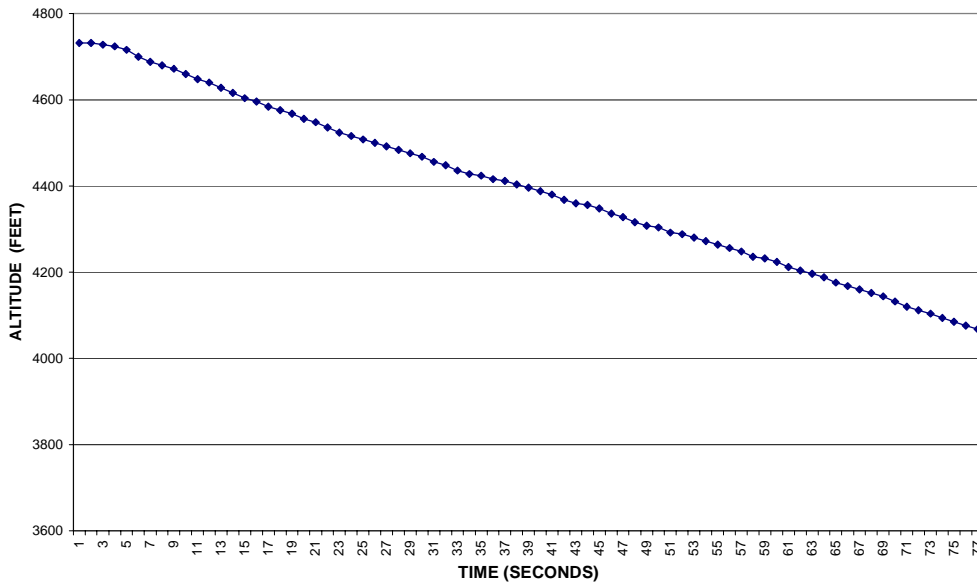
Proving Flight Two – Profile Five

It was understood that there is no technical reason why the localizer cannot transmit the same erroneous path. To test this hypothesis, the glideslope CSB signal was returned to a ‘fly down’ DDM, and the localizer left transmitting a CSB only. From an intercept heading of 080° and with an on-track indication, the APP mode was armed, resulting in an instantaneous G/S and localizer capture. The aircraft turned left to 043° then turned right on to a heading of 053° and finally stabilised on a heading of 058°. There was an initial suspicion that there was some logic related to the selected front course of 051°, and a second profile was flown to better understand this. Of interest on this first localizer profile was the recording again of a steepening vertical profile.

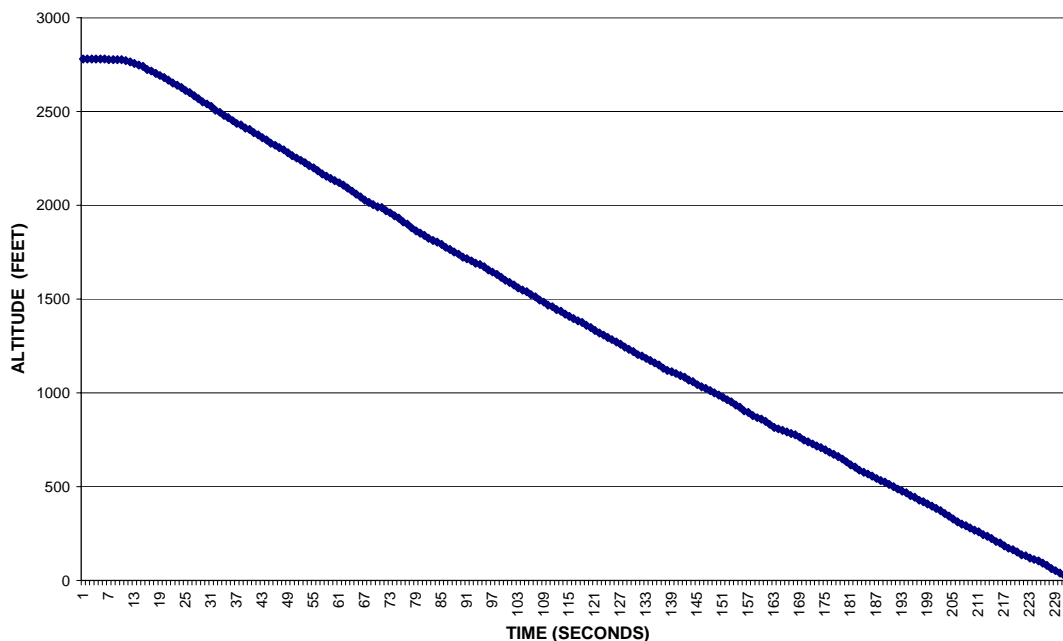
Proving Flight Two – Profile Eight

A DDM value of 0.01 DDM was noted at glideslope capture.
