Lauda Air B767 Accident Report

**AIRCRAFT ACCIDENT INVESTIGATION COMMITTEE
MINISTRY OF TRANSPORT AND COMMUNICATIONS
THAILAND**

**LAUDA AIR LUFTFAHRT AKTIENGESELLSCHAFT
BOEING 767-300ER
REGISTRATION OE-LAV
DAN CHANG DISTRICT
SUPHAN BURI PROVINCE
THAILAND
26 MAY B.E. 2534 (A.D. 1991)**

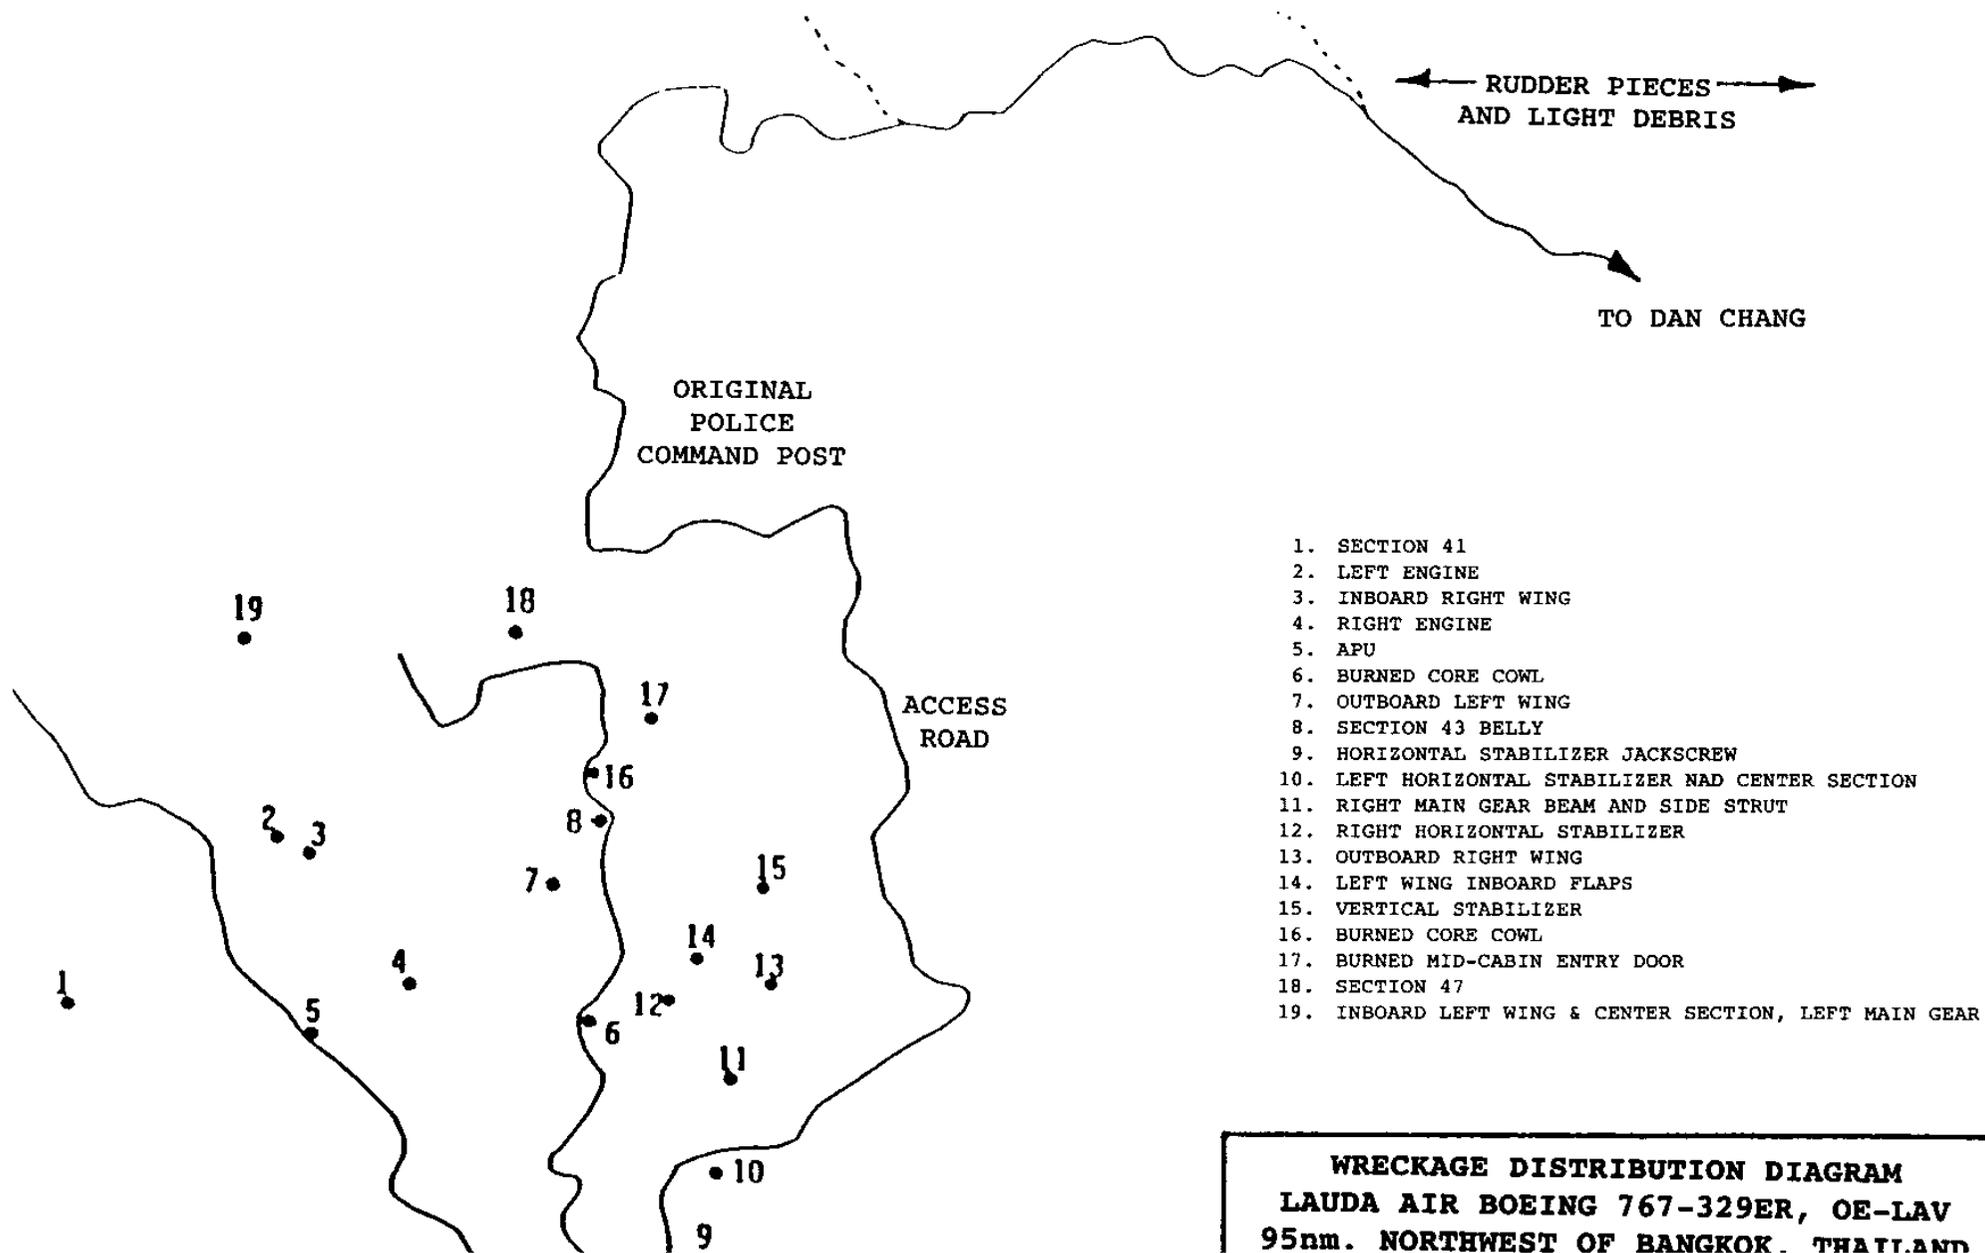
APPENDIX B Wreckage Distribution Diagram

Most of the wreckage was found in a one square kilometer area, but some lighter weight components were found up to 2,000 metres from the initial impact point. The horizontal stabilizer was the first major component found in the debris pattern, which was along a generally northwest/southeast track. Thrust reverser actuators from the left engine (both sleeves) were found in the fully deployed position. A diagram of the wreckage spread is included in this report as [Appendix B](#).

1. SECTION 41
2. LEFT ENGINE
3. INBOARD RIGHT WING
4. RIGHT ENGINE
5. APU
6. BURNED CORE COWL
7. OUTBOARD LEFT WING
8. SECTION 43 BELLY
9. HORIZONTAL STABILIZER JACKSCREW
10. LEFT HORIZONTAL STABILIZER NAD CENTER SECTION
11. RIGHT MAIN GEAR BEAM AND SIDE STRUT
12. RIGHT HORIZONTAL STABILIZER
13. OUTBOARD RIGHT WING
14. LEFT WING INBOARD FLAPS
15. VERTICAL STABILIZER
16. BURNED CORE COWL
17. BURNED MID-CABIN ENTRY DOOR
18. SECTION 47
19. INBOARD LEFT WING & CENTER SECTION, LEFT MAIN GEAR
