FINAL REPORT

97-75/A-26

PH-TKC

Final report of the investigation into the probable cause of the accident with Transavia Boeing 757, registration PH-TKC, on December 24th, 1997 at Amsterdam Airport Schiphol.

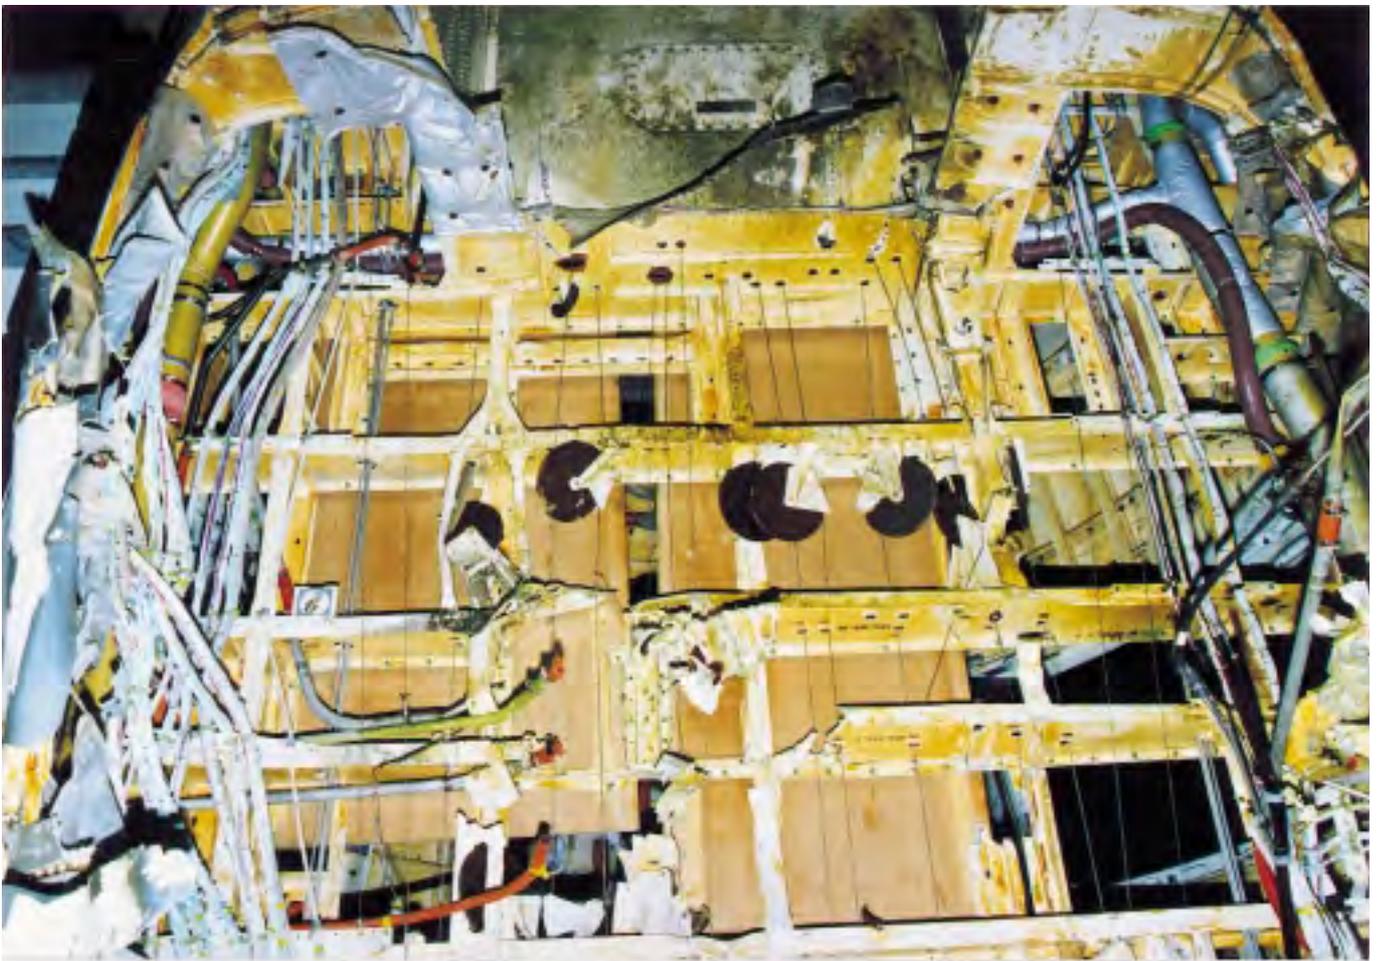
The aircraft sustained severe damage to the nose section, main undercarriage, engines and engine nacelles. In addition, as a result of the collapse of the nosewheel doghouse various engine and flight control cables located behind the nose gear well structure were ruptured. In the same area components of electric/electronic systems were damaged. Refer to the Boeing Field report in Appendix 3.1.

DAMAGE TO CONTROL CABLES

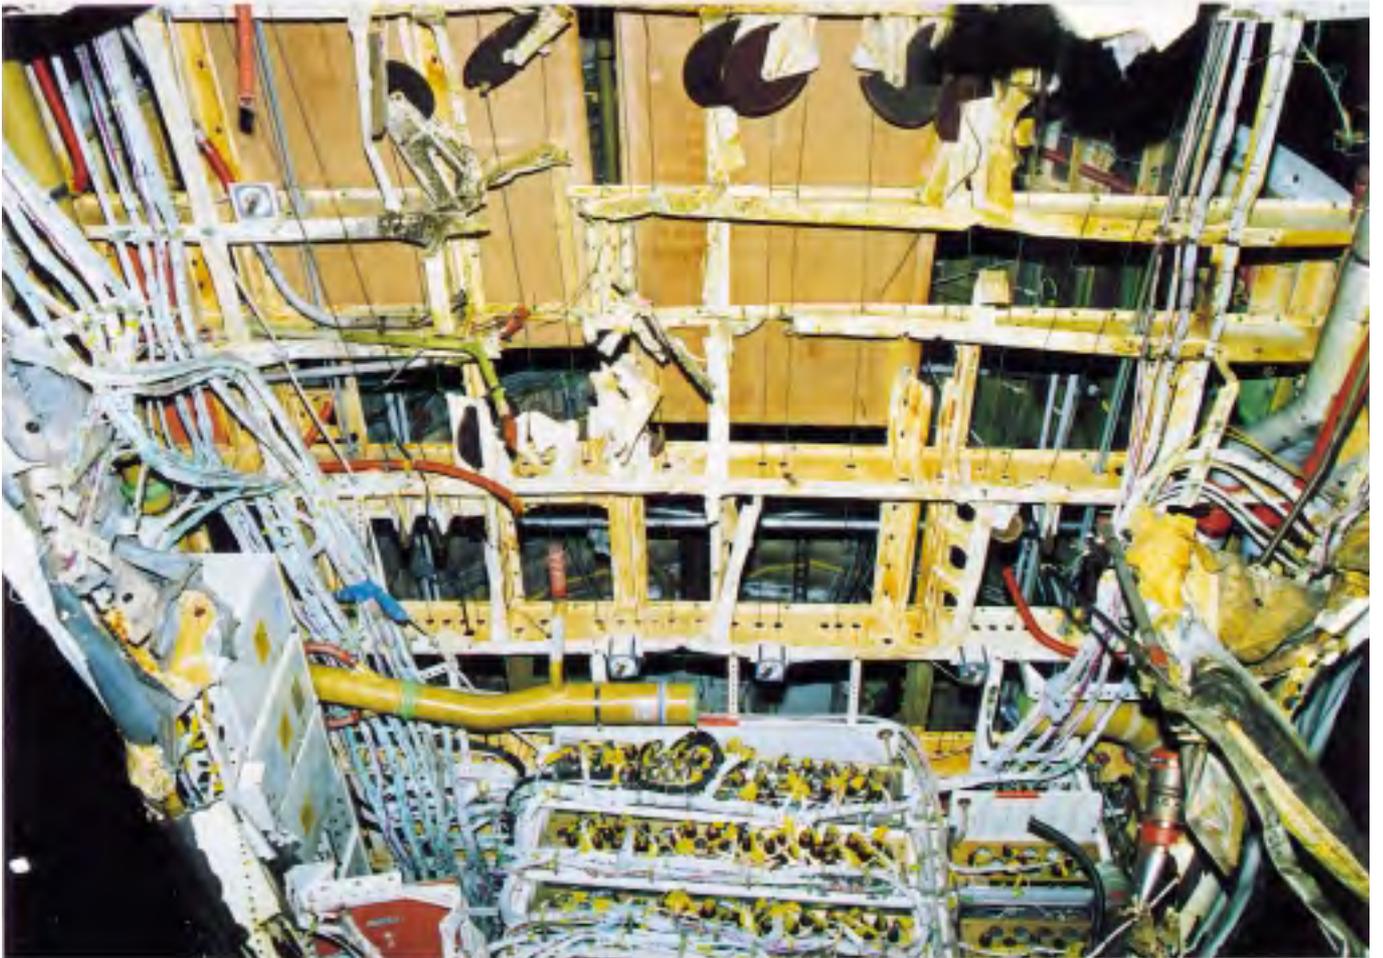
The DFDR stopped at the moment of nose wheel collapse, due to damage to the electronic compartment by the rearward movement of the nose wheel doghouse.

DAMAGE TO ELECTRONIC COMPARTMENT

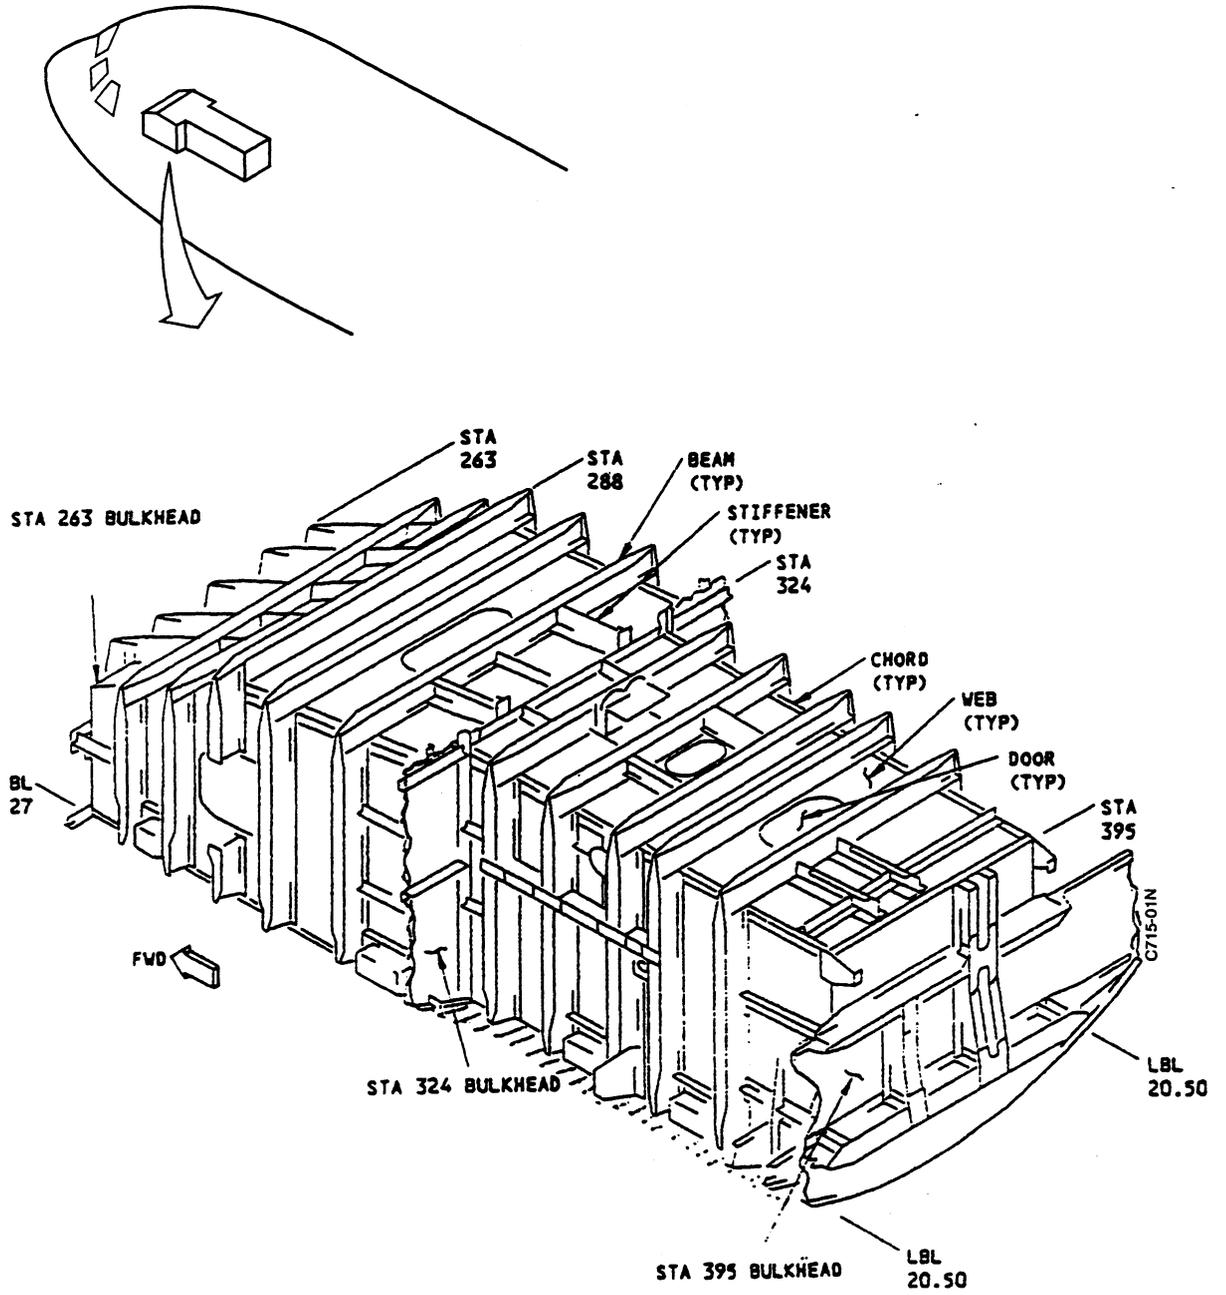
Fig. 1 Nose wheel well structure

The NLR conducted an investigation into the breakaway sequence of the nosegear wheel well (Appendix 3.2). Inspection showed that the aft part of the nosegear wheel well (doghouse) was broken loose from the surrounding structure.

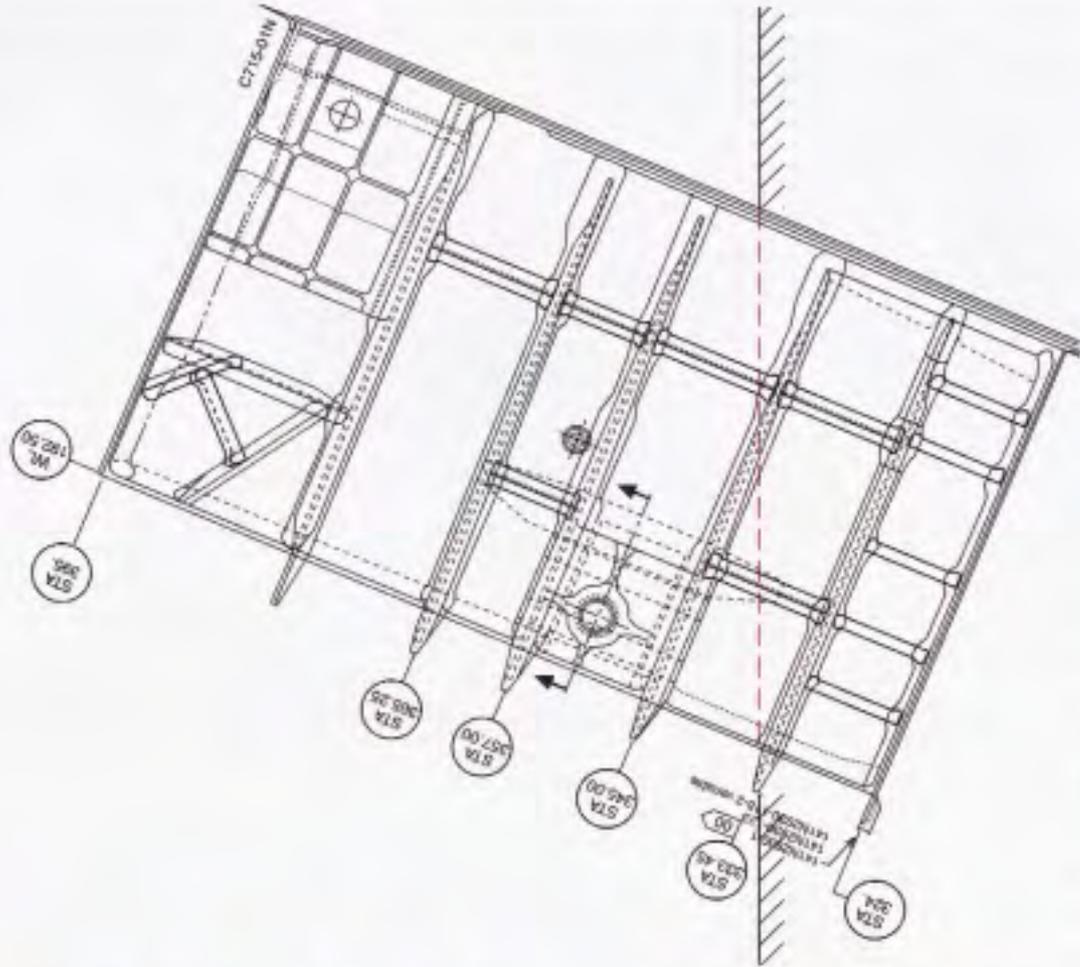
Fig. 4 Schematic of the aft doghouse in final position

of the aft doghouse to displace in upward direction. The increased load on the STA 324 bulkhead resulted in deformation and fracture. After the aft doghouse separated from the STA 324 bulkhead the aft doghouse rotated aft, thereby bending and twisting the STA 395 frame which ultimately resulted in fracture and complete separation of the aft doghouse.

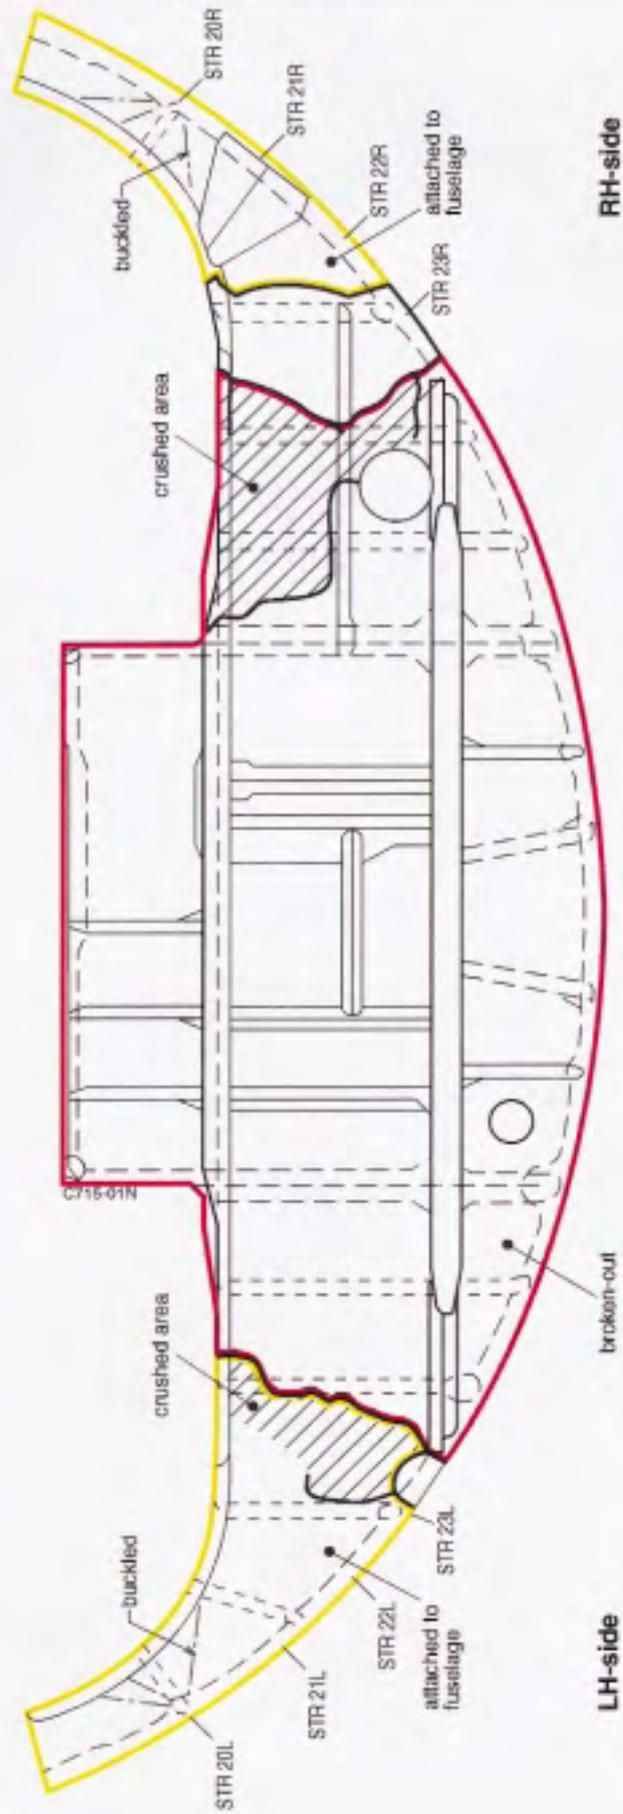
The failure started with the buckling of the STA 395 frame, which enabled the aft side

Fig. 10 Schematic of the lower STA 395 bulkhead with web fracture locations indicated
