ATSB TRANSPORT SAFETY REPORT
Aviation Occurrence Investigation – AO-2010-089
Preliminary

**In-flight uncontained engine failure
overhead Batam Island, Indonesia
4 November 2010
VH-OQA
Airbus A380-842**

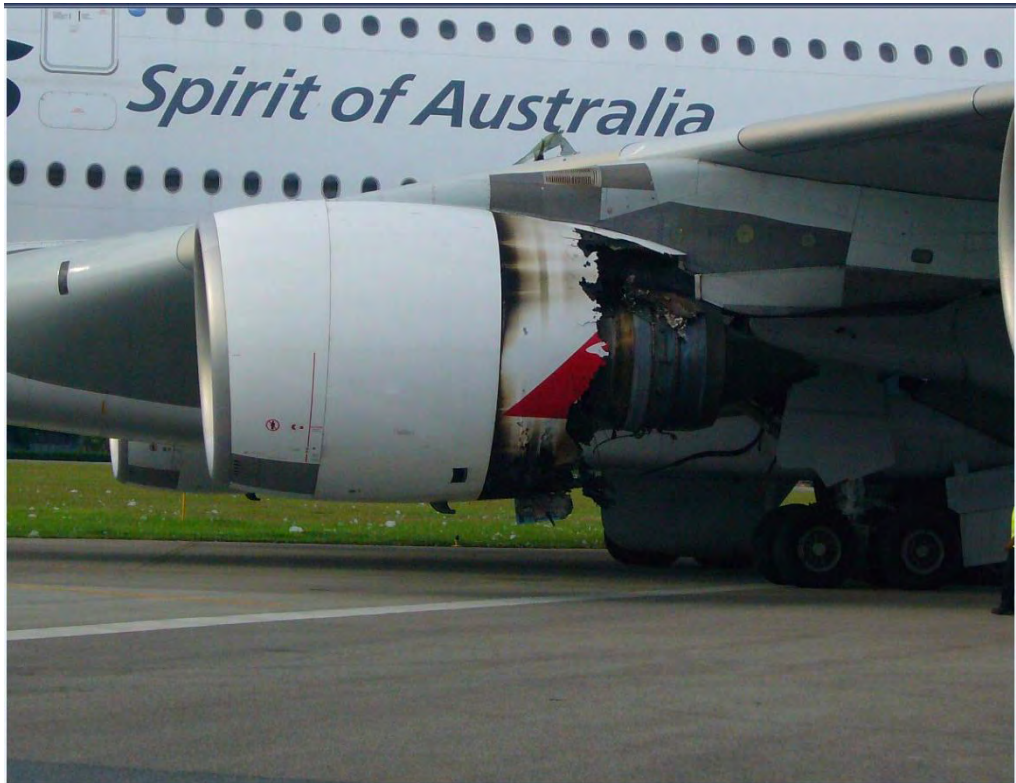
Figure 1: VH-OQA showing the damaged No 2 engine

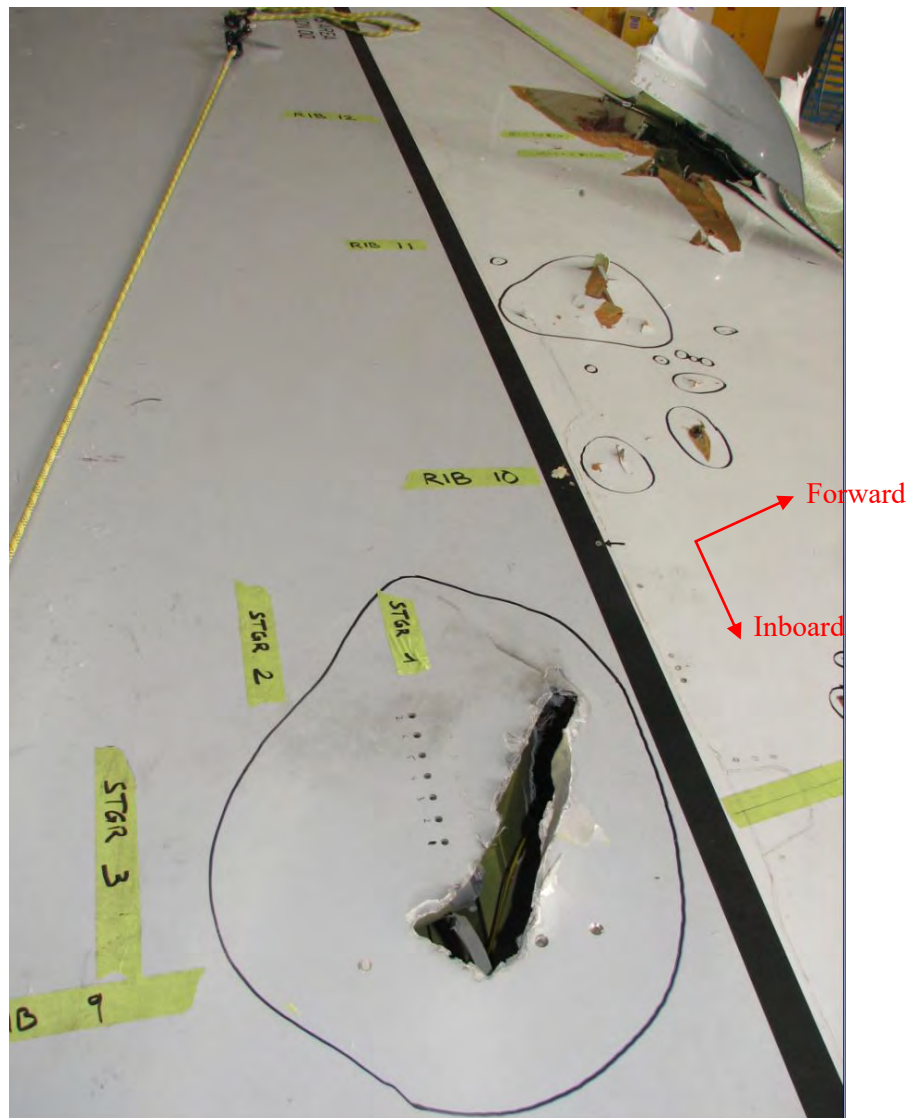
The failure of the No 2 engine ejected a number of engine components that struck the aircraft or were liberated overboard. Sections of the intermediate pressure (IP) turbine disc penetrated the leading edge of the left wing inboard of the No 2 engine, resulting in damage to the leading edge structure, the front wing spar and the upper surface of the wing (Figure 3). A small section of liberated turbine disc penetrated the left wing-to-fuselage fairing, resulting in damage to numerous system components, the fuselage structure and elements of the aircraft's electrical wiring. Released debris also impacted the left wing's lower surface, resulting in a fuel leak from the Number 2 engine fuel feed tank and left wing inner fuel tank.

Figure 3: Damage to left wing upper surface

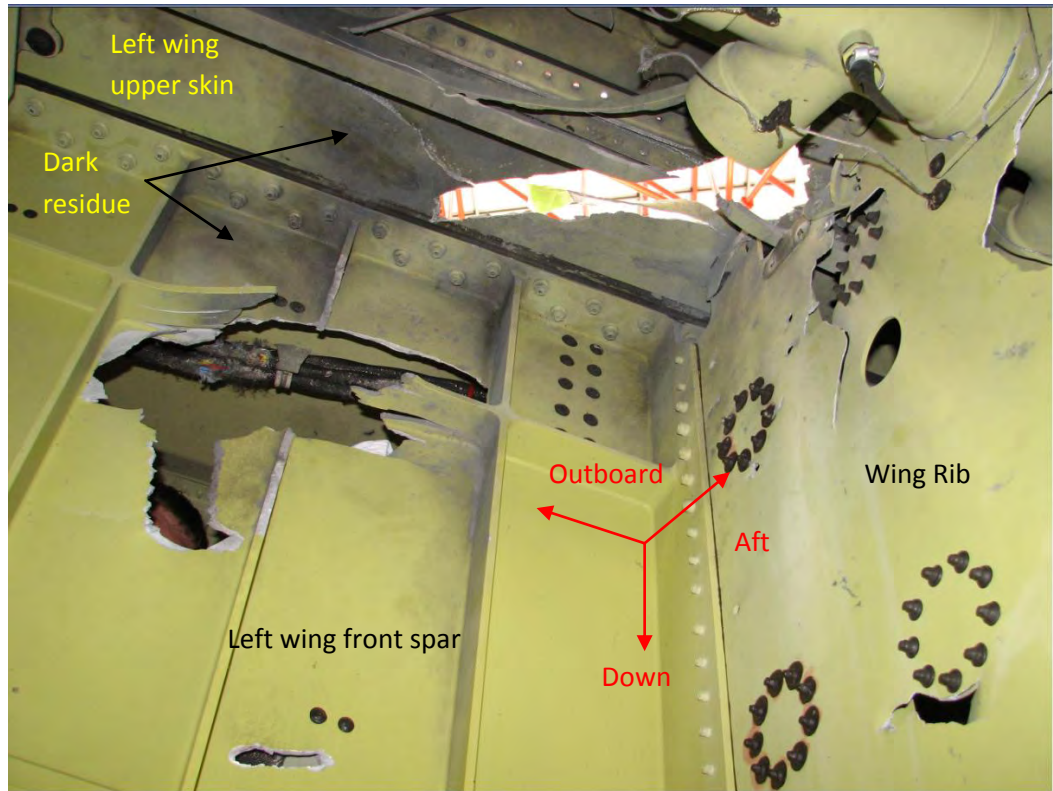
A dark residue was observed inside the left wing inner fuel tank between ribs 8 to 10 (Figure 4). The residue will be subject to further technical examination.

Figure 4: Dark residue observed in the left wing inner fuel tank

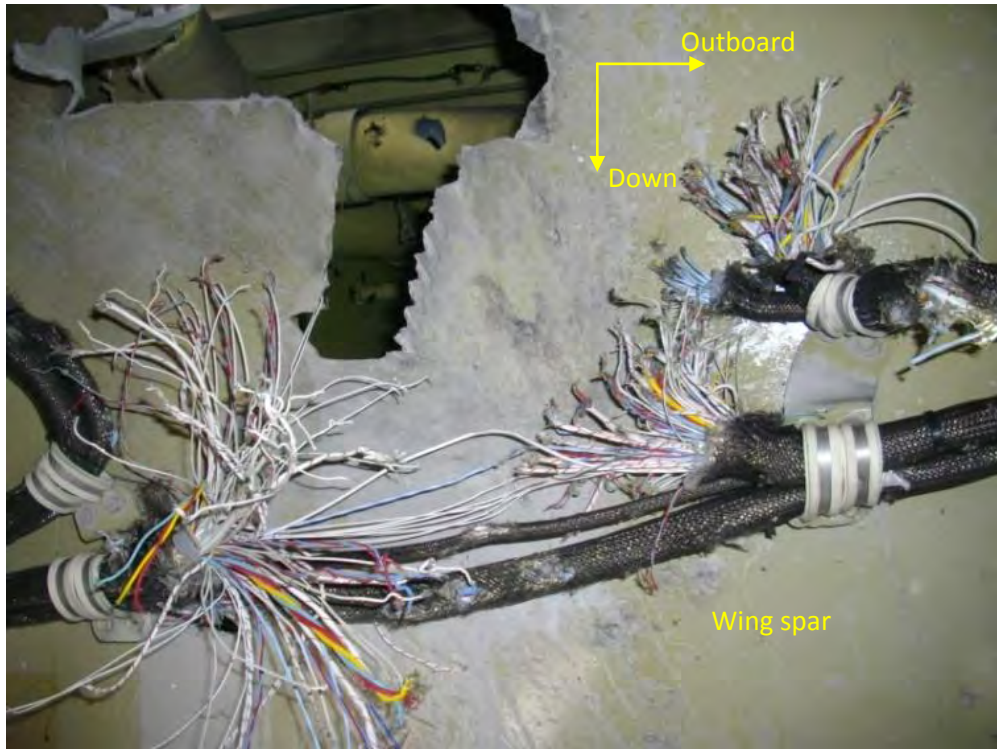
Impact damage from the liberated engine debris affected a number of aircraft systems. Damage was observed to: elements of the aircraft's electrical wiring that affected the operation of the hydraulic system, landing gear and flight controls; a number of fuel system components; and the leading edge slat system (Figure 5).

Figure 5: Damage to electrical wiring located in the leading edge of the left wing

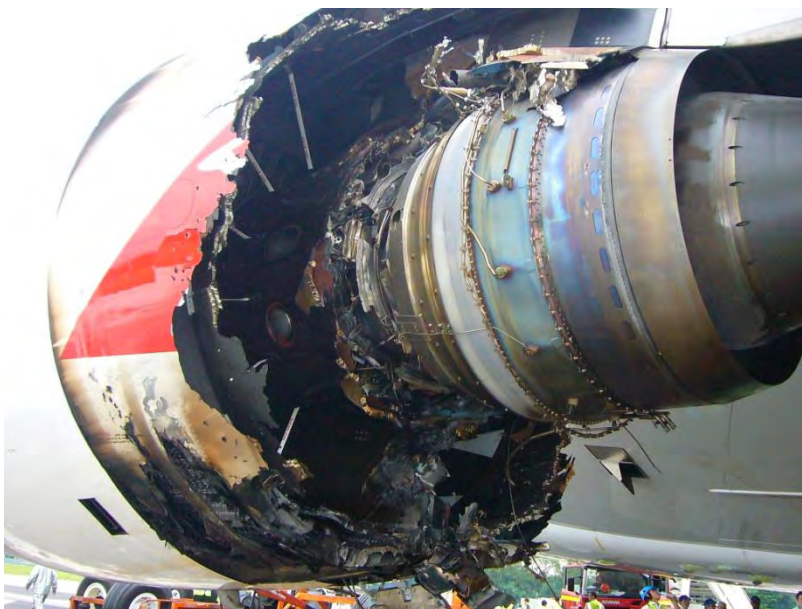
Examination of the failed No 2 engine indicated that it had sustained an uncontained failure of the IP turbine (Figure 7). The turbine disc, blade and nozzle

Damage was also evident to the engine cold stream duct and outer cowl panels. The No 2 engine thrust links were severed and extensive damage was evident to the LP turbine nozzle guide vanes and stage-1 LP turbine blades.

Figure 7: Damage to the No 2 engine

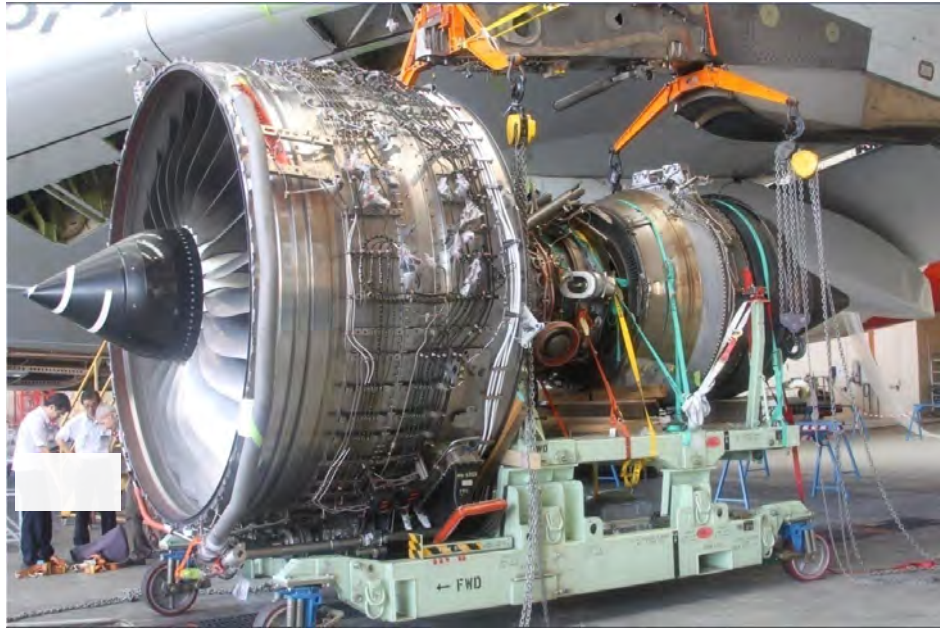
Figure 8: No 2 engine after removal from the aircraft

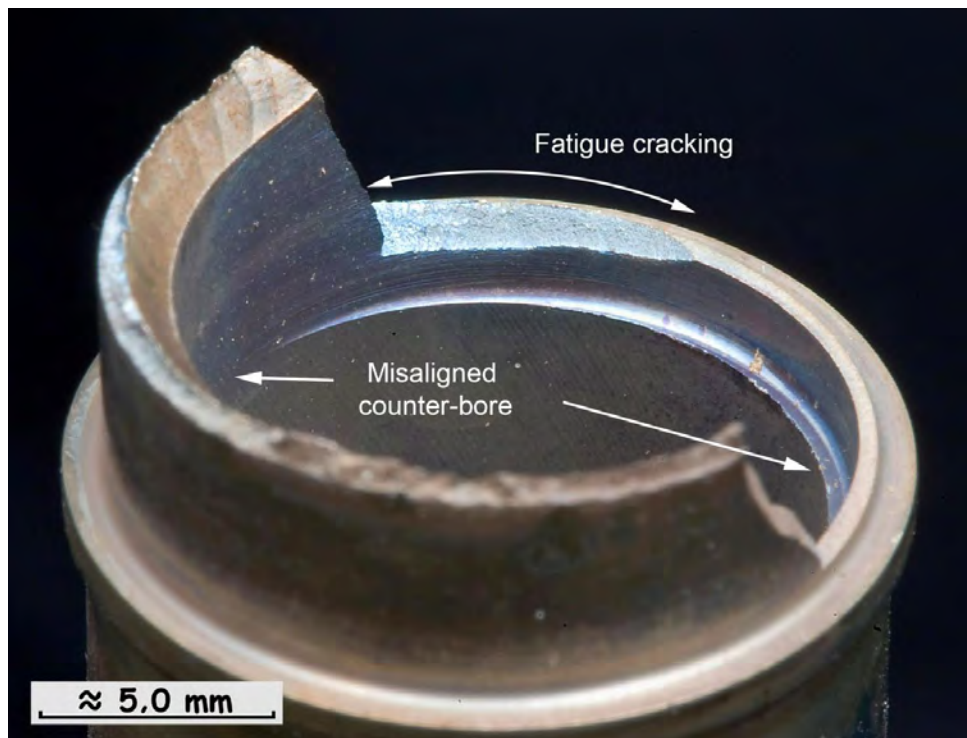
A recent key finding from those examinations was the presence of an area of fatigue cracking within a stub pipe that feeds oil to the HP/IP bearing structure. That cracking was associated with a misaligned region of counter-boring within the stub pipe outlet. The misaligned counter-boring had produced a localised thinning of one side of the pipe wall (Figure 9).

Figure 9: Detail of stub pipe showing misaligned counter-bore

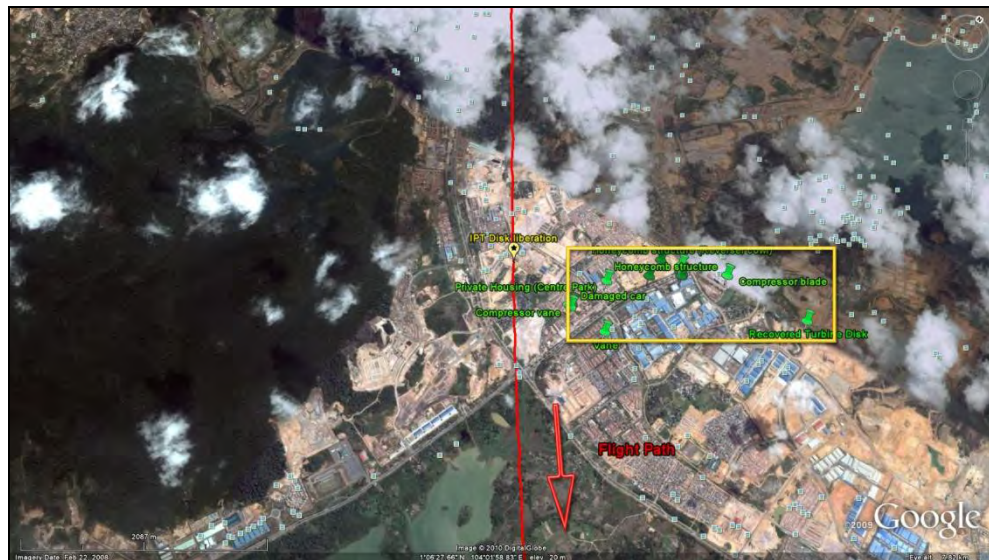
The components that were located on Batam Island were all to the left of the aircraft's flight path. A large segment of IP turbine disc was located about 2.5 km from the aircraft's location at the time of the failure (Figure 10).

Figure 10: Area of recovered components

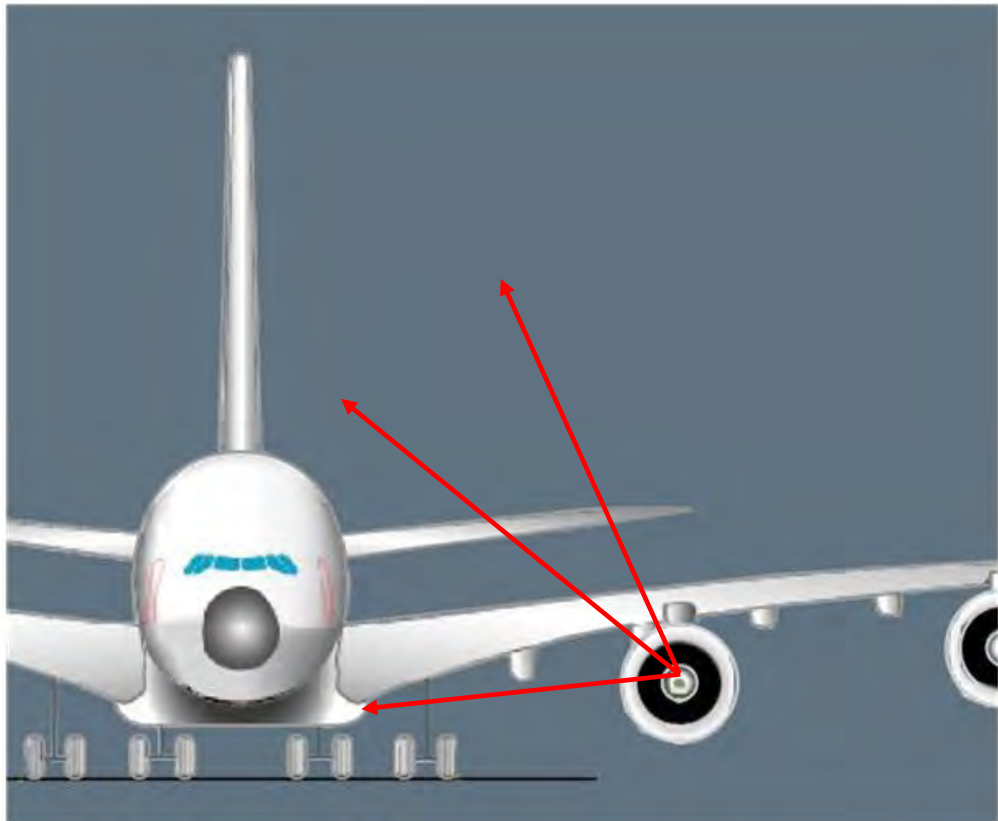
Damage to the aircraft's left wing and the wing-to-fuselage fairing indicated that several IP turbine disc segments were liberated inboard (Figure 11).

Figure 11: Known direction of travel of some of the liberated engine segments

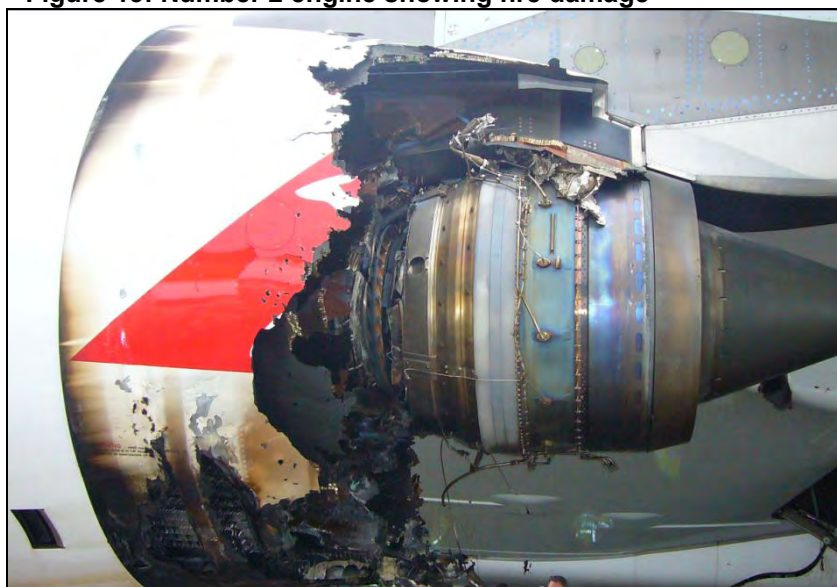
The rear section of the No 2 engine and cowl was damaged by fire (Figure 13). Some components forward of the engine firewall were heat affected.

Figure 13: Number 2 engine showing fire damage

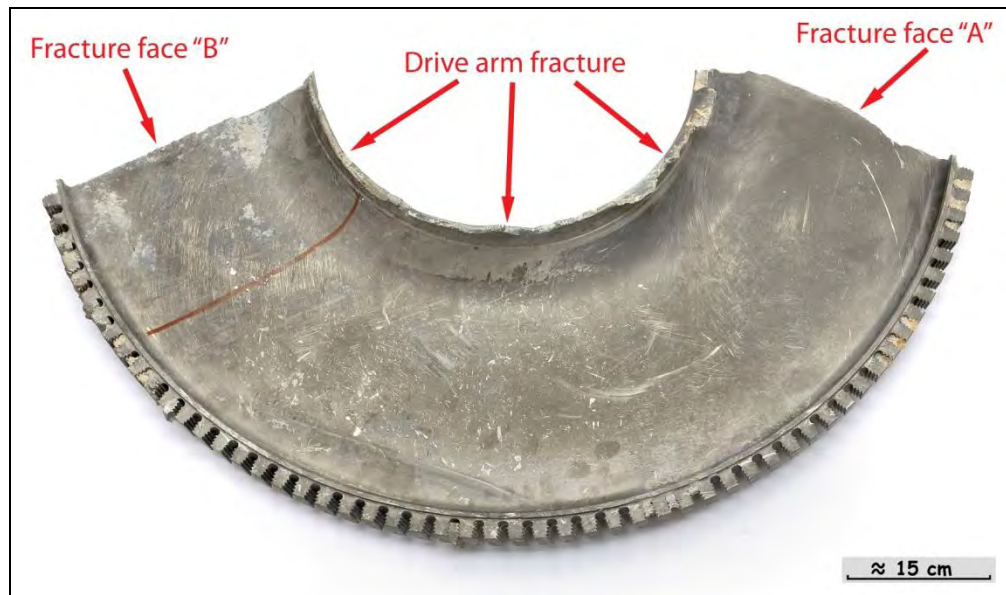
The recovered section of IP turbine disc approximated one-third of the total disc (Figure 14).

Figure 14: Recovered section of IP turbine disc (as viewed from the rear of the engine)

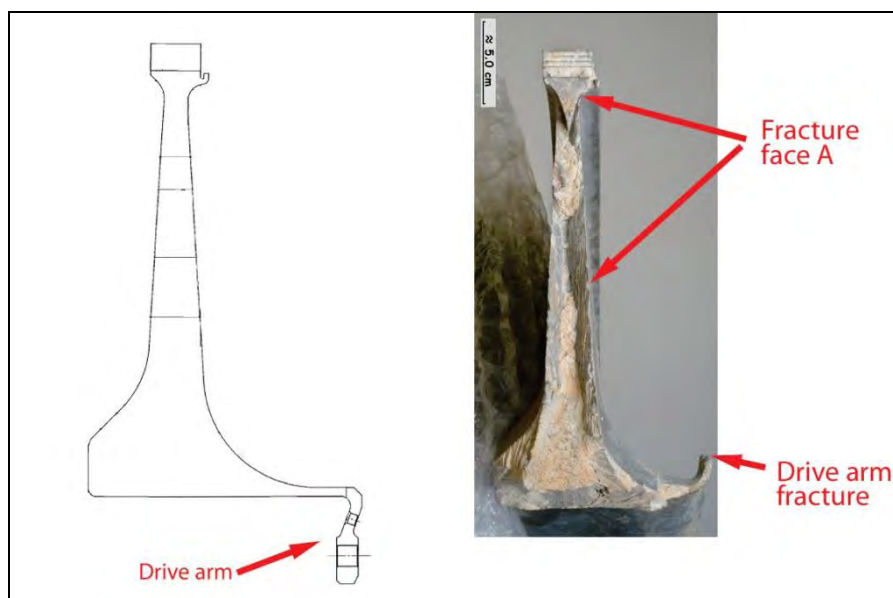
The mass of the recovered IP turbine disc section was almost 70 kg. The section exhibited three distinct fracture faces; two radial fractures from the bore to the external diameter (labelled 'A' and 'B' in Figure 14), and a circumferential fracture face in the region adjacent to the drive arm (the central cylindrical connection to the intermediate pressure spool shaft). The remaining section of the drive arm presented considerable plastic deformation, having bent outward by about 90° (Figure 15). The arm failed at the R850 holes and a section of the drive arm is still missing.

Figure 15: Cross section of the recovered portion of the IP turbine disc

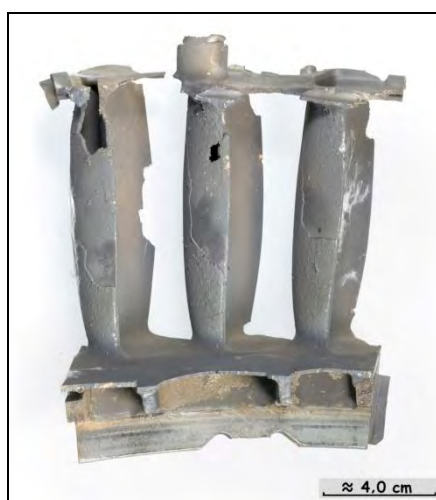
Three triple segments of the LP1 NGV were received. One of the segments was almost complete, with all three vanes present along with the inner platform and some areas of the outer platform (Figure 16). The remaining two NGV segments retrieved contained the remains of the inner platform only, and the vanes exhibited significant damage.

Figure 16: Portion of LP turbine first stage nozzle guide vanes that was recovered from Batam Island, Indonesia

Evidence of a deposit was observed on the leading (inlet) vane surfaces (as shown in Figure 15). A flaked sample of the deposit was extracted from the vane and the cross section prepared for further examination.
