Landing Overruns- Human Factors

Captain David Oliver

Qantas Airways Limited

A review of the events leading to, and lessons learnt from the over-run of flight QF1 at Bangkok Thailand, September 23, 1999.

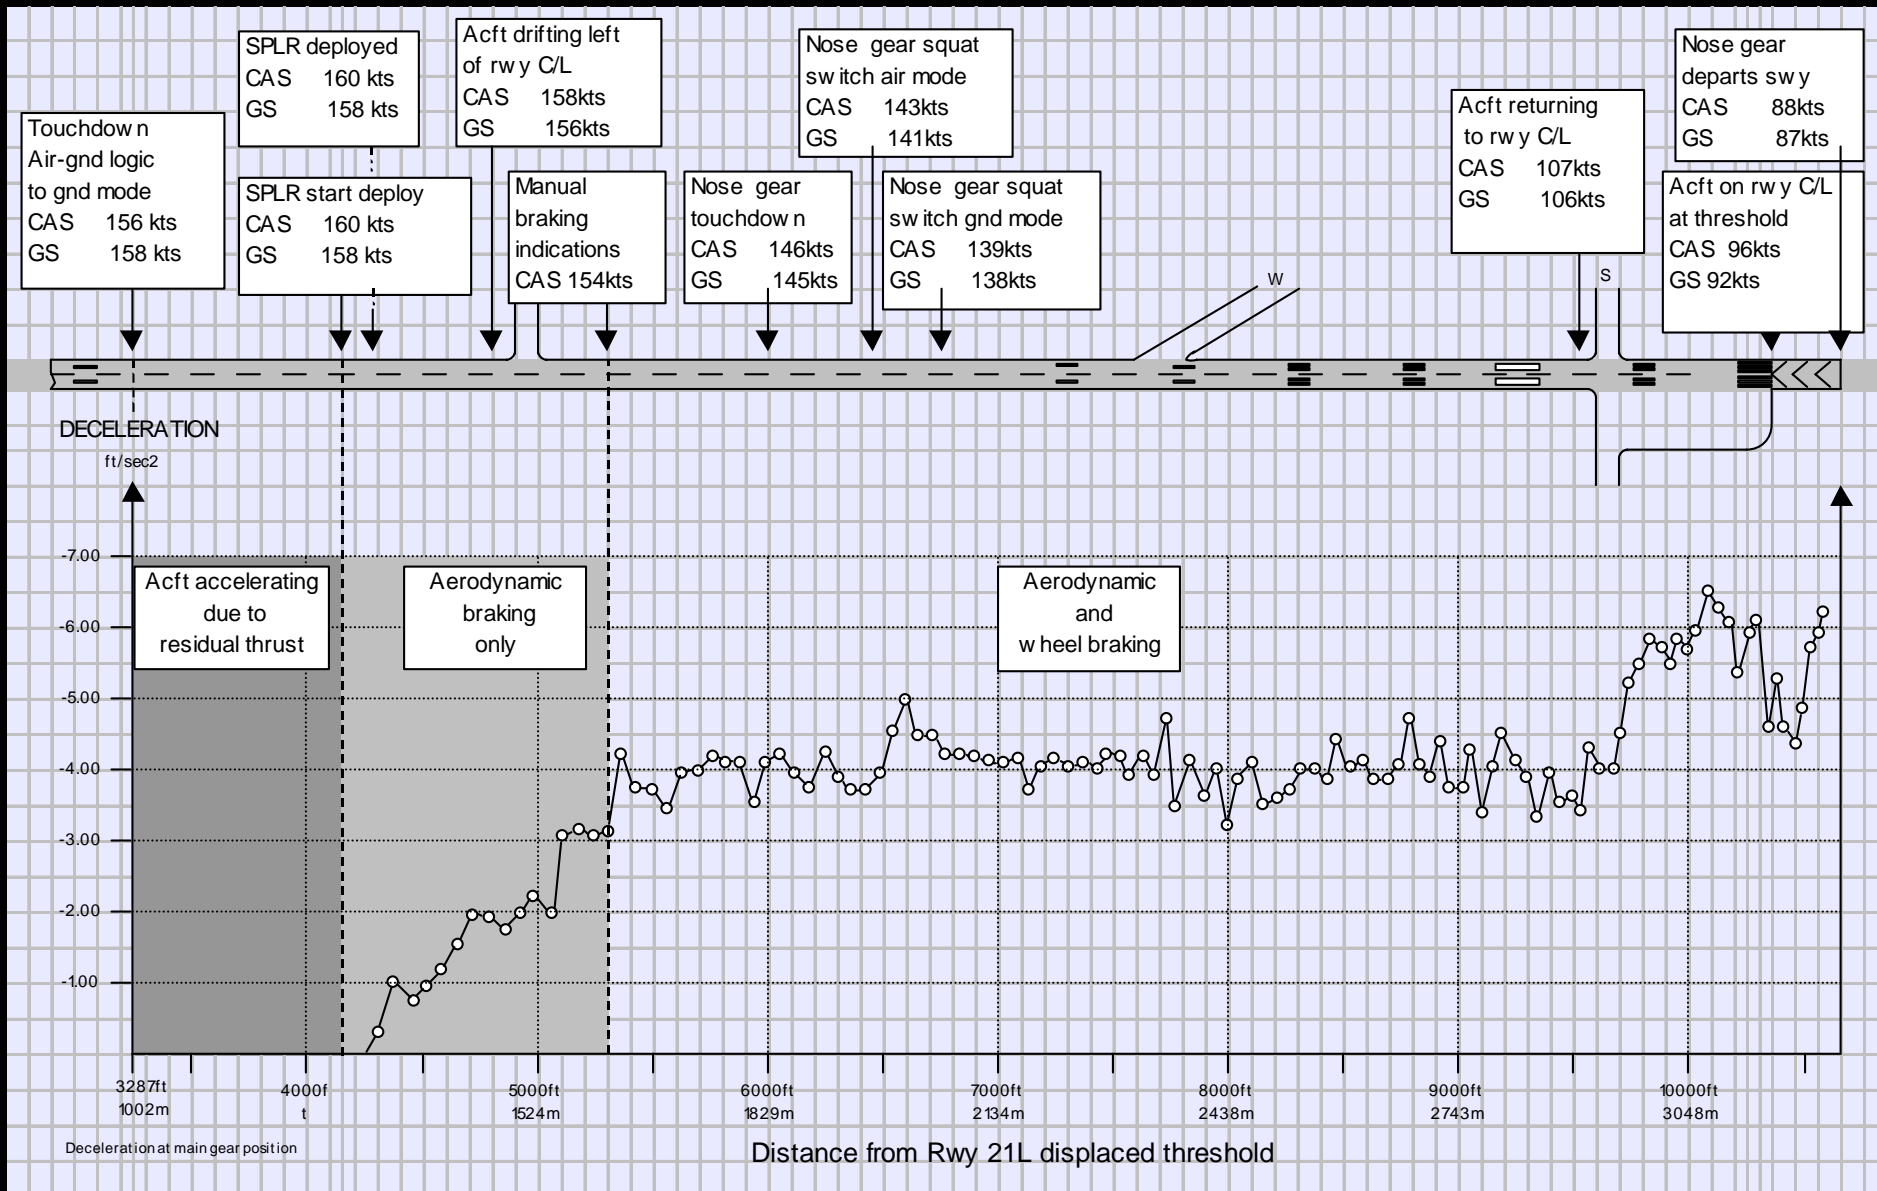
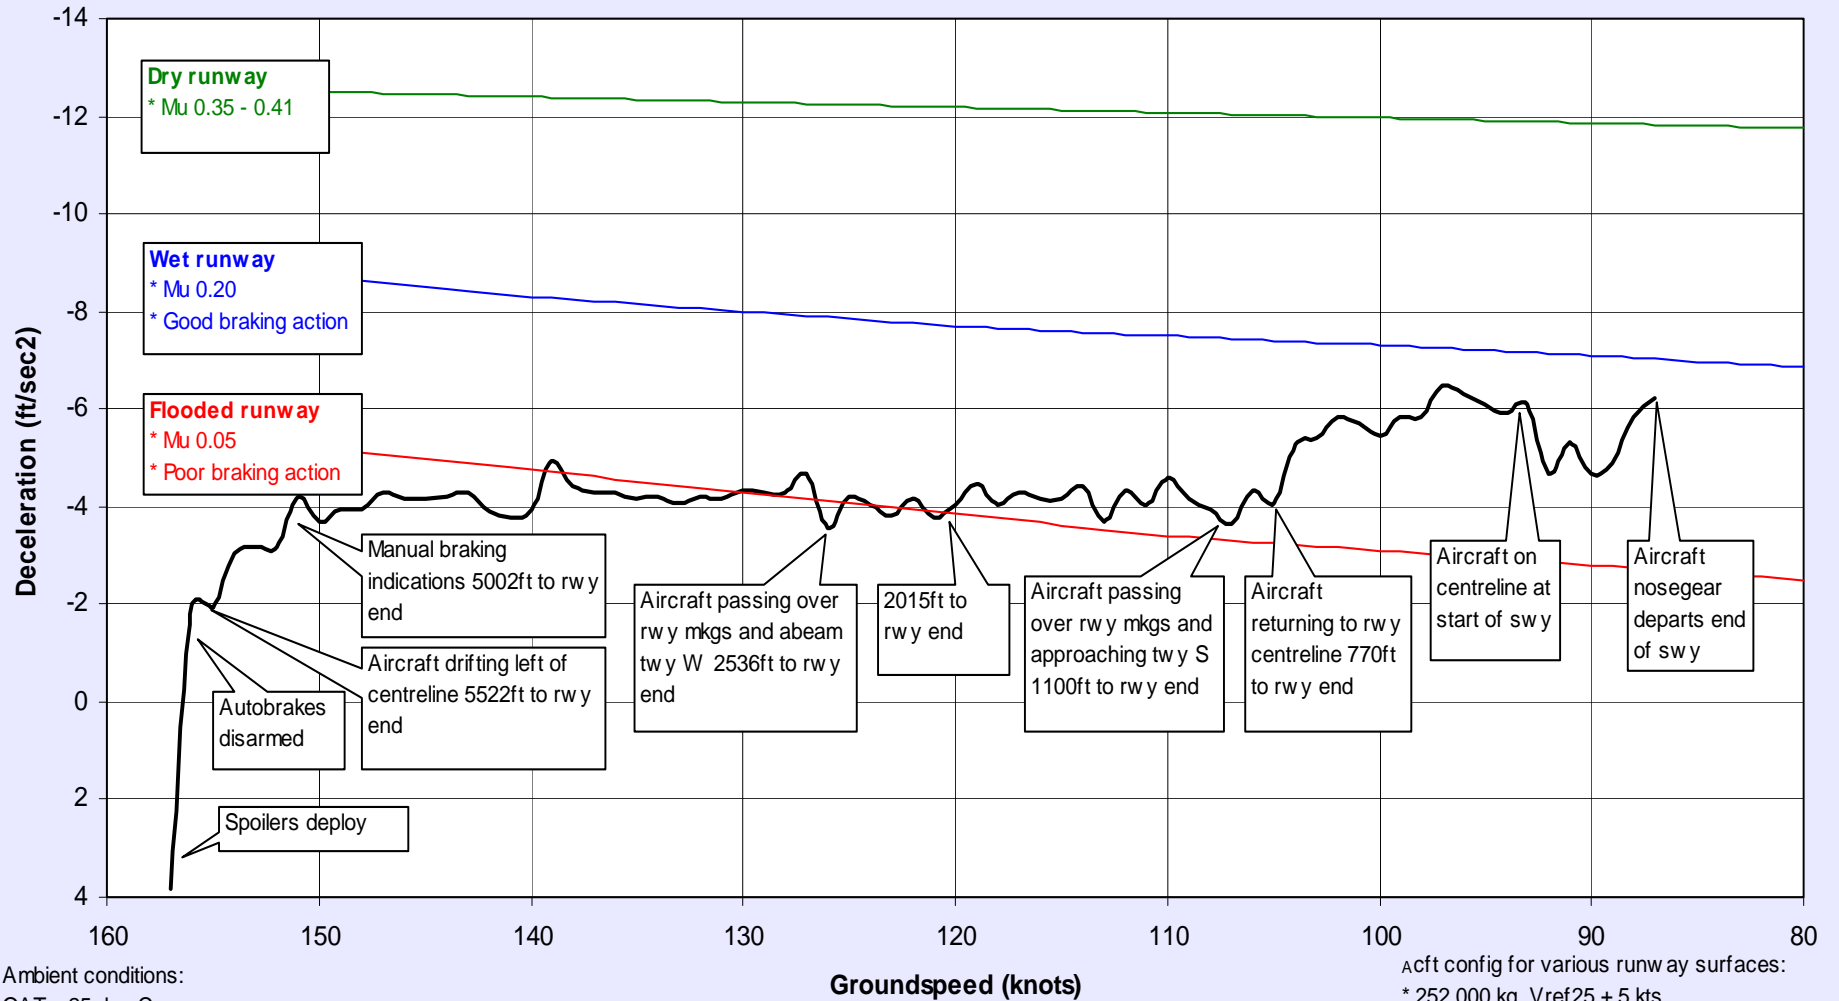
Comparison of rollout deceleration on various runway surfaces and VH-OJH 23 September 1999

- When manual braking was applied
NO deceleration was felt
- Both pilots exerted maximum force on the
brake pedals, still with no deceleration
– *The airplane was aquaplaning*
- The airplane only began to decelerate as it
entered the last 1000 feet of the runway and
the groundspeed reduced below 110kts

Ambient conditions:
 OAT 25 deg C
 QNH 1013.2
 WIND 3.6 kt HWC

Aircraft configuration for various runway surfaces:
 * 252,000 kg Vref25 + 5 kts
 * Maximum manual braking
 * Spoilers deployed, Idle forward thrust

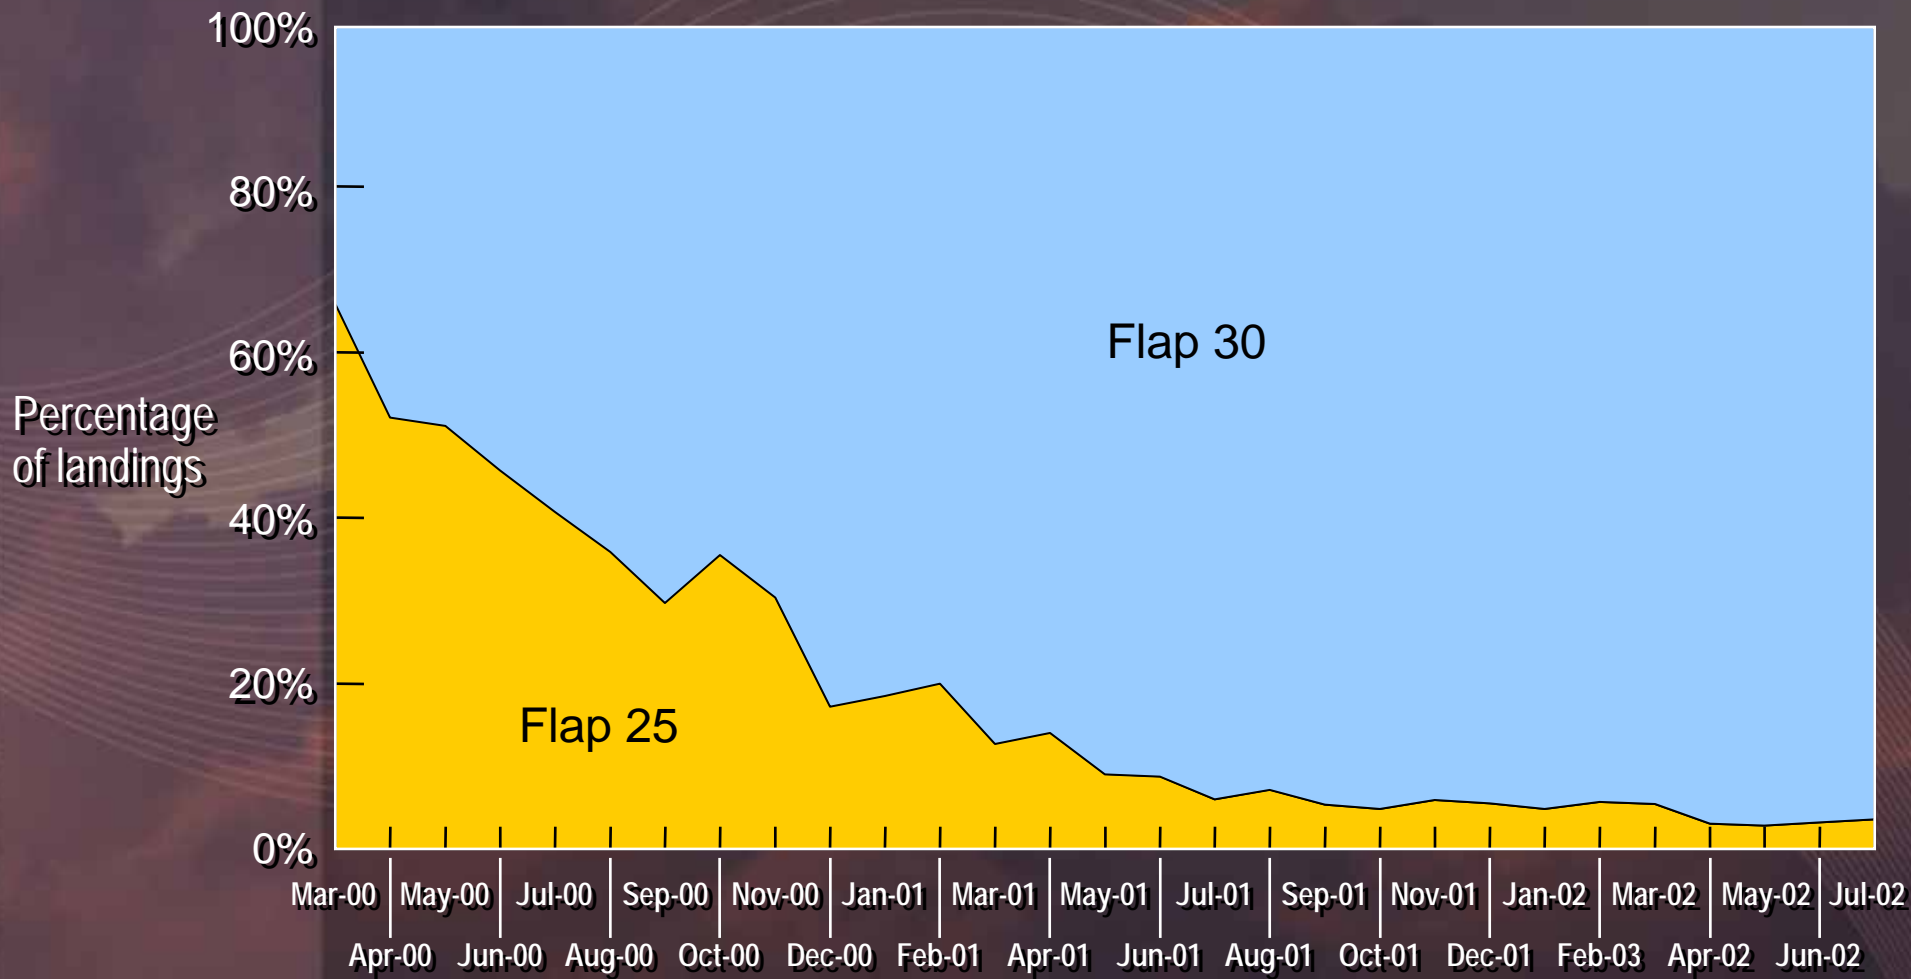
Trend in Landing Flap Setting

- Monitoring of landing configurations and touchdown points has shown:
 - Significant trend towards flap 30 irrespective of runway conditions
 - Max. reverse thrust used on most occasions
 - Touchdown points are closer to the “desired” point. i.e. less “float”
