FINAL REPORT

97-75/A-26

PH-TKC

Final report of the investigation into the probable cause of the accident with Transavia Boeing 757, registration PH-TKC, on December 24th, 1997 at Amsterdam Airport Schiphol.

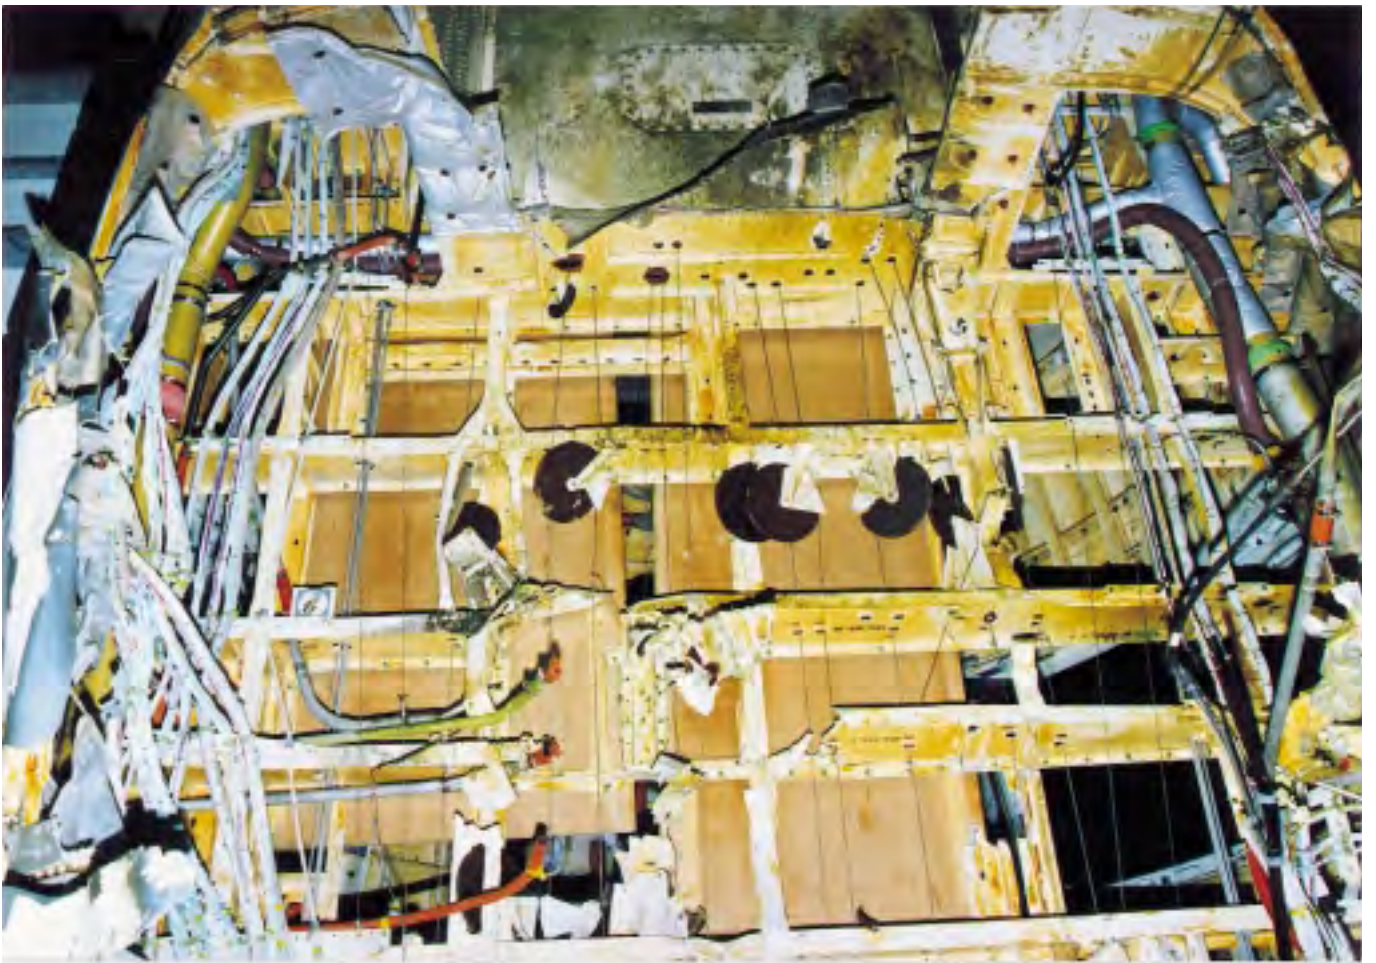
The aircraft sustained severe damage to the nose section, main undercarriage, engines and engine nacelles. In addition, as a result of the collapse of the nosewheel doghouse various engine and flight control cables located behind the nose gear well structure were ruptured. In the same area components of electric/electronic systems were damaged. Refer to the Boeing Field report in Appendix 3.1.

DAMAGE TO CONTROL CABLES

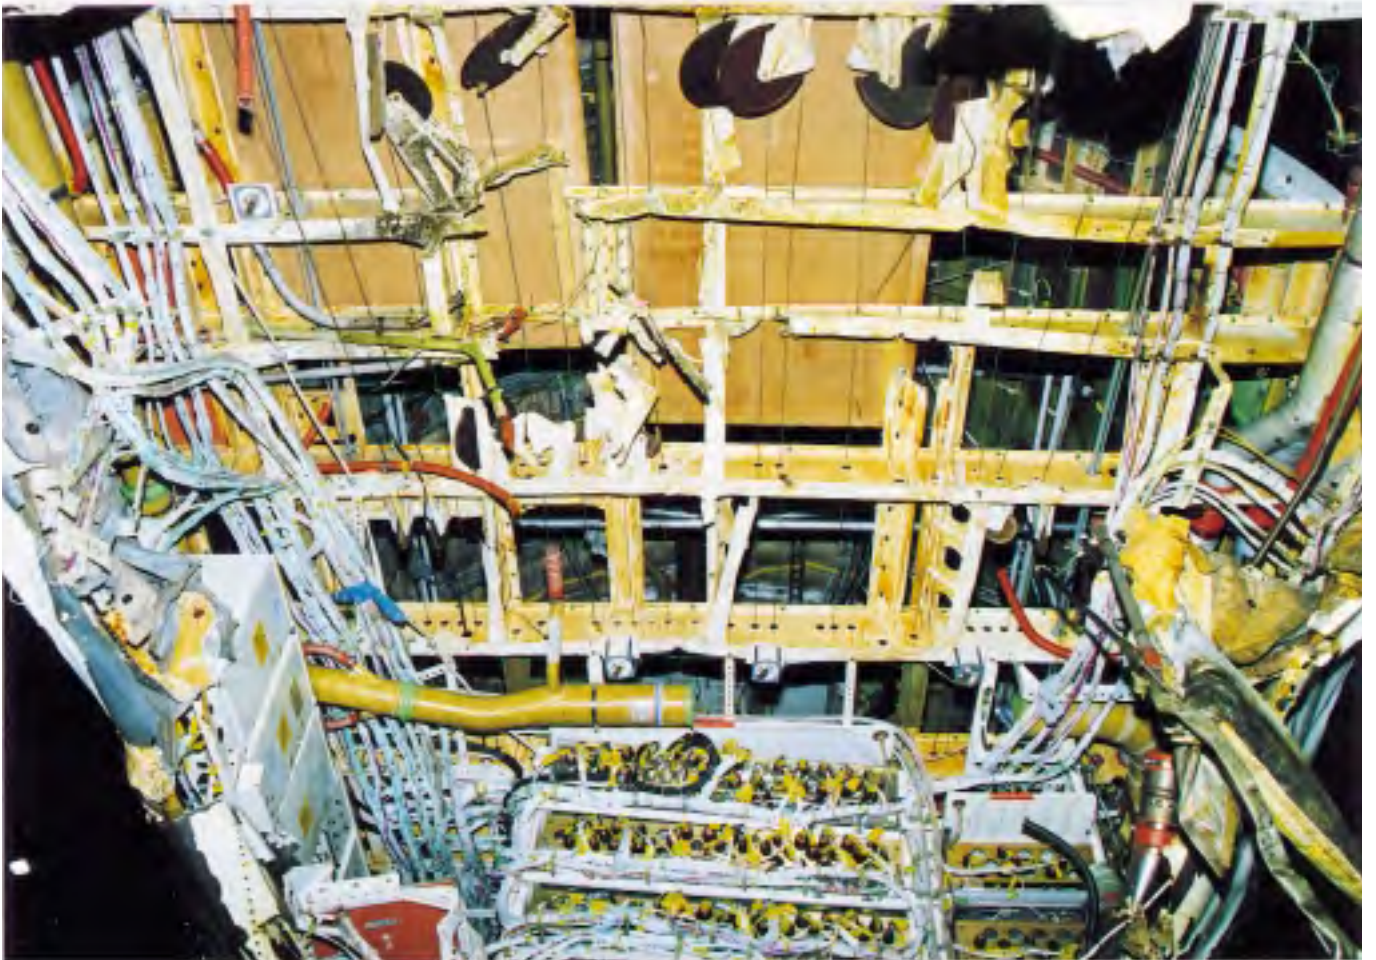
The DFDR stopped at the moment of nose wheel collapse, due to damage to the electronic compartment by the rearward movement of the nose wheel doghouse.

DAMAGE TO ELECTRONIC COMPARTMENT

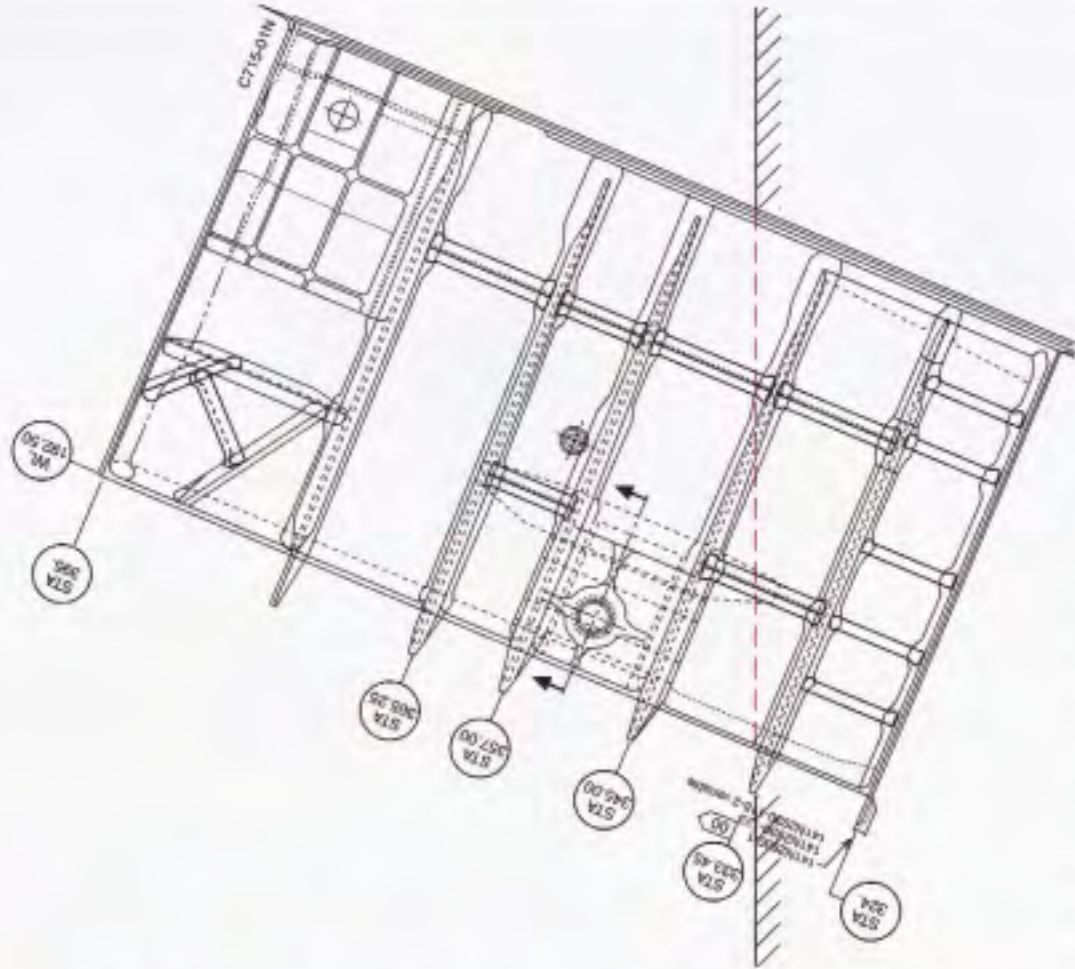
Fig. 4 Schematic of the aft doghouse in final position

of the aft doghouse to displace in upward direction. The increased load on the STA 324 bulkhead resulted in deformation and fracture. After the aft doghouse separated from the STA 324 bulkhead the aft doghouse rotated aft, thereby bending and twisting the STA 395 frame which ultimately resulted in fracture and complete separation of the aft doghouse.

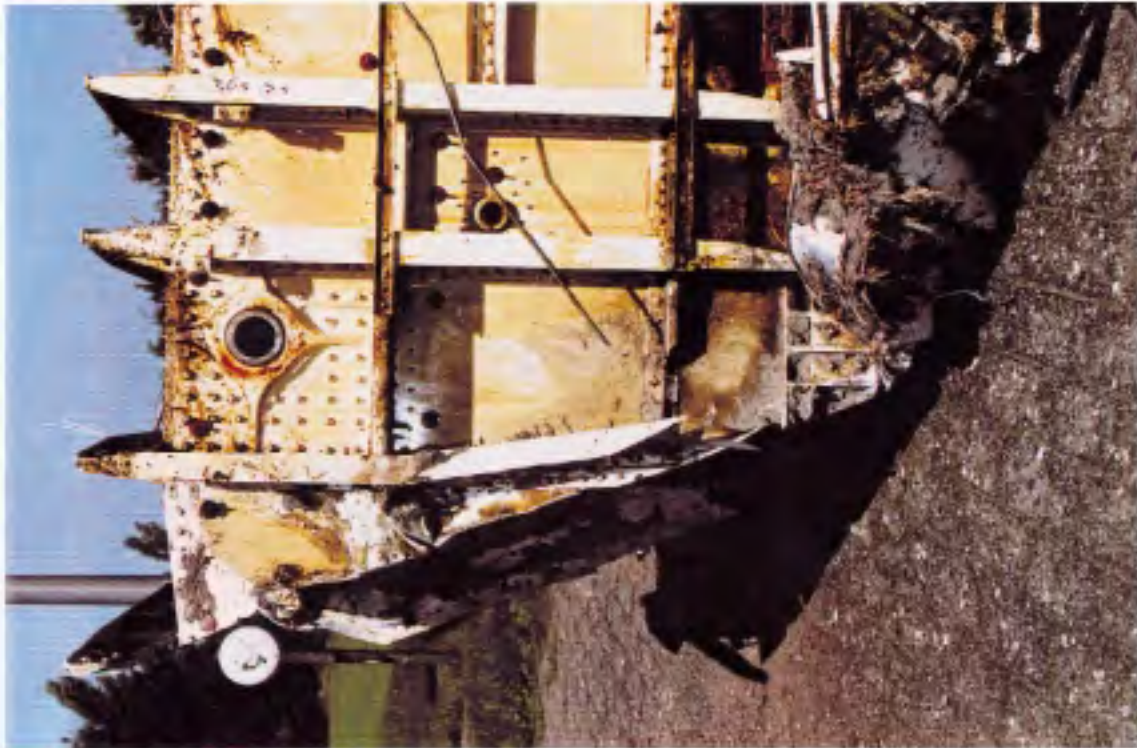
Fig. 3 Side view of the aft doghouse

The NLR conducted an investigation into the breakaway sequence of the nosegear wheel well (Appendix 3.2). Inspection showed that the aft part of the nosegear wheel well (doghouse) was broken loose from the surrounding structure.

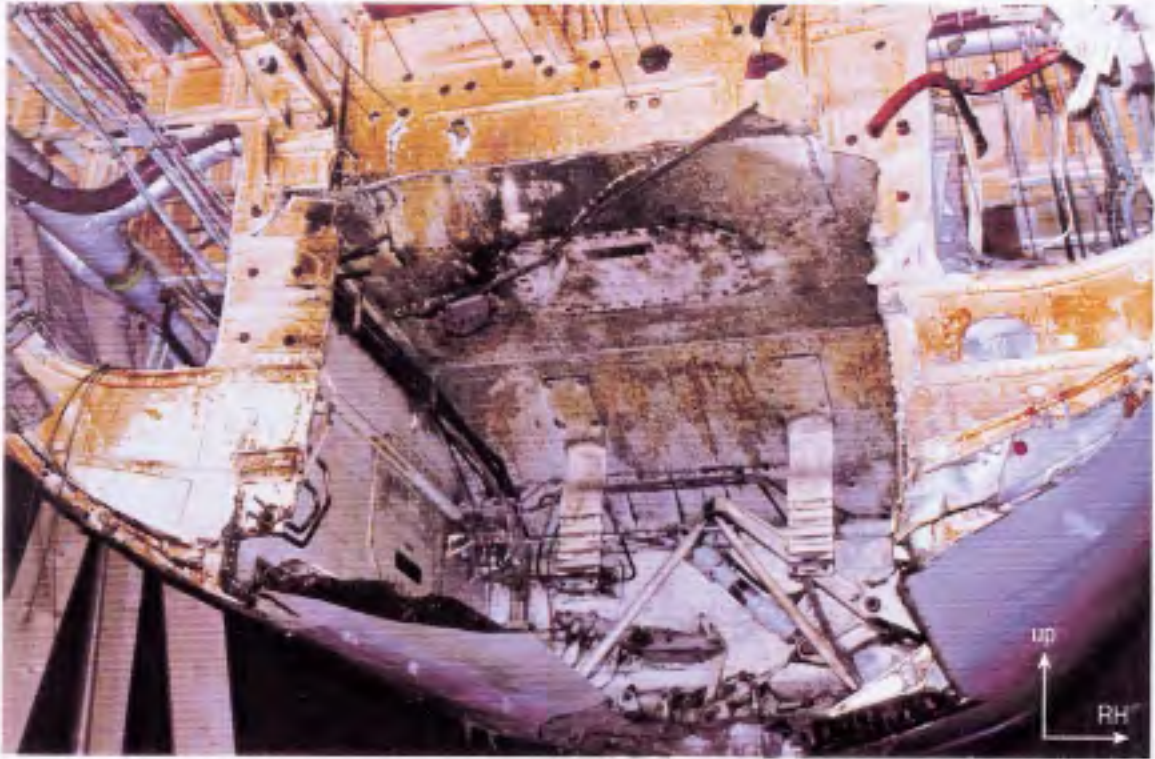
Fig. 5 Lower part of the STA 324 bulkhead

Macro-examination of the fracture surfaces of the STA 324 and 395 bulkheads showed no indications of pre-existing cracks. Macroscopic features indicated overload as the fracture mechanism.

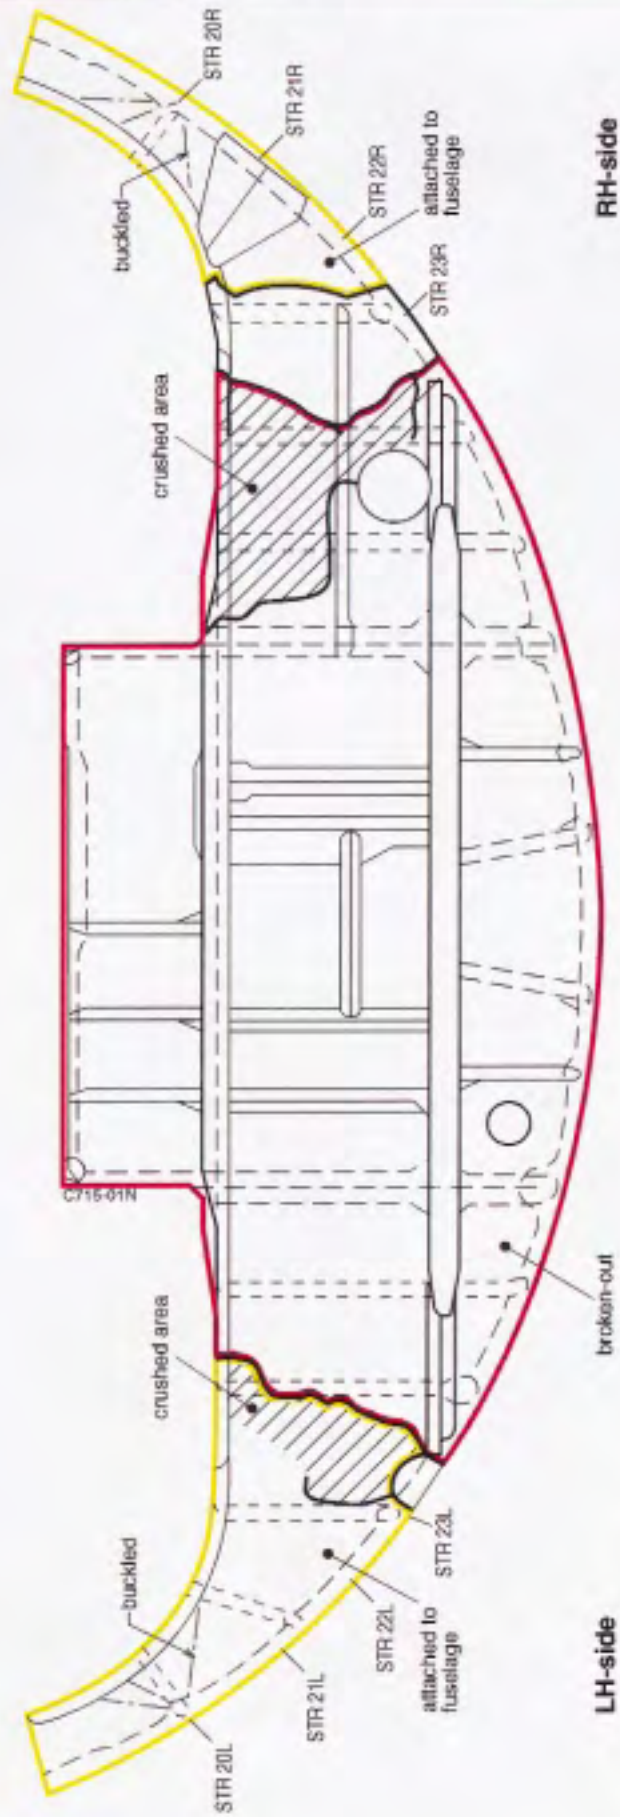
Fig. 10 Schematic of the lower STA 395 bulkhead with web fracture locations indicated

The failure started with the buckling of the STA 395 frame, which enabled the aft side
