AIRCRAFT ACCIDENT REPORT

**PAN AMERICAN WORLD AIRWAYS
BOEING 747, N 737 PA**

**KLM ROYAL DUTCH AIRLINES
BOEING 747, PH-BUF**

**TENERIFE, CANARY ISLANDS
MARCH 27, 1977**

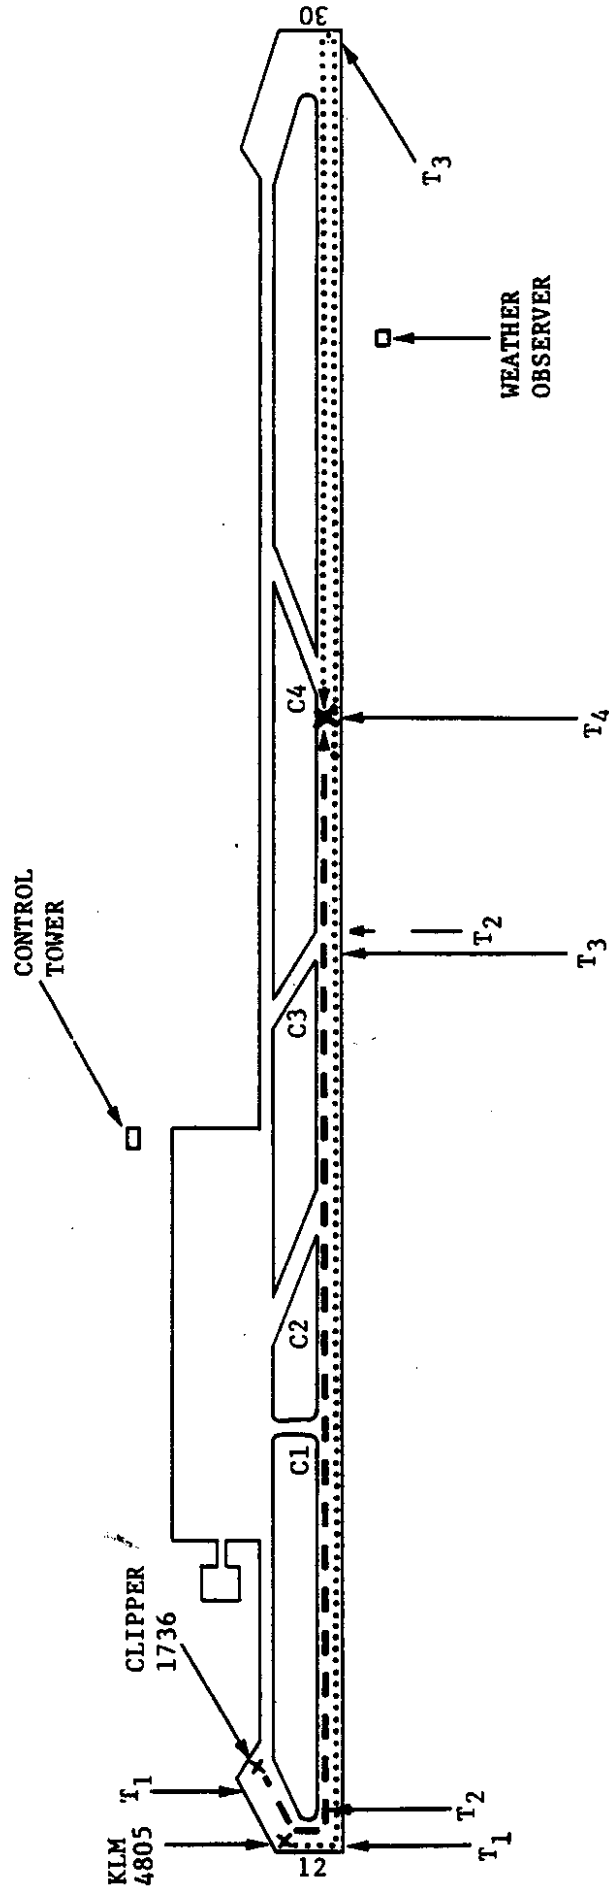
T₃ = 1705:53 (GMT)
Pan Am passing C3
KLM receiving ATC clearance

T₄ = 1706:49 (GMT)
Impact point near C4
