Commuter Captain Fails to Follow Emergency Procedures After Suspected Engine Failure, Loses Control of the Aircraft During Instrument Approach

The airline failed to obtain the captain's training records from his previous employer, where he had received negative evaluations. The records were also inadequate for assessing flight proficiency, the official investigation found.

—
FSF Editorial Staff

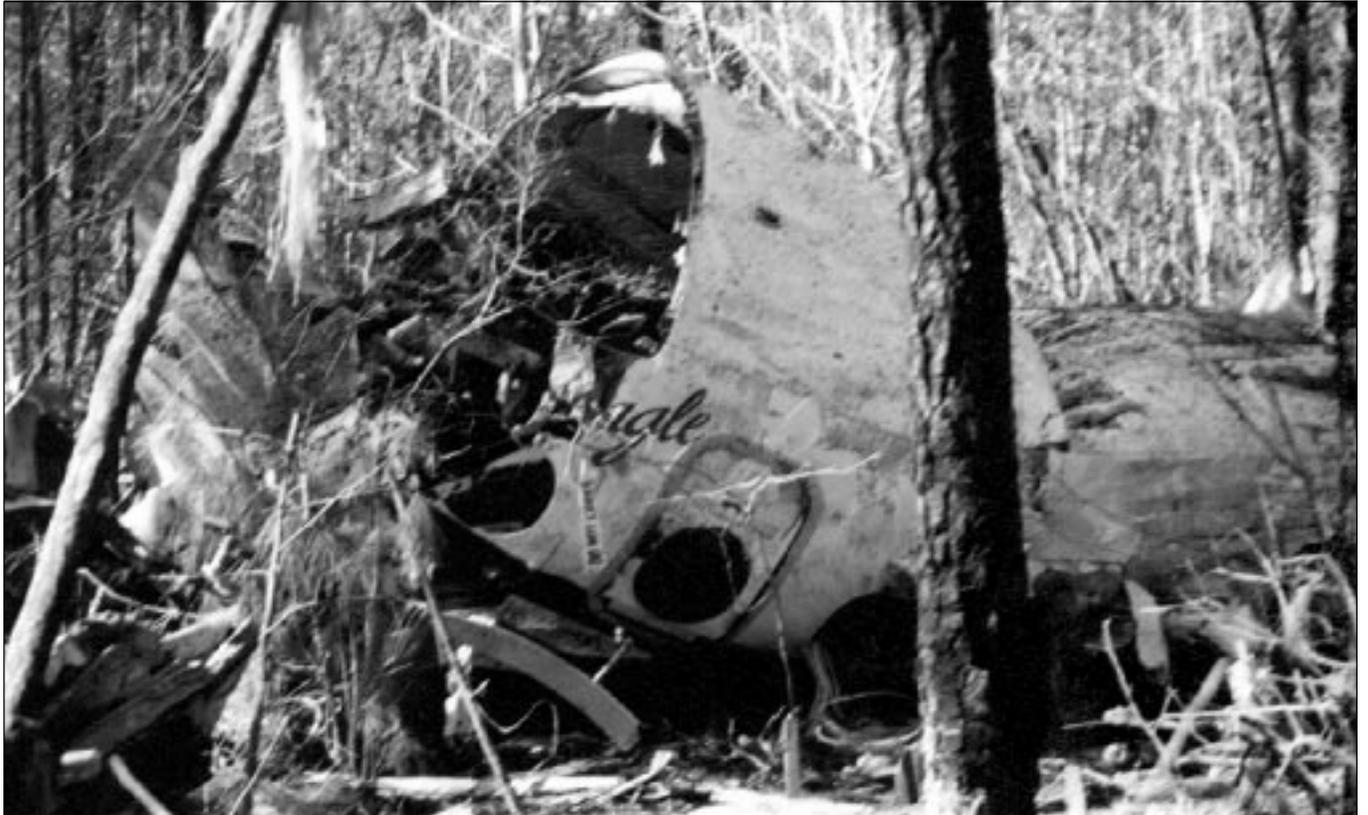
The fuselage separated into three sections after it impacted trees and terrain. The second section and third section are shown here.

The report continued: “The second fuselage section, from aft of the over-wing emergency exits to forward of the empennage, was in the main wreckage area, approximately 290 feet [88 meters] past the first tree strike. This section was not fire damaged. The third section of the fuselage, from the aft pressure bulkhead to the empennage, was in the same general area. There was light fire damage on the lower right fuselage skin, and on the lower portion of the aft pressure bulkhead. The last significant piece of wreckage, a section of inboard elevator, was found 338 feet [103 meters] from the initial tree strike.”

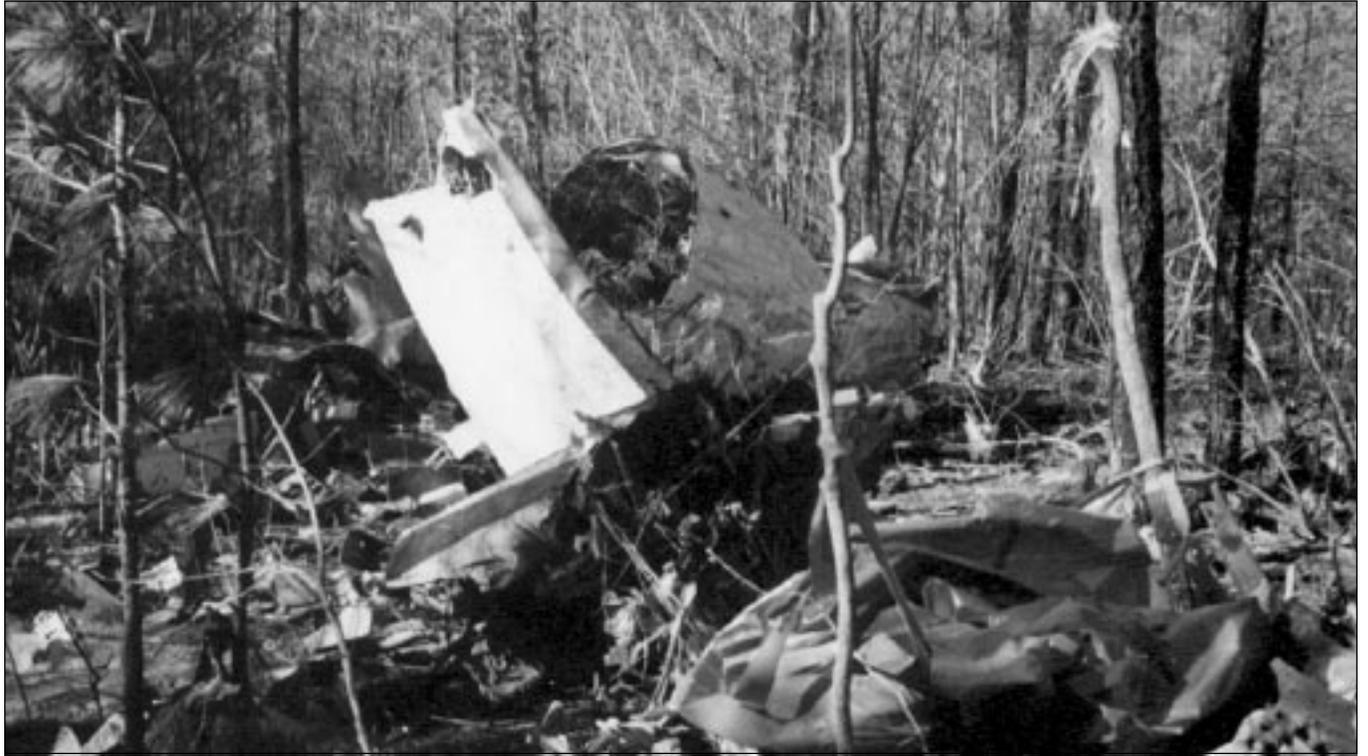
Wreckage is strewn in front of the remains of the aft fuselage.
