FLIGHT SAFETY FOUNDATION

Accident Prevention

April 1997

During Nonprecision Approach at Night, MD-83 Descends Below Minimum Descent Altitude and Contacts Trees, Resulting in Engine Flame-out and Touchdown Short of Runway

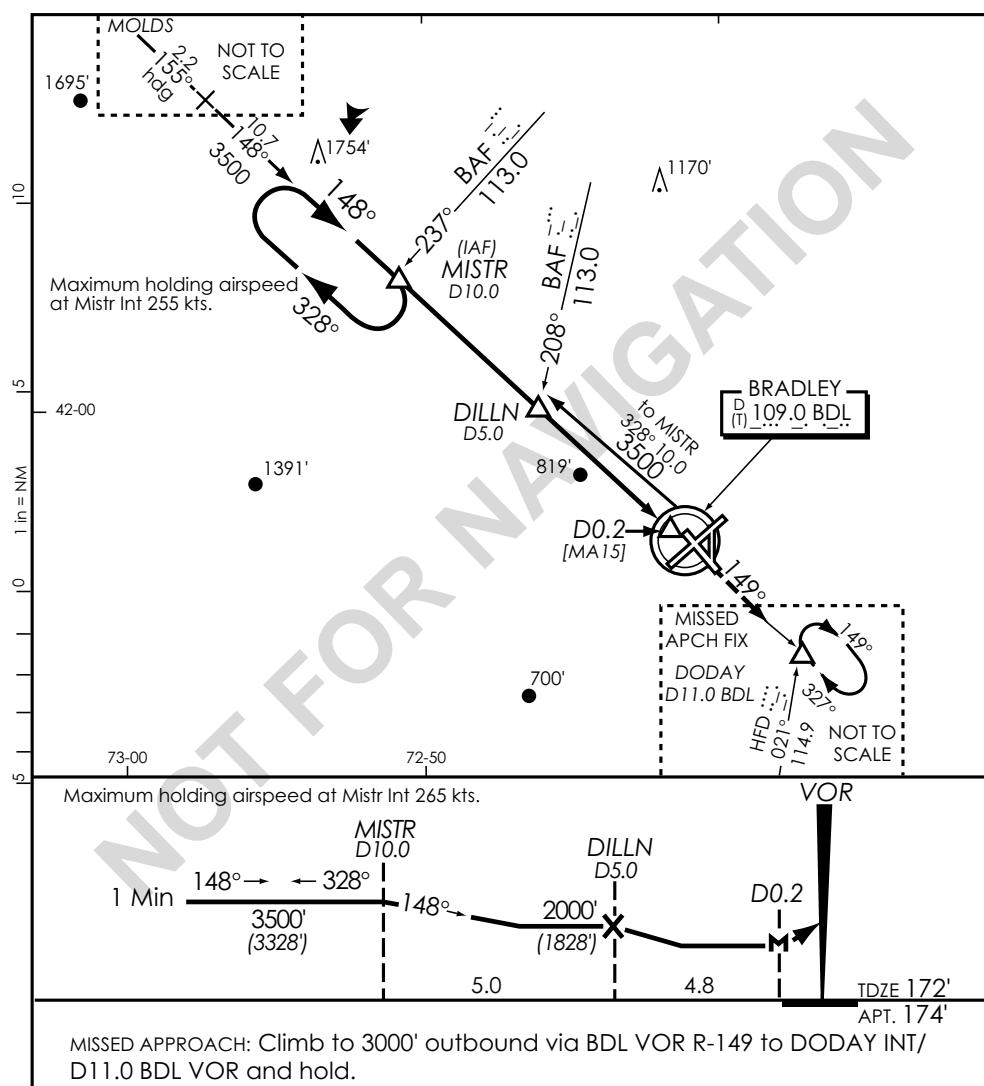
Figure 1

Runway 15 Very High Frequency Omnidirectional Radio Range (VOR) Approach, Bradley International Airport, Windsor Locks, Connecticut, U.S.

The elevation of the ridgeline and trees is noted on the plan view of the VOR Runway 15 approach chart as “819” and is located about halfway between the FAF and the missed-approach point. “The single 819-foot obstacle depicted on the final approach course of most BDL Runway 15 VOR approach plates could lead flight crews to believe that there was one discrete obstacle, and that it was the only dangerous point on the final approach,” the report said.

The NTSB also recommended that the FAA establish a VDP on the BDL VOR Runway 15 approach. In 1996, the FAA published a VDP at 2.3 nautical miles [3.7 kilometers] (BDL 2.4 DME) on the approach. The VDP descent angle is 3.5 degrees, which coincides with the Runway 15 VASI glideslope.

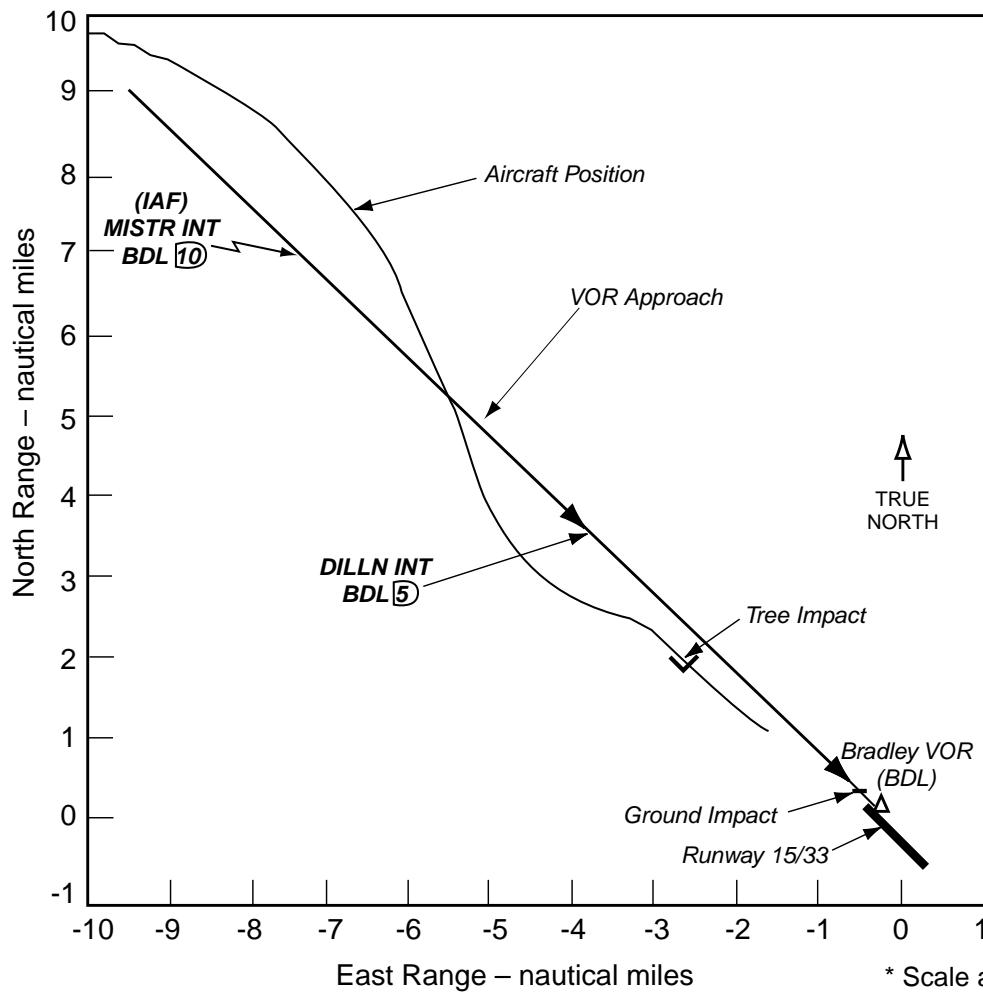
The flight crew used the autopilot for the descent and approach. Figure 2 shows lateral radar-track data for Flight 1572's VOR approach to Runway 15.

"The captain stated that he selected the VOR/LOC (localizer) mode for the autopilot during the approach; however, due to the strong winds, the autopilot attempted to apply about a 30-degree course correction and the 'autopilot couldn't hold it,'" the report said.

Lateral Radar-track Data for Flight 1572 Very High Frequency Omnidirectional Radio Range (VOR) Approach, Nov. 12, 1995*

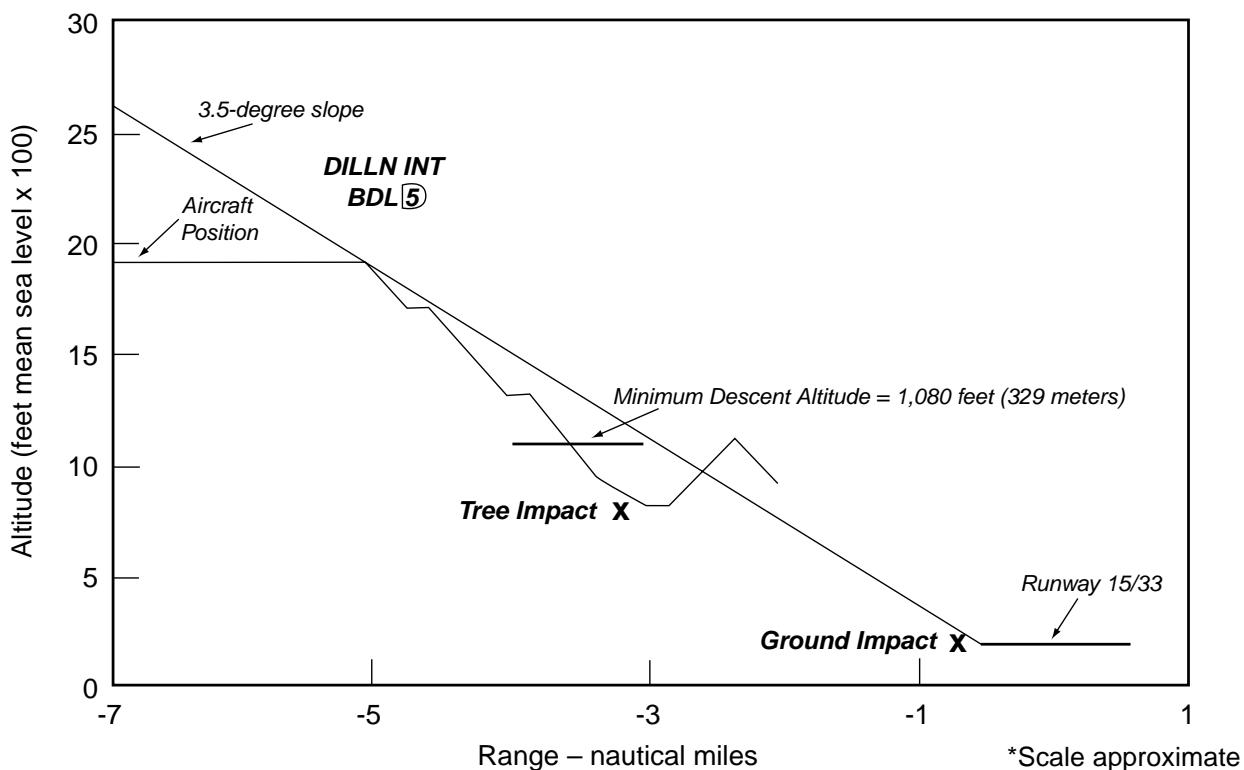
Descent Profile Radar-track Data for Flight 1572 Very High Frequency Omnidirectional Radio Range (VOR) Approach, Nov. 12, 1995*

Also after crossing MISTR, the aircraft began to descend to 2,000 feet (610 meters), which was the minimum altitude for crossing DILLN (the final approach fix [FAF]). The captain used the vertical speed (VERT SPD) mode of the autopilot for pitch control. Figure 3 shows radar-track data for Flight 1572’s descent profile.

The report noted: “Information from the DFDR indicates that a constant rate of descent of 1,100 feet [336 meters] per minute was maintained until the first officer uttered his ‘you’re going below your ...’ statement. The [NTSB] concludes that if the first officer had monitored the approach on instruments until reaching MDA and delayed his search for the airport until after reaching MDA, he would have been better able to notice and immediately call the captain’s attention to the altitude deviation below the MDA.”

The report said, “The linear nature of the pressure-altitude trace indicates that the airplane’s flight path was probably not significantly affected by updrafts, downdrafts or wind shear. Such an effect would be seen as a deviation from the near-linear pressure-altitude trace. Therefore, the [NTSB] concludes that the decreasing headwind shear seen in the estimated mean wind-profile data was not severe enough to cause the flight crew to deviate below the MDA.”
