## Flight Crew of DC-10 Encounters Microburst During Unstabilized Approach, Ending in Runway Accident

*The approach controller did not warn the crew of the possibility of wind shear, but the official Portuguese accident report noted that such an experienced crew should have been aware that wind shear was a possibility.*

—  
*FSF Editorial Staff*

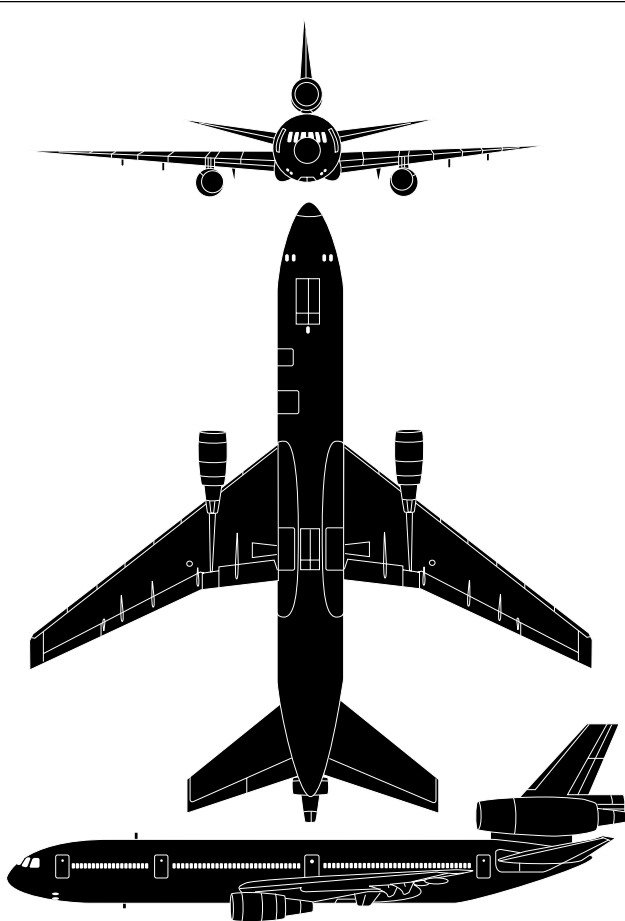
### McDonnell Douglas DC-10

The McDonnell Douglas DC-10 first flew in 1970. It was designed as an all-purpose commercial transport able to carry 270 mixed-class passengers and 380 passengers in an all-economy configuration. The DC-10-30 series has a maximum takeoff weight of 263,085 kilograms (580,000 pounds), a maximum cruising speed of 490 knots (908 kilometers per hour) and a service ceiling of 10,180 meters (33,400 feet). The DC-10-30 has a range of 4,000 nautical miles (7,413 kilometers) with maximum payload at maximum zero-fuel weight.
