Nonadherence to Standard Procedures Cited in Airbus A320 CFIT in Bahrain

The report said that spatial disorientation likely was involved in the flight crew's controlled flight into terrain (CFIT) during an attempted go-around. The ground-proximity warning system generated nine warnings before the aircraft struck the sea.

FSF Editorial Staff

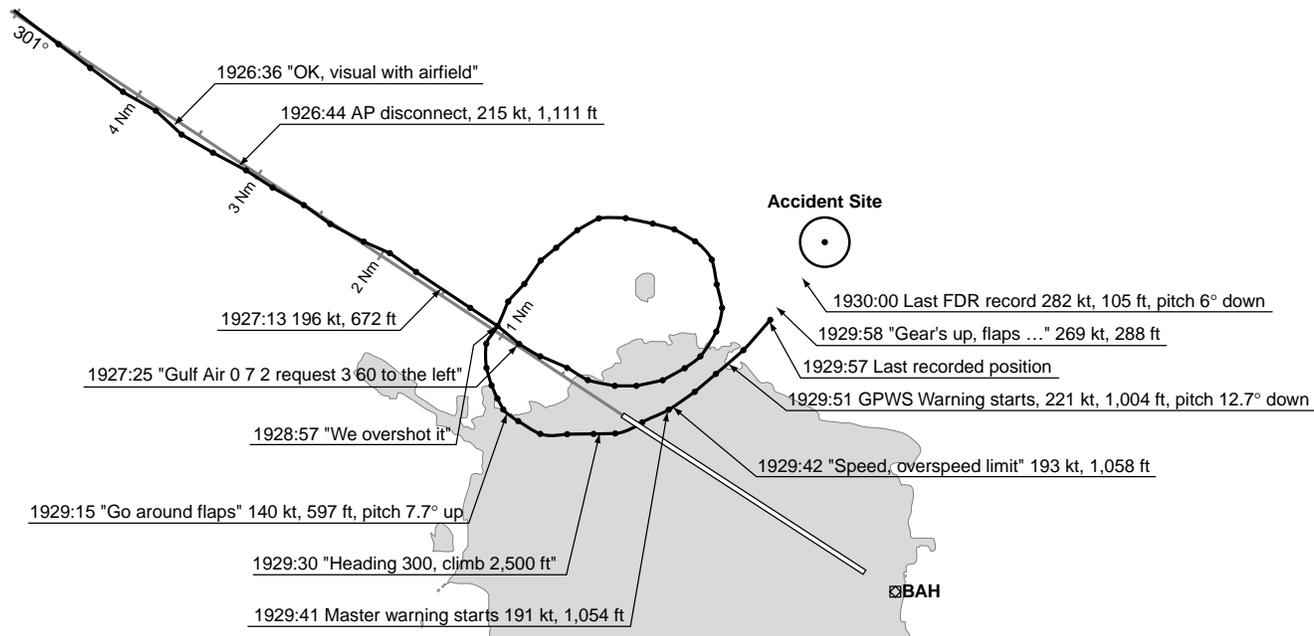
Figure 1

The captain then said “OK, visual with airfield” and disengaged the autopilot and the flight director; the autothrottles remained engaged (see Figure 1, page 4).

Flight Path of Gulf Air Airbus A320 and Selected Cockpit Voice Recorder Data and Flight Data Recorder Data; Muharraq, Bahrain; Aug. 23, 2000
