Training, Deicing and Emergency Checklist Linked in MD-81 Accident Following Clear-ice Ingestion by Engines

Editorial Staff Report

The crash of a Scandinavian Airlines System (SAS) McDonnell Douglas DC-9-81 (MD-81) after clear ice was ingested by the engines raises serious issues about training, quality control and flight operations, an official Swedish aircraft accident investigation said.

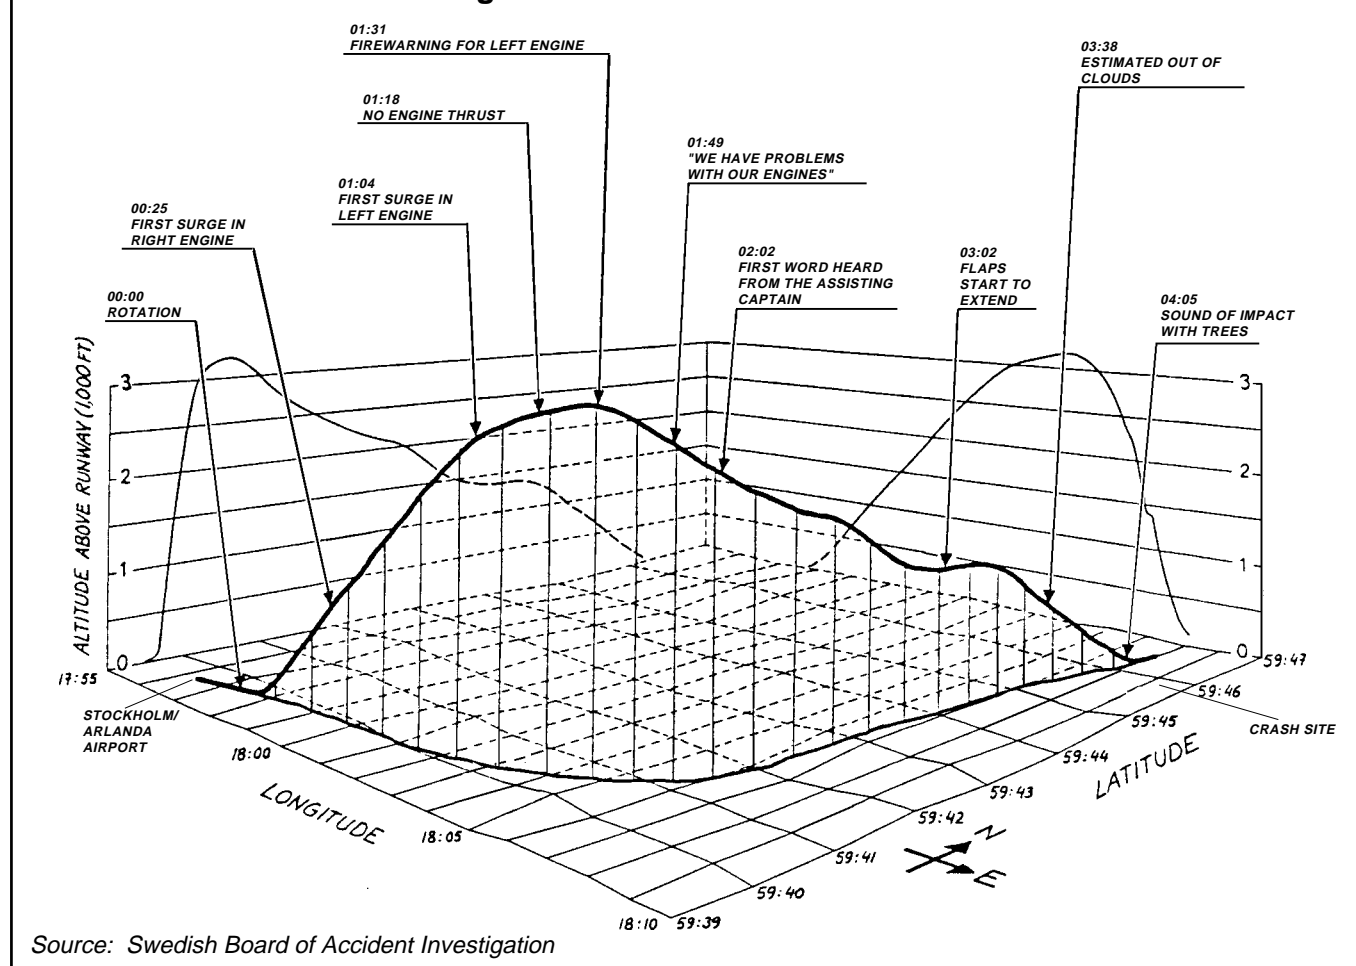
Figure 1

Flight Path of Accident Aircraft

“The pilots never realized that the left engine was surging,” the report said. The aircraft had reached an indicated altitude of 3,318 feet (1,011 meters) when all power was lost (Figure 1).
