Failure of Stabilizer-trim System Blamed For Crew's Loss of Control of MD-83

Insufficient lubrication led to excessive wear and to failure of the jackscrew assembly in the McDonnell Douglas MD-83's horizontal-stabilizer-trim system. The failure caused the horizontal stabilizer to jam in a position beyond normal limits and the aircraft to enter a nose-down pitch attitude from which recovery was not possible.

At 1621 local time Jan. 31, 2000, a McDonnell Douglas MD-83, being operated as Alaska Airlines Flight 261, struck the Pacific Ocean about 2.7 nautical miles (5.0 kilometers) north of Anacapa Island, California, U.S. The two pilots, three cabin crewmembers and 83 passengers were killed. The airplane was destroyed.

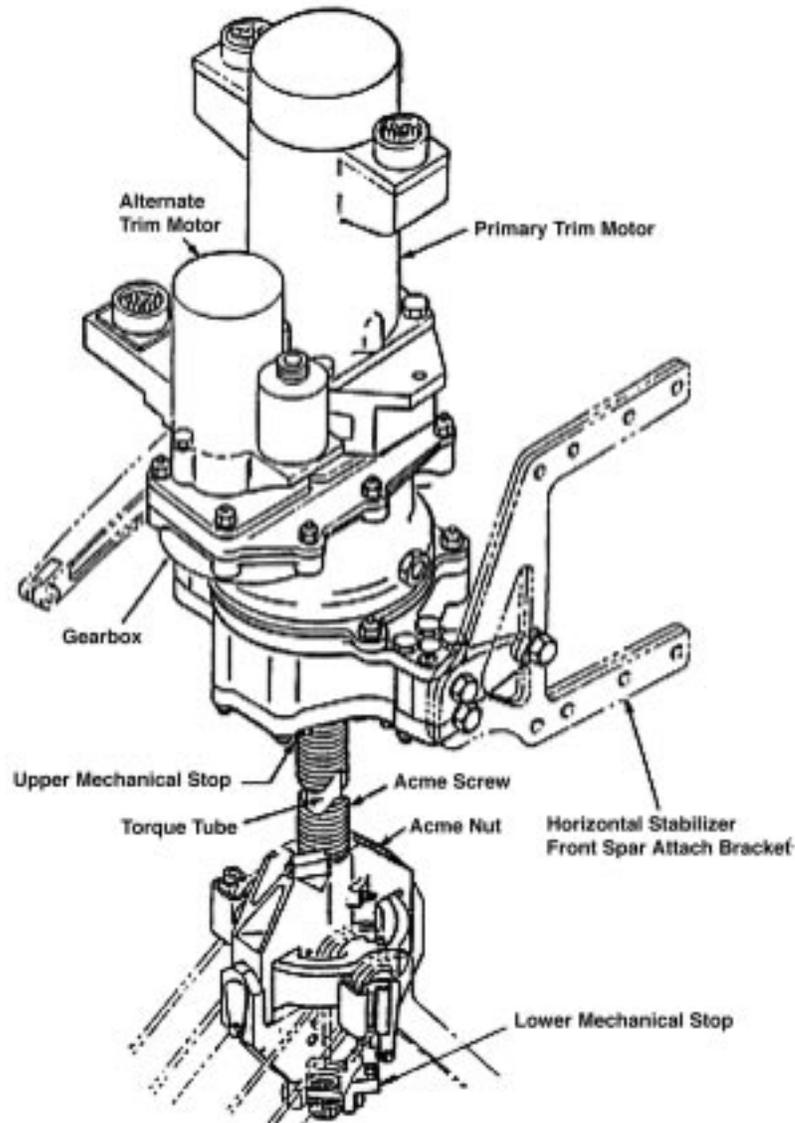
Figure 1

McDonnell Douglas MD-83 Horizontal-stabilizer-trim System

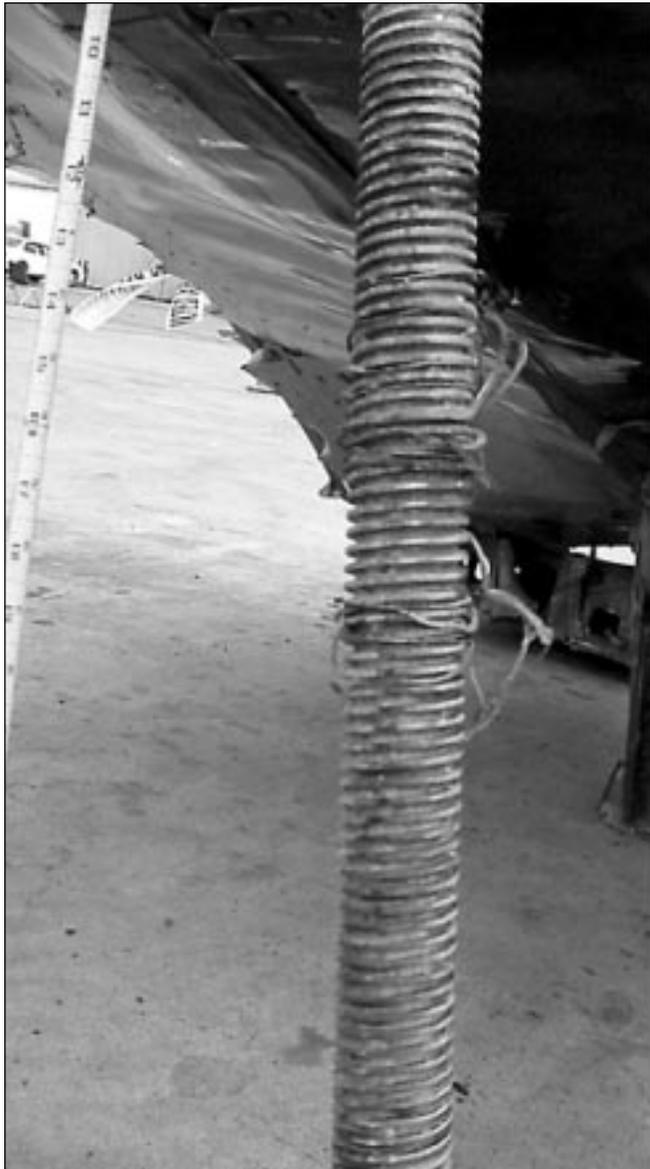
During examination of the wreckage, acme-nut-thread remnants were found wrapped around the acme screw (see photo, page 11).

“The condition of the recovered acme-nut-thread remnants indicated that approximately 90 percent of the thread thickness had worn away before the remainder of the threads sheared off,” the report said.

Corrosion pitting and red rust were found on most of the acme screw.

No grease was found on the threads of the “working region” of the acme screw — that is, the section of the acme screw that normally comes in contact with the acme nut.

Examination of the acme nut showed that most of the threads were missing.

Remnants of thread material sheared from the acme nut can be seen wrapped around this approximately 17-inch (43-centimeter) section of the acme screw. (NTSB photo)

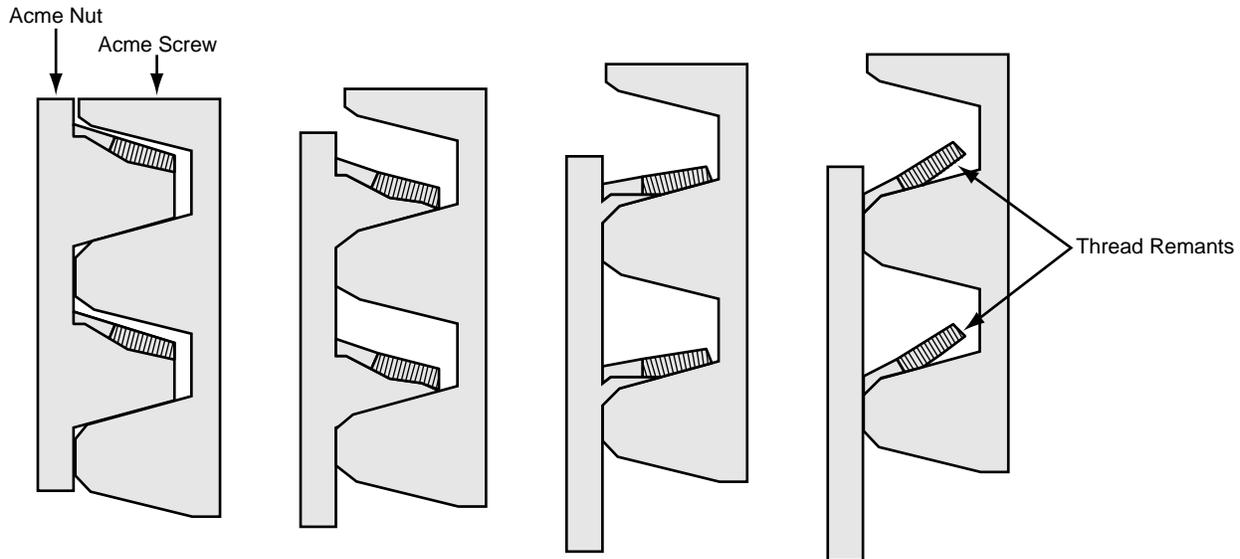
“The acme nut was designed with a softer material than the acme screw, and its threads were designed to wear,” the report said. “Acme-nut threads are made of an aluminum-bronze alloy . . . The acme-screw threads are made of case-hardened steel.”

Figure 4 (page 12) shows the stages of acme-nut-thread wear to the point of thread failure.

“The only portion of the jackscrew assembly that wears significantly is the aluminum-bronze acme nut,” the report said.

Stages of Acme-nut-thread Wear to Point of Bending-induced Shear
