Main Causes of Hard Landings

Soviet study covers 10 years of accidents and incidents.

Alexey A. Koutskov

*Director, Accident Investigation and Prevention Department (Gosavianadzor)
State Supervisory Commission for Flight Safety, Council of Ministers, U.S.S.R.*

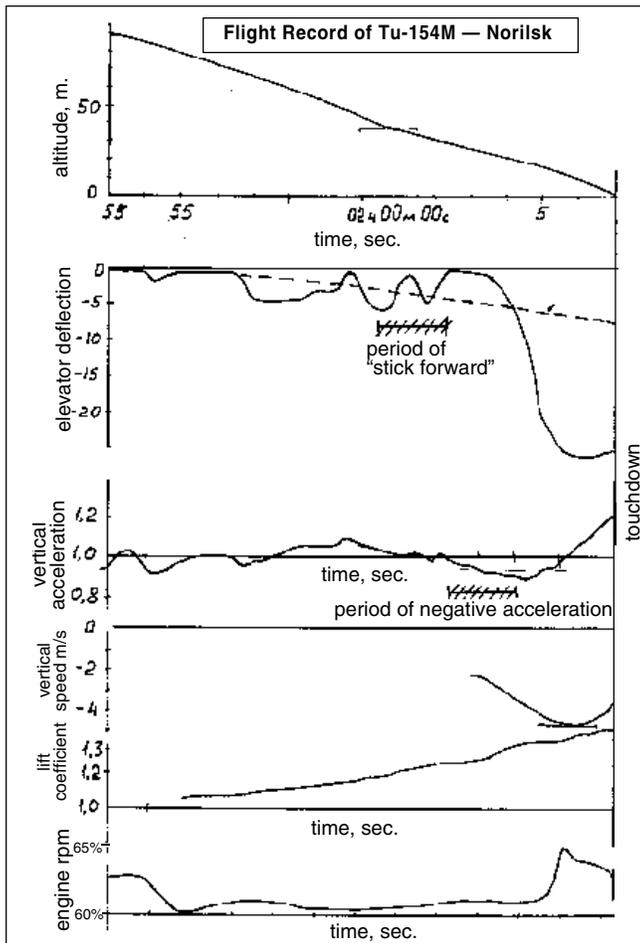
Pilots often believe that a hard landing results from low landing speed, and that the increase of this speed is a reliable guarantee against a hard landing. After an analysis of all hard landings of Tu-154/134 airplanes, distributions of values of deviations of actual landing speeds from recommended speeds were plotted, taking into account the landing weights. It was found that the distribution of these values in cases of hard landings correspond closely to the distributions of values of the deviation of landing speeds from those recommended for normal landings:

Normal landings: Differential $V_{avg} = 12-13$ km/h (19-21 mph); rate of descent (V_y) = 8-9 km/h (435-495 fpm)

Hard landings: Differential $V_{avg} = 10-11$ km/h (16-18 mph); rate of descent (V_y) = 10 km/h (550 fpm)

In other words, the analysis indicated that high rates of descent, and the resultant hard landings, generally occurred when airspeeds exceeded normal speeds. Therefore, safety recommendations that suggest higher approach speeds will prevent hard landings are not supported by the facts.

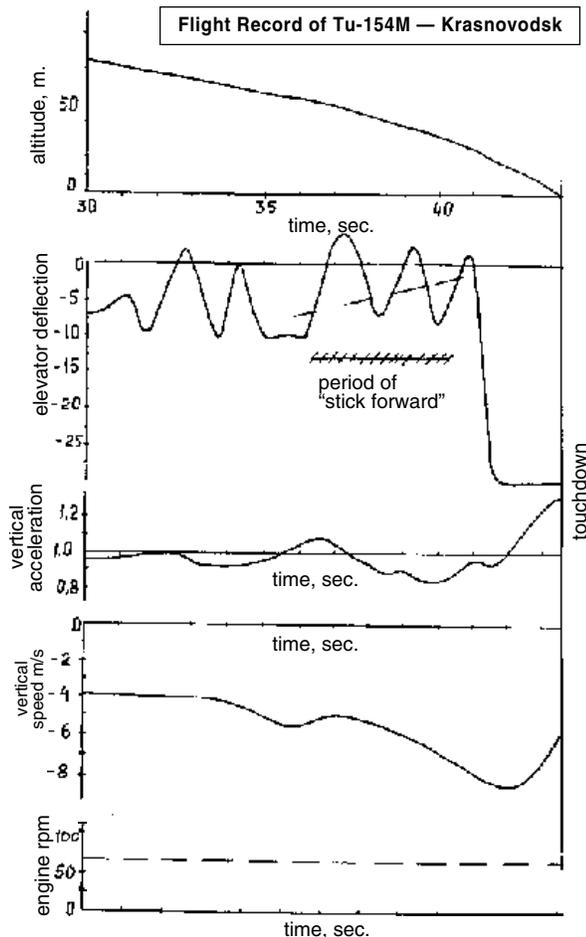
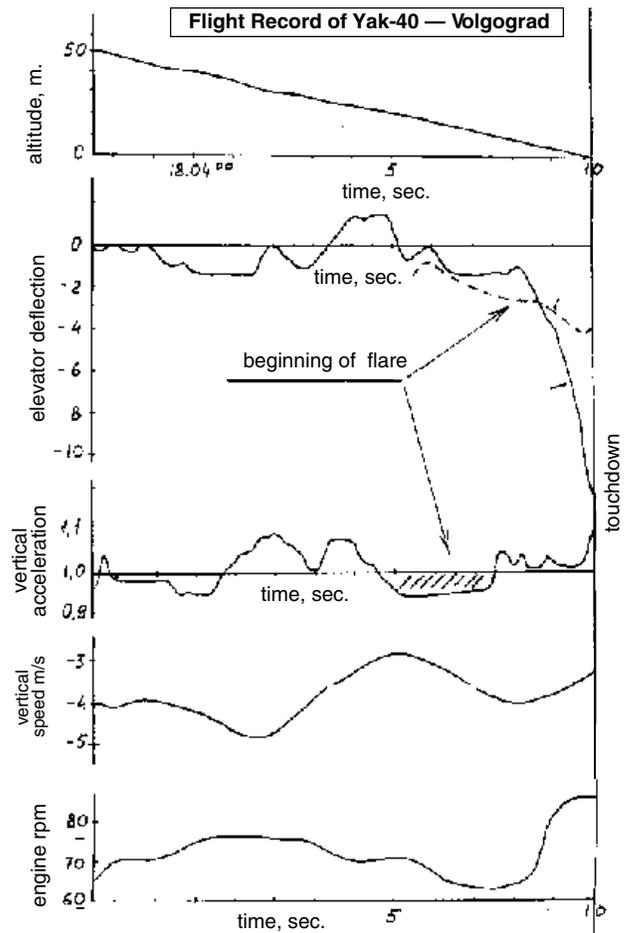
Another example involved a Yak-40 landing at the Volgograd airport. At an altitude of 65 meters (215 feet), the vertical rate of descent was increased, and at 35 meters (115 feet) the aircraft descended below the glidepath. In this case, the vertical rate of descent fluctuation was obvious.

The vertical rate of descent reached its maximum value of 4.8 m/s (945 fpm) at an altitude of 35 meters, with a subsequent decrease to 2.8 m/s, and at the moment of starting to flare, it again increased, to 4.1 m/s. The flare was initiated with a vertical acceleration of 0.95 g. In such conditions, a vertical acceleration increment of 0.15 g., resulting from routine movement of the control yoke, somewhat diminishes due to the airplane being out of trim before starting to flare. The proper vertical acceleration exceeded 1 g later, after the control yoke was pulled to flare, and even a slight exceedance of the vertical rate of descent automatically affects the value of vertical acceleration at touchdown. In this case, a hard landing resulted with relatively low vertical acceleration (2.2 g).
