## Captain Stops First Officer's Go-around, DC-9 Becomes Controlled-flight-into-terrain (CFIT) Accident

*Poor crew cooperation, altimeter misreading and a navigation radio malfunction were cited in the fatal CFIT accident.*

by  
*Russell Lawton*  
*Aviation Consultant*

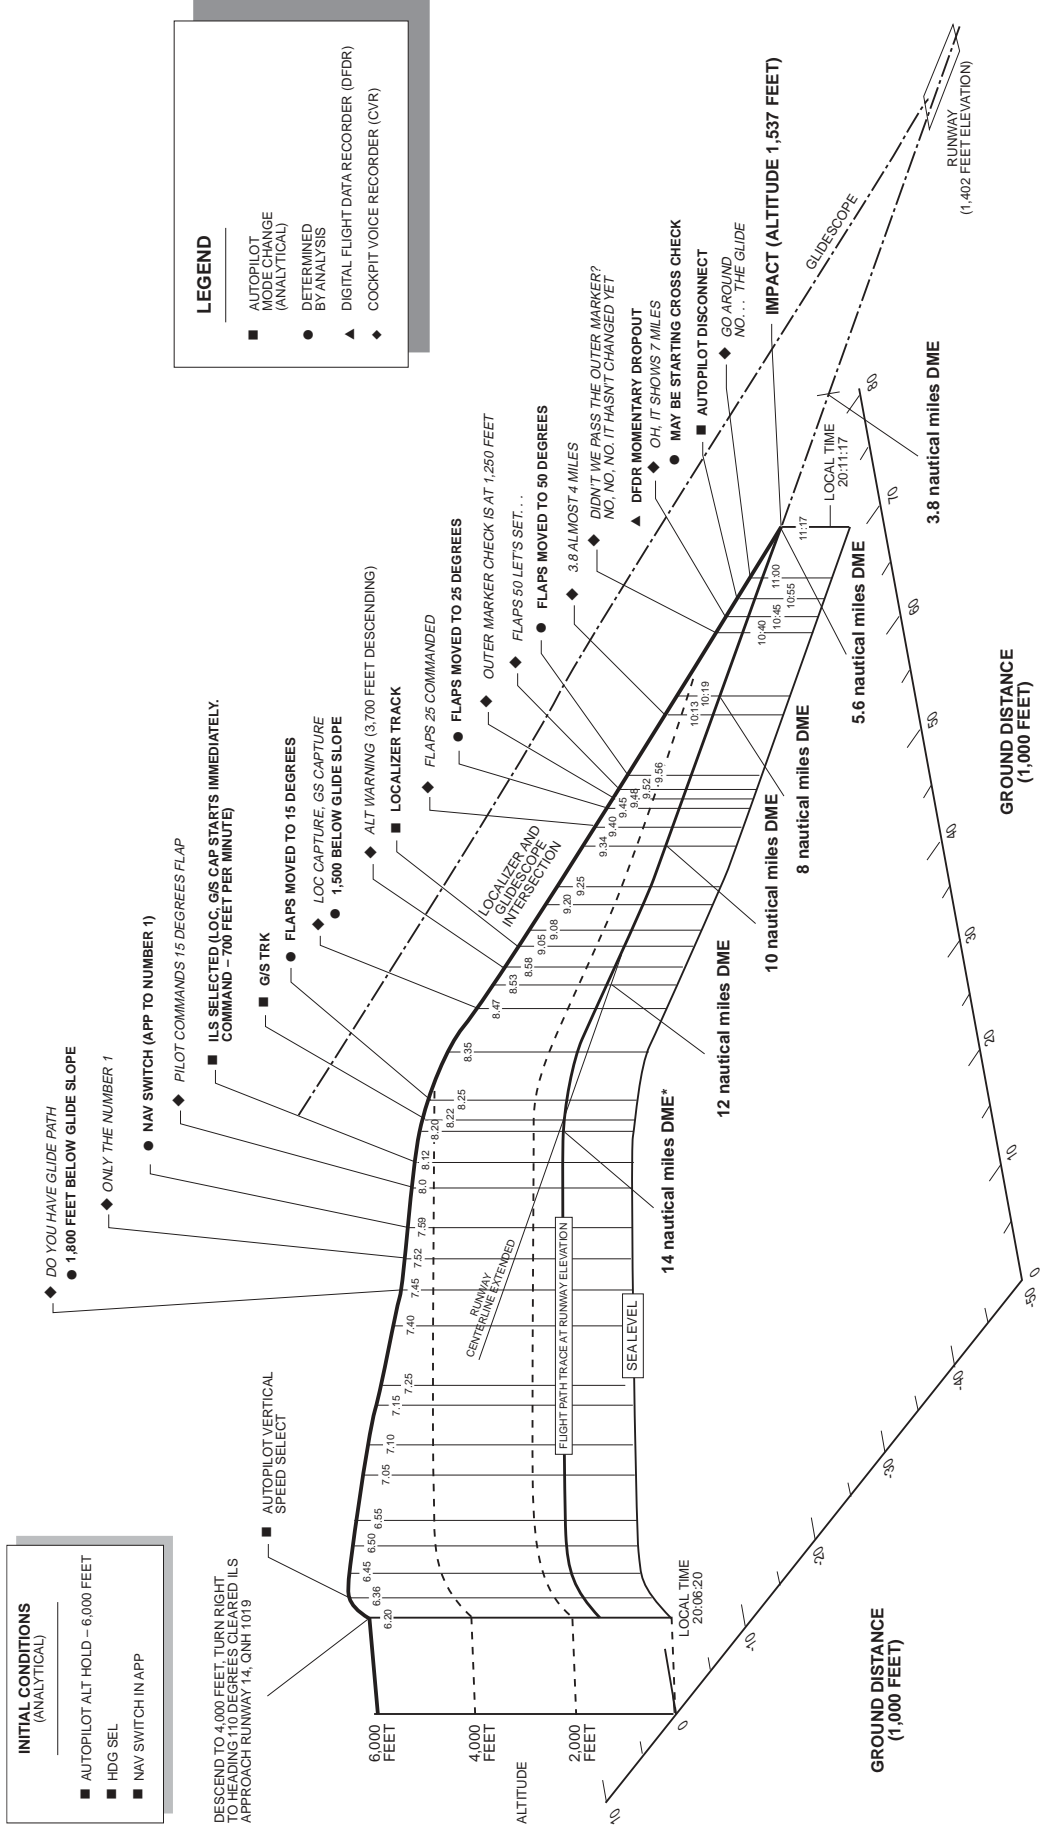
Figure 1

At 1906:20, Zürich arrival told AZ 404 to “descend to 4,000 feet [1,220 meters], turn right heading 110, cleared ILS approach Runway 14,” the report said (Figure 1, page 3). When the captain acknowledged the clearance, he read back a heading of 120. The controller did not correct the captain’s read-back of the wrong heading. The report said that the incorrect read-back of the clearance caused the first officer some uncertainty about the heading to be flown. The captain confirmed the approach clearance and the cleared altitude of 4,000 feet.

# Final Approach Track of Alitalia Flight AZ404
