Aircraft Descended Below Minimum Sector Altitude and Crew Failed to Respond to GPWS as Chartered Boeing 707 Flew into Mountain in Azores

Poor cockpit discipline, nonstandard phraseology and poor radio communications technique, nonadherence to company procedures, limited crew experience and inadequate training were among the facts cited in the Portuguese controlled-flight-into-terrain accident report.

Capt. Thomas A. Duke
with
Editorial Staff

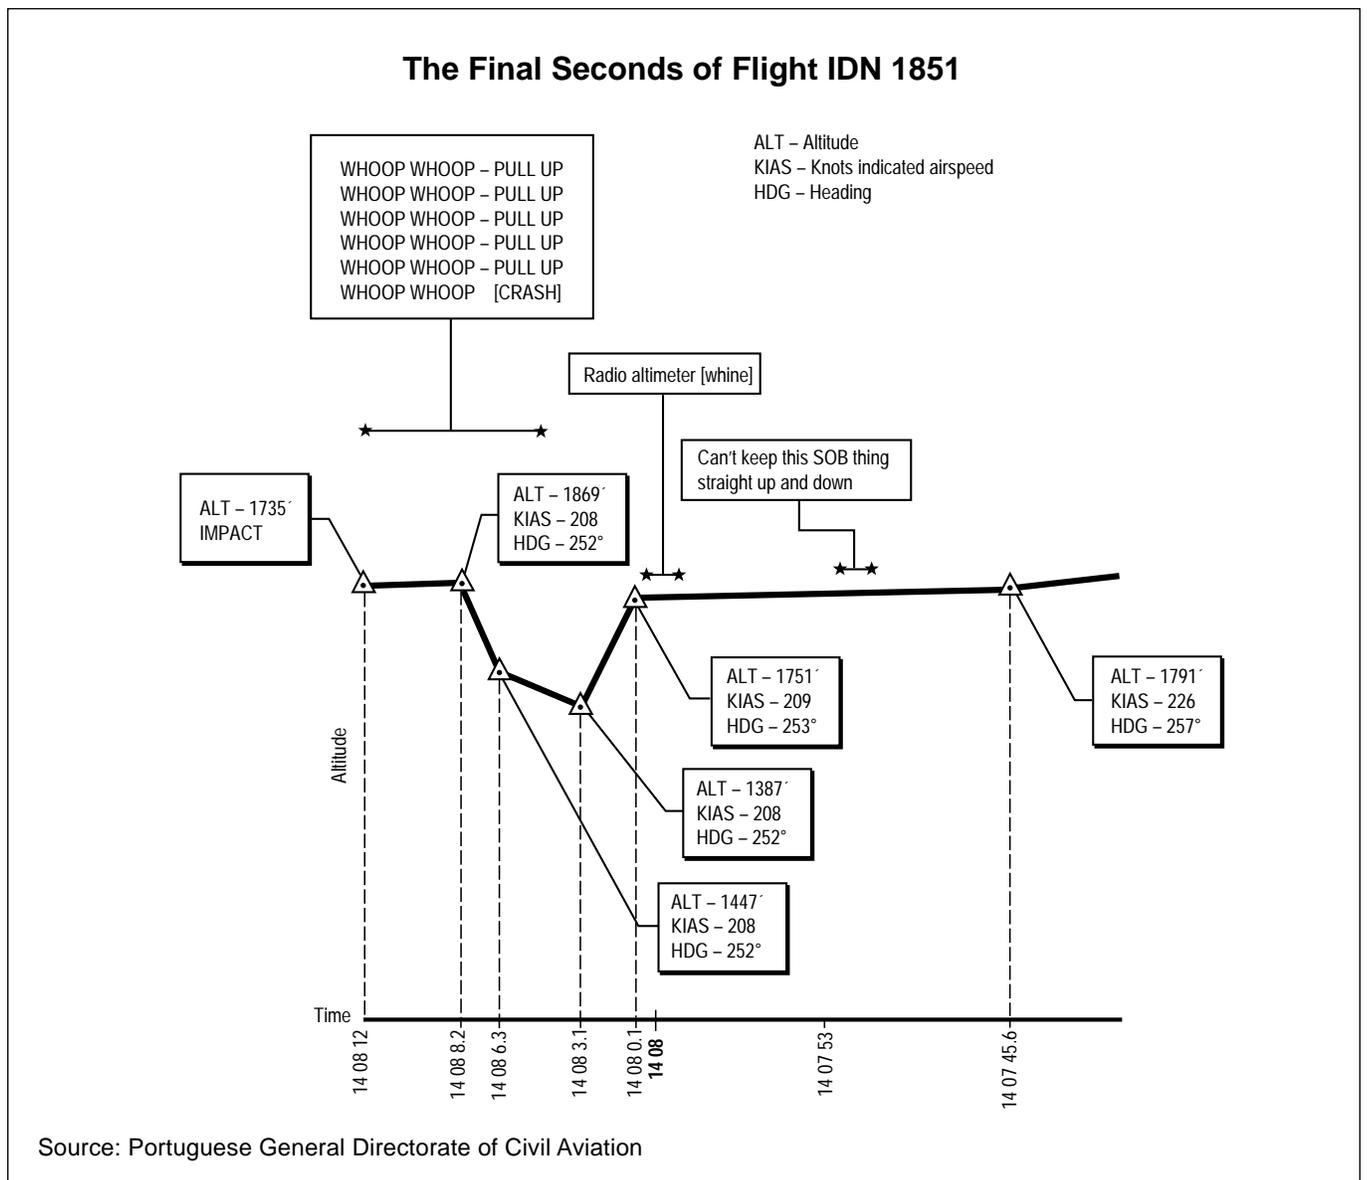
Figure 1

1. “Transmission by the Santa Maria Control Tower of a QNH superior by 9 hPa to the real one which put the aircraft at an actual altitude 240 feet below that indicated on board;

A Worst-case Scenario: Misunderstood Altitude Clearance and Incorrect Altimeter Setting Combined To Overcome Safety Margin
