In-flight Separation of Propeller Blade Results in Uncontrolled Descent and Fatal Accident to Twin-turboprop Commuter Aircraft

FSF Editorial Staff

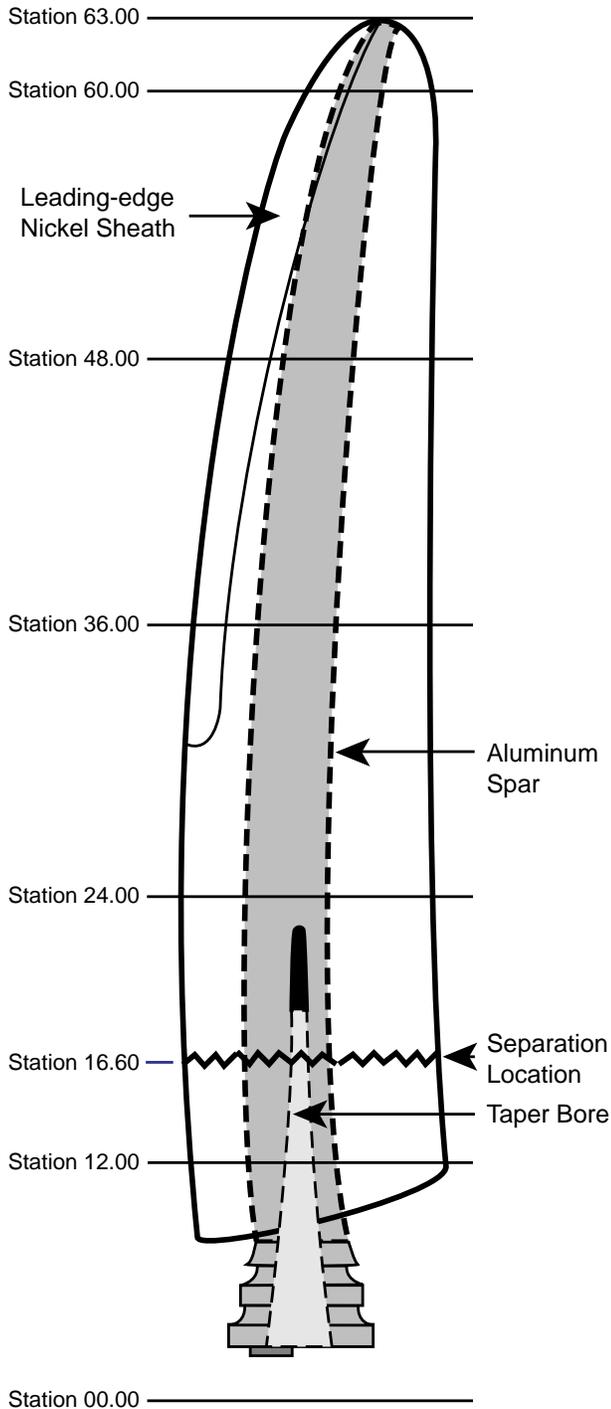
Figure 1

When the left-engine propeller blade that separated on the accident airplane was examined, the NTSB concluded that its failure resulted from “a fatigue crack that originated from multiple corrosion pits in the taper bore surface of the blade spar [that] propagated toward the outside of the blade, around both sides of the taper bore [and] then reached critical size,” the report said.

Investigators found that the accident propeller blade “exhibited a nearly continuous layer of oxide deposits on the initial [1.25 centimeter (0.49 inch)] of the crack depth.” The oxide was attributed to a residue from before the accident propeller blade had been repaired by Hamilton Standard in June 1994. Because

The propeller blade “contained corrosion damage (pitting) in the taper bore and the oxide layer in the origin area of the fatigue crack ... ,” the report said. This same condition was found on two previous failures of Hamilton Standard composite-type propeller blades in 1994. One of these failures

**Hamilton Standard
14RF-9 Propeller Blade,
Showing Location of Separation on
Embraer EMB-120RT Accident Aircraft,
Aug. 21, 1995**
