## Boeing 767 Descends Below Glide Path, Strikes Tail on Landing

*The flight crew responded to a visual illusion with an unwarranted power reduction, said the official accident investigation report. Just before landing, the aircraft's pitch attitude increased; the tail skid struck the runway surface as the aircraft landed.*

FSF Editorial Staff

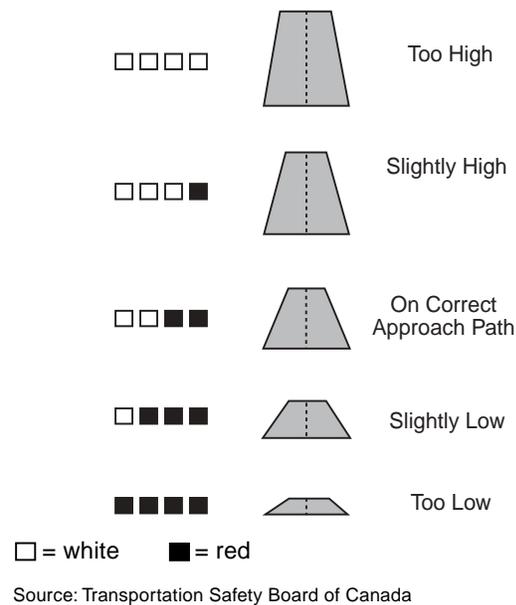
**Figure 1**

The report said, “If adequate visual reference were established, a pilot would continue the approach and use the PAPI ... for glide path guidance. This method [Figure 1], although more difficult than using a constant-rate descent provided by a glide path, has been used safely for many years. ... The Boeing flight

crew training manual, in describing PAPI, states that ‘PAPI may be safely used with respect to threshold height, but may result in landing [farther] down the runway.’”

Assuming no landing flare, an aircraft following indications from PAPI would touch down about 214 meters from the runway threshold; with normal flare, touchdown would be expected about 305 meters from the runway threshold.
