Accident Report Provides Lessons Learned About Preventing Takeoff on a Closed Runway

FSF Editorial Staff

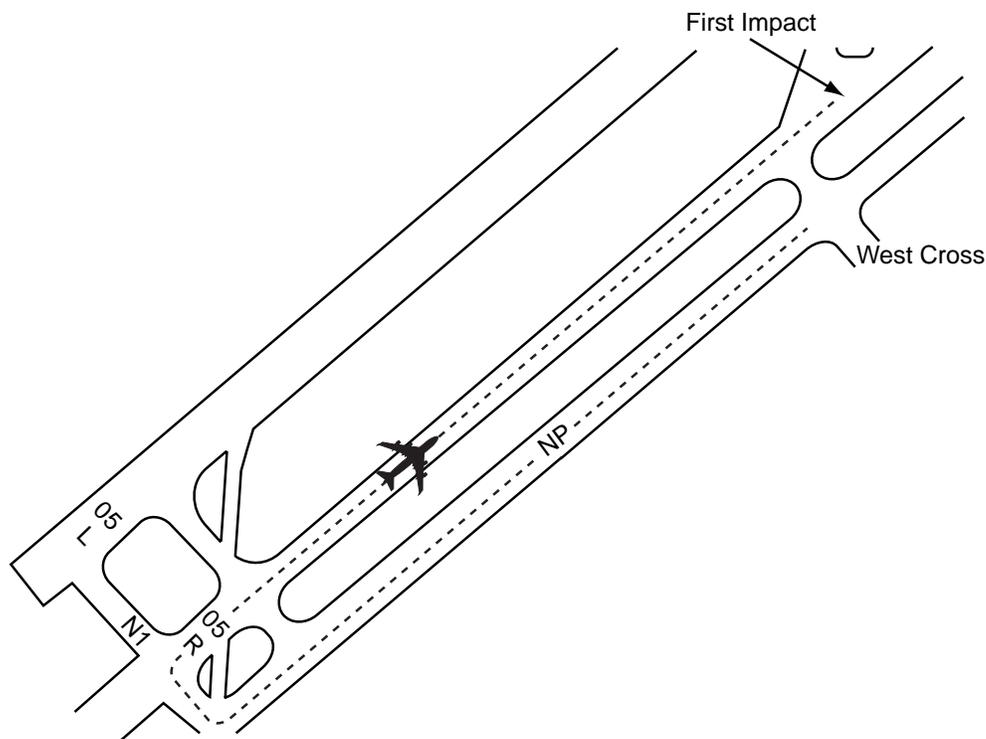
Figure 1

Runway 05L and Runway 05R, Chiang Kai-Shek International Airport, Taoyuan, Taiwan

[the aircraft] entered Runway 05R and [the captain] commenced the takeoff roll (see Figure 1). [The first officer and the relief pilot] did not question [the captain's] decision to take off;
