Runway Overrun Occurs After Captain Cancels Go-around

The Boeing 747 was configured for a dry-runway landing when heavy rain occurred on final approach to Bangkok, Thailand. The captain told the first officer (the pilot flying) to go around but then retarded the throttle levers when the main landing gear touched the runway. The airplane was substantially damaged. None of the occupants was injured seriously during the approach-and-landing accident, but the delay in evacuation of the aircraft focused attention on improving training for emergencies.

At 2247 local time Sept. 23, 1999, a Boeing 747-438 operated by Qantas Airways (Qantas) was landed beyond the touchdown zone on Runway 21L at Bangkok (Thailand) International Airport, hydroplaned on the wet runway and ran off the end of the runway. The airplane was substantially damaged. The crew began a precautionary evacuation of the airplane 20 minutes after the accident. None of the 410 occupants was injured seriously.

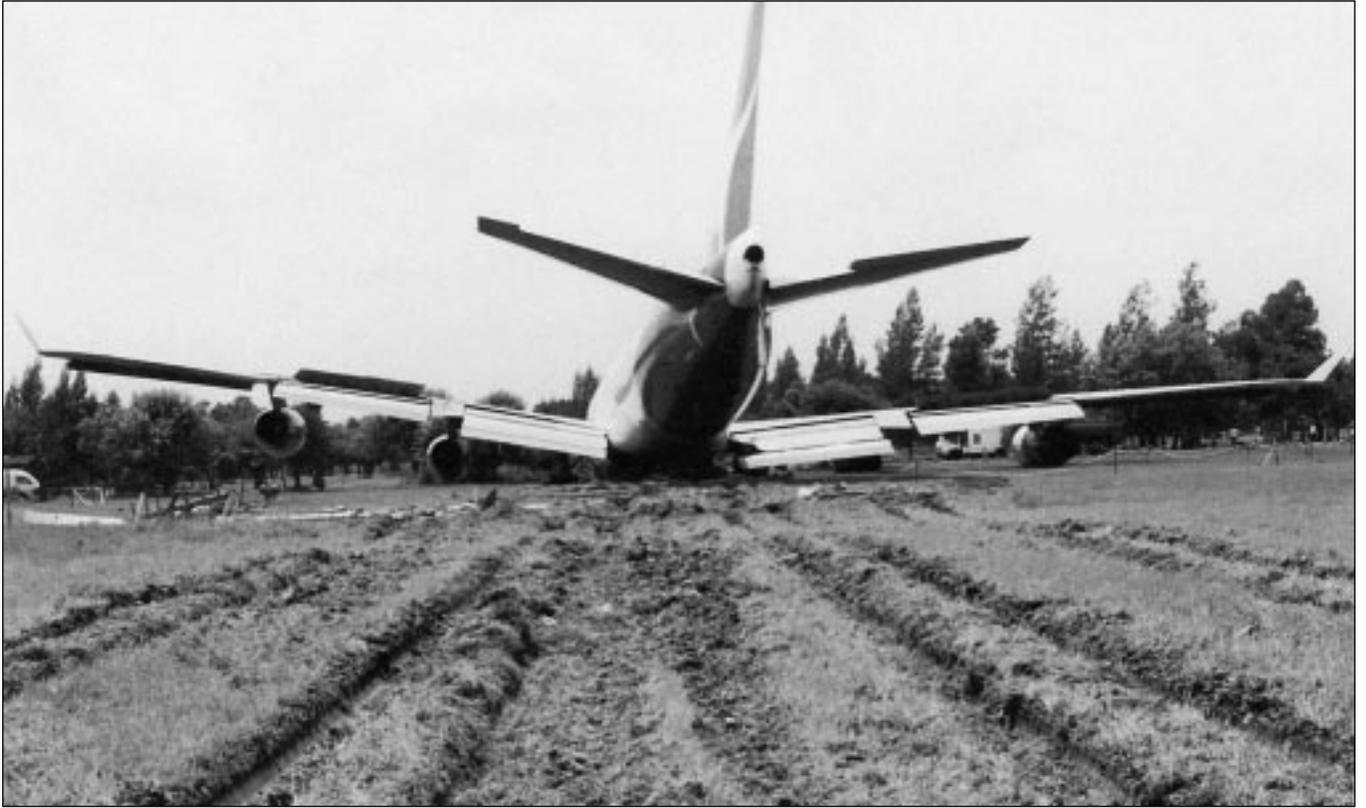
The nose-landing gear and the right-wing landing gear collapsed when the airplane struck the instrument landing system localizer antenna. The airplane continued over wet ground and came to a stop 220 meters (722 feet) from the end of the stopway.
(Photo: Australian Transport Safety Bureau)

customer-service manager (CSM) on the cabin-interphone system. (The controllers for the public-address system and cabin-interphone system were damaged when the nose-landing gear collapsed.) The captain then told the second officer to go to the cabin and tell the CSM to come to the flight deck.

- “[The U.S. Federal Aviation Administration and the European Joint Aviation Authorities should] review the design requirements for high-capacity aircraft to ensure the integrity of the cabin interphone and passenger-address systems, particularly with respect to cabin/flight deck communications, in the event of runway overruns and other relatively common types of events which result in landing-gear [damage] and lower-fuselage damage;

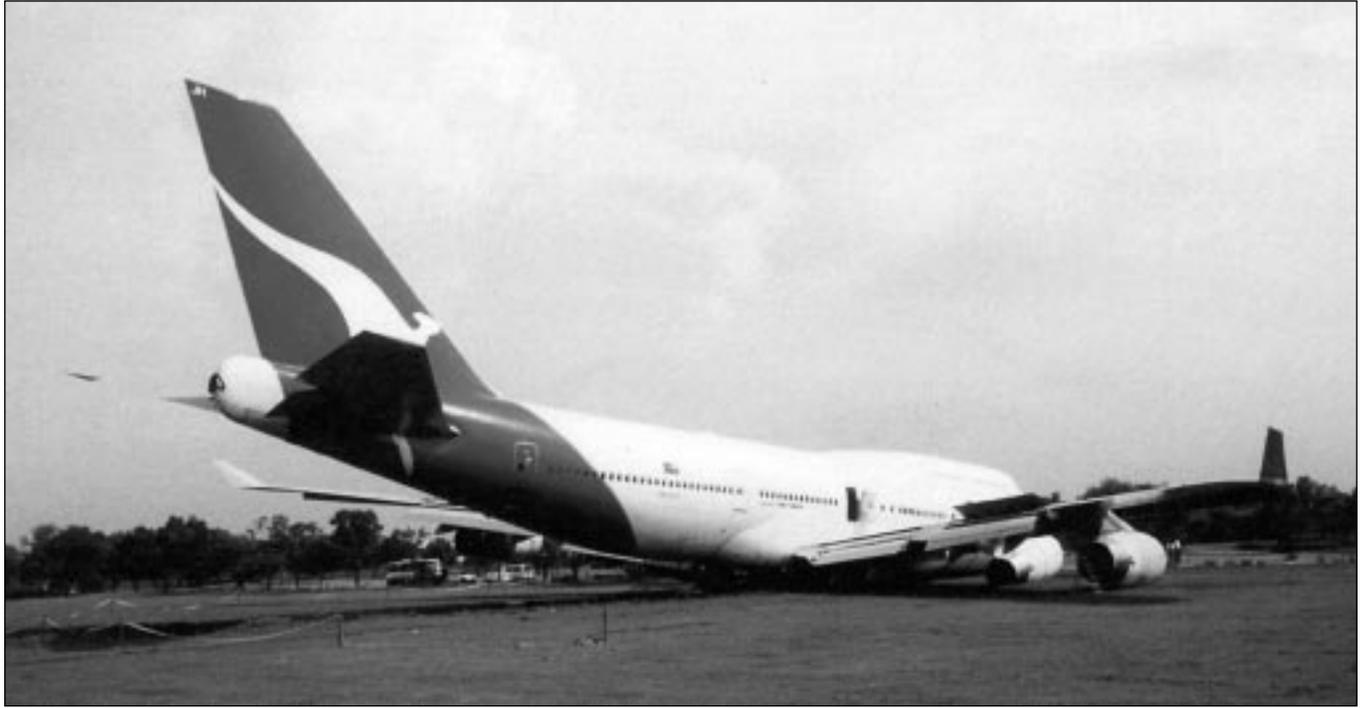
The airplane's landing gear, no. 3 engine nacelle and lower fuselage were damaged during the runway overrun. The airplane came to rest with its nose on an airport-perimeter road. (Photo: Australian Transport Safety Bureau)

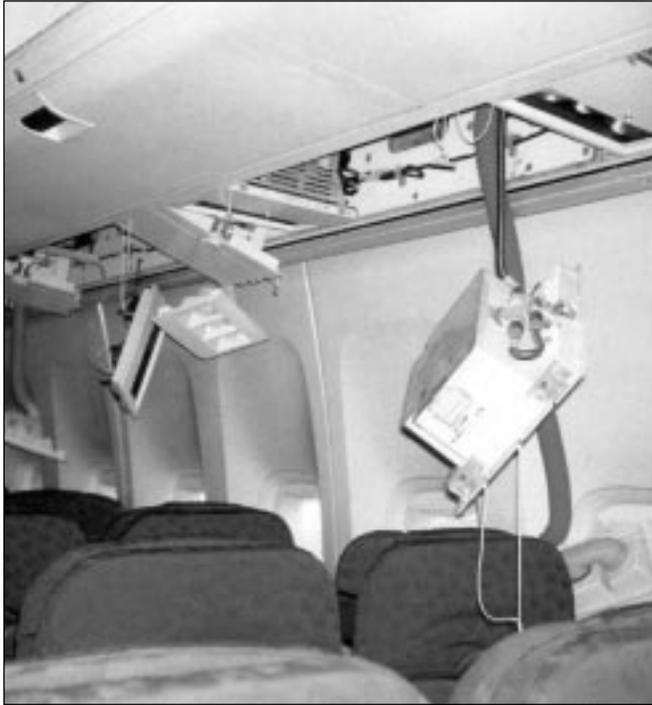
Three passengers said that they were struck by passenger service units that dislodged during the accident. (Photo: Australian Transport Safety Bureau)
