## Failure to Maintain Situational Awareness Cited in Learjet Approach Accident

*During the approach, the crew was unaware of 40-knot winds that led to the controlled-flight-into-terrain<sup>1</sup> accident during instrument meteorological conditions. At the time of the accident, no emergency locator transmitter was required on the turbojet; the accident site was not located until nearly three years after the aircraft was reported missing.*

—  
FSF Editorial Staff

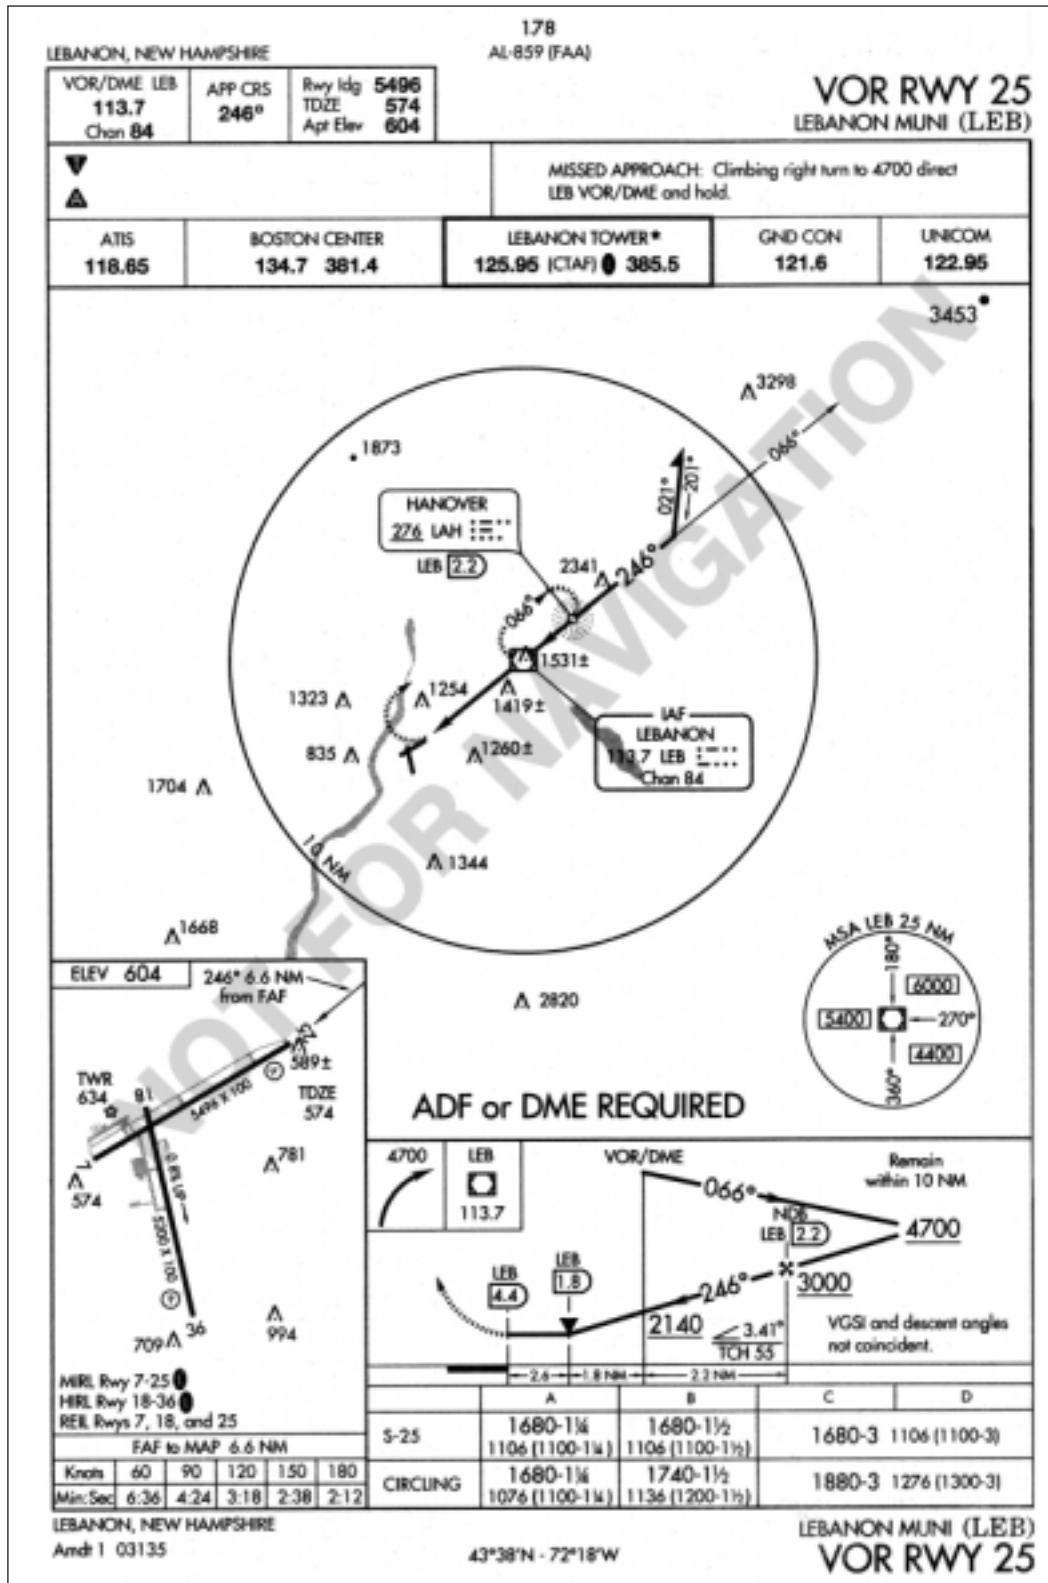
**Figure 1**

[Figure 1 (page 5) shows the VOR Runway 25 approach procedure that was in effect on May 15, 2003. The approach procedure that was in effect at the time of the accident included a minimum altitude of 4,300 feet while flying outbound from the VOR and while conducting the procedure turn, a minimum altitude of 2,900 feet when established on the final approach course inbound, a minimum altitude of 2,300 feet after passing over the Hanover NDB (2.2 nautical miles [4.1 kilometers] from the VOR) and, a minimum altitude of 1,620 feet — the MDA for the circling maneuver — after passing over the VOR inbound.]

**Very-high-frequency Omnidirectional Radio (VOR) Runway 25 Approach,  
Lebanon, New Hampshire, U.S., as of May 15, 2003**
