Spatial Disorientation Linked to Fatal DC-8 Freighter Crash

Editorial Staff Report

ACCIDENT PREVENTION

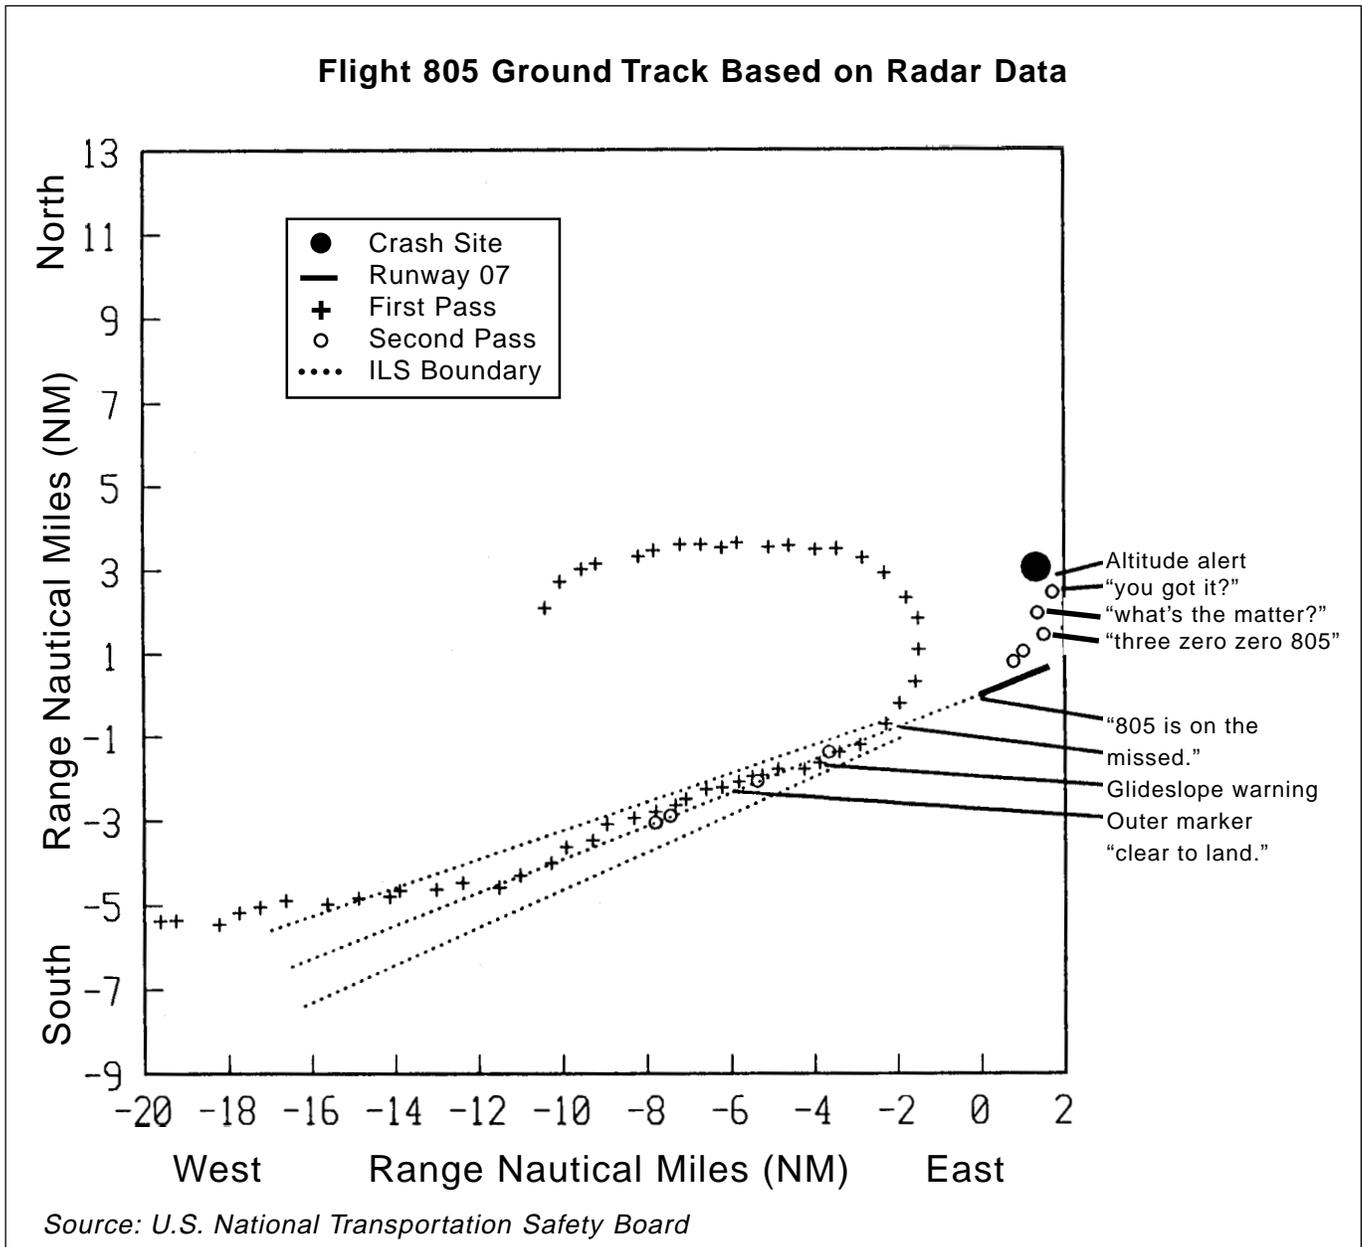
Figure 2

“It is obvious that the captain was frustrated with the first officer’s performance when he commented ‘... still don’t have enough flaps for this speed ... add power ... you’re not on the glidepath ... bring it up to the glidepath.’ He then added, ‘you’re not even on the (expletive) localizer at all.’ Finally, he had to remind the first officer to raise the landing gear during the go-around.” (Figure 2)
