Fractured Fuse Pin in Engine Pylon Results in Dragged Engine During B-747's Landing Roll-out

Maintenance and inspection personnel who worked on the accident airplane were not adequately trained and qualified to perform the required maintenance and inspection functions, according to a special report by U.S. NTSB.

Editorial Staff Report

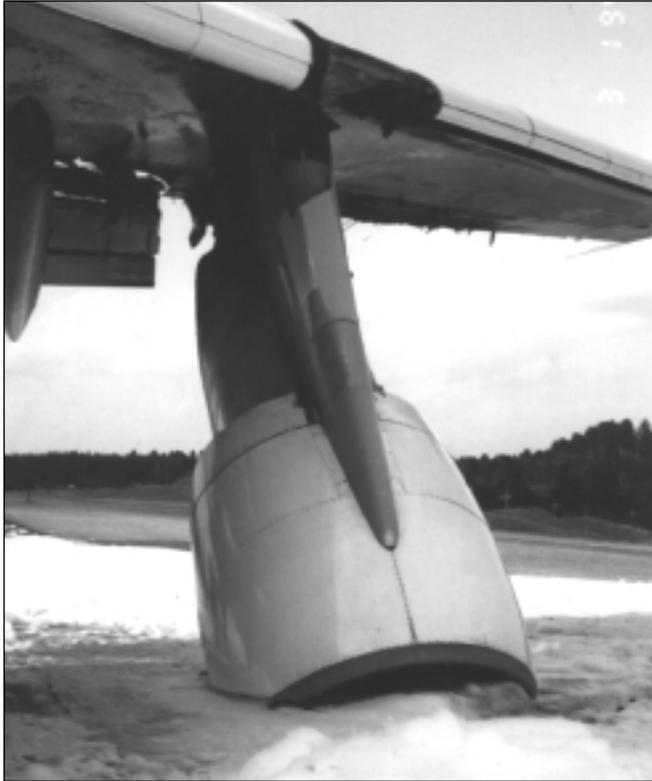
The primary forward upper-link fuse pin in the No. 1 engine pylon was found to be fractured. In addition, the aft fuse pin on the pylon diagonal brace was found to be loose in the pylon structure. The report said, "The aft diagonal-brace fuse pin is normally retained by both a primary retainer (two washer-like retainer caps and a through bolt) and a secondary retention clip (a bolt-on C-shaped bracket). ... The day after the accident ... a set of diagonal brace fuse-pin primary and secondary retainers had been found in the NWA maintenance facility in an unmarked white cloth bag."

Northwest Airlines Boeing 747's No. 1 engine and pylon rotated downward during the landing roll-out. The lower forward part of the engine cowling was ground away by dragging on the runway.

some point during the 14 flights, and the upper-link fuse pin failed in overload during roll-out at Narita."

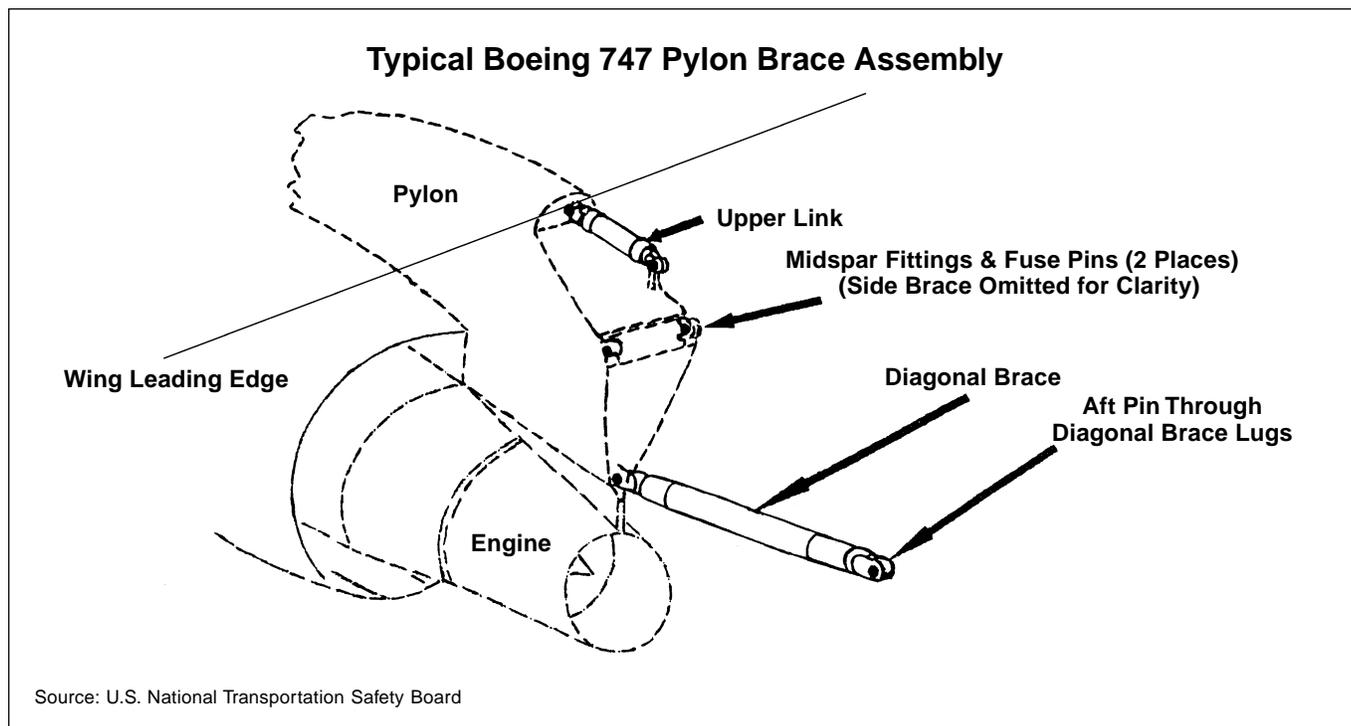
Figure 1

The accident airplane was placed in the NWA maintenance facility to undergo a scheduled nondestructive testing (NDT) inspection of the diagonal brace lugs (Figure 1) and other work in the No. 1 and No. 4 engine pylons, as part of what was known as a “C” check. Mechanics were assigned to open the strut aft fairing doors and prepare the diagonal brace and other components for inspection.
