## Captain Rejects Takeoff as Boeing 747 Veers off Slippery Runway

*The airline's flight attendant procedures did not provide adequate guidance to flight attendants on how to coordinate their actions during and after the impact sequence, the official U.S. report said.*

The final report of the U.S. National Transportation Safety Board (NTSB) said that the probable cause of the accident to Tower Air Flight 41 "was the captain's failure to reject the takeoff in a timely manner when excessive nosewheel steering tiller inputs resulted in a loss of directional control on a slippery runway."

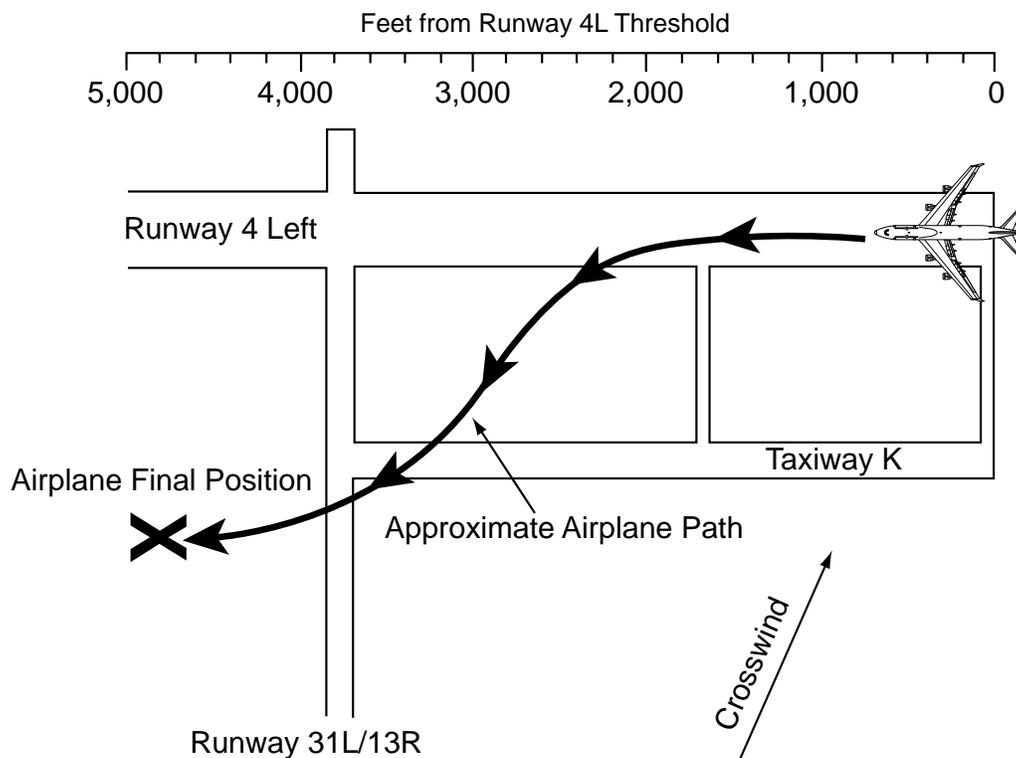
Figure 1

The captain rejected the takeoff, and the airplane went off the left side of the runway and continued for a short distance. The airplane came to rest approximately 1,464 meters (4,800 feet) from the runway threshold and 183 meters (600 feet) left of the runway centerline (Figure 1, page 3). One cabin crew member was seriously injured, and 24 passengers received minor injuries in the Dec. 20, 1995, accident. The airplane sustained substantial damage and was declared a total loss.

The captain said that he knew where the runway centerline was, “but he was unable to control the direction of movement,” the report said. “The captain said that while the airplane was still on the runway with the veer and drift to the left increasing, he applied full right rudder and nosewheel steering tiller. He said that he then retarded the power levers to idle and applied maximum braking. He said that he intentionally did not use reverse thrust because of the airplane’s slow speed at the time of the abort, the long runway and the possibility that reverse thrust could have worsened directional control. The airplane then departed the left side of the runway.”

### Path of Tower Air Boeing 747 Following Rejected Takeoff, Dec. 20, 1995

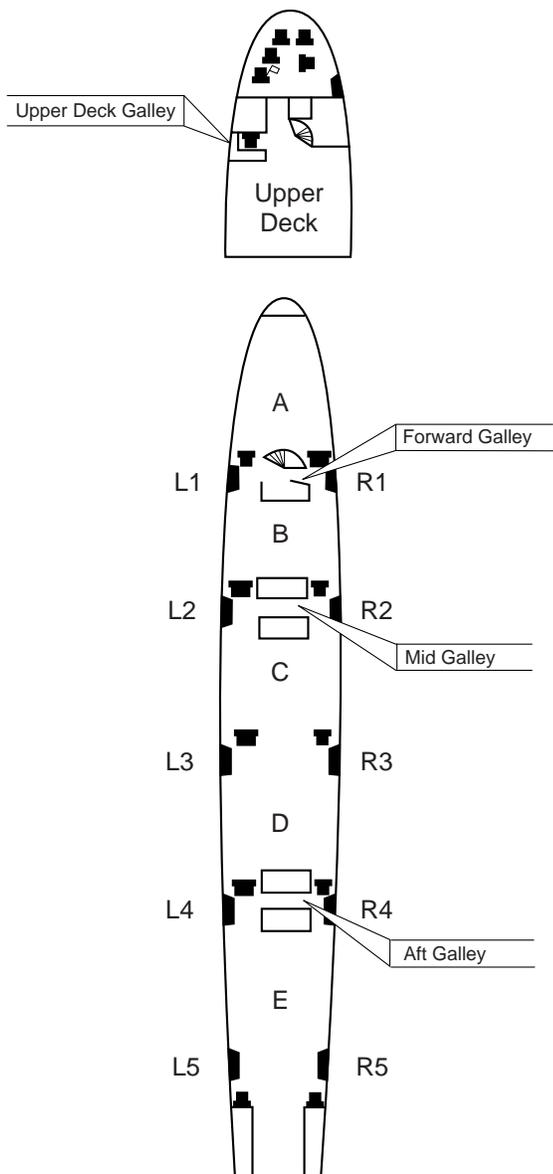
**Figure 2**

A flight attendant who was seated in the aft-facing jumpseat at door R4 (Figure 2, page 4) sensed, at the beginning of the takeoff and during the ensuing accident sequence, “movement toward the right side of the runway with a skidding sensation,” the report said. “Later, she heard ‘crunching, tearing’ noises, and saw the no. 4 engine skidding down the runway before the airplane stopped. She recalled that while the airplane was still moving, many overhead bins opened and spilled their contents. The larger side bins in the cabin nearby also opened and spilled even more debris.”

## Cabin Layout, Boeing 747, Tower Air Flight 41, Dec. 20, 1995

saw an ice cart and a beverage cart come loose,” the report said. “The ice cart hit her right shoulder, and she suffered a broken right shoulder. The ice cart continued to move forward and stopped upright in front of the empty passenger seats across from her jumpseat. The loose beverage cart hit the ice cart and then came to rest tilted against the seats, blocking the R4 exit.”

Investigators reviewed the security of service carts, galley containers, drawers and other galley items that were not contained during the accident sequence. “The most serious breach of galley security occurred in the aft galley complex, between the R4 and L4 exits [Figure 2, page 4],” the report said. “The two carts that came loose injured the R4 flight attendant and blocked the R4 exit.”

The NTSB recommended that the FAA "develop certification standards for the installation of secondary galley latches ... on all transport-category aircraft," the report said. "Further, the FAA should require changes to existing installations as necessary to ensure that the strength of secondary latches and their installation are sufficient to adequately restrain carts."
