## Boeing 737 Postmaintenance Test Flight Encounters Uncommanded Roll-and-yaw Oscillations

*Fluid leaking from the cabin onto the yaw-damper coupler in the electronic-and-equipment bay affected electronic signals transmitted to the yaw-damper actuator and caused a dutch-roll oscillation.*

FSF Editorial Staff

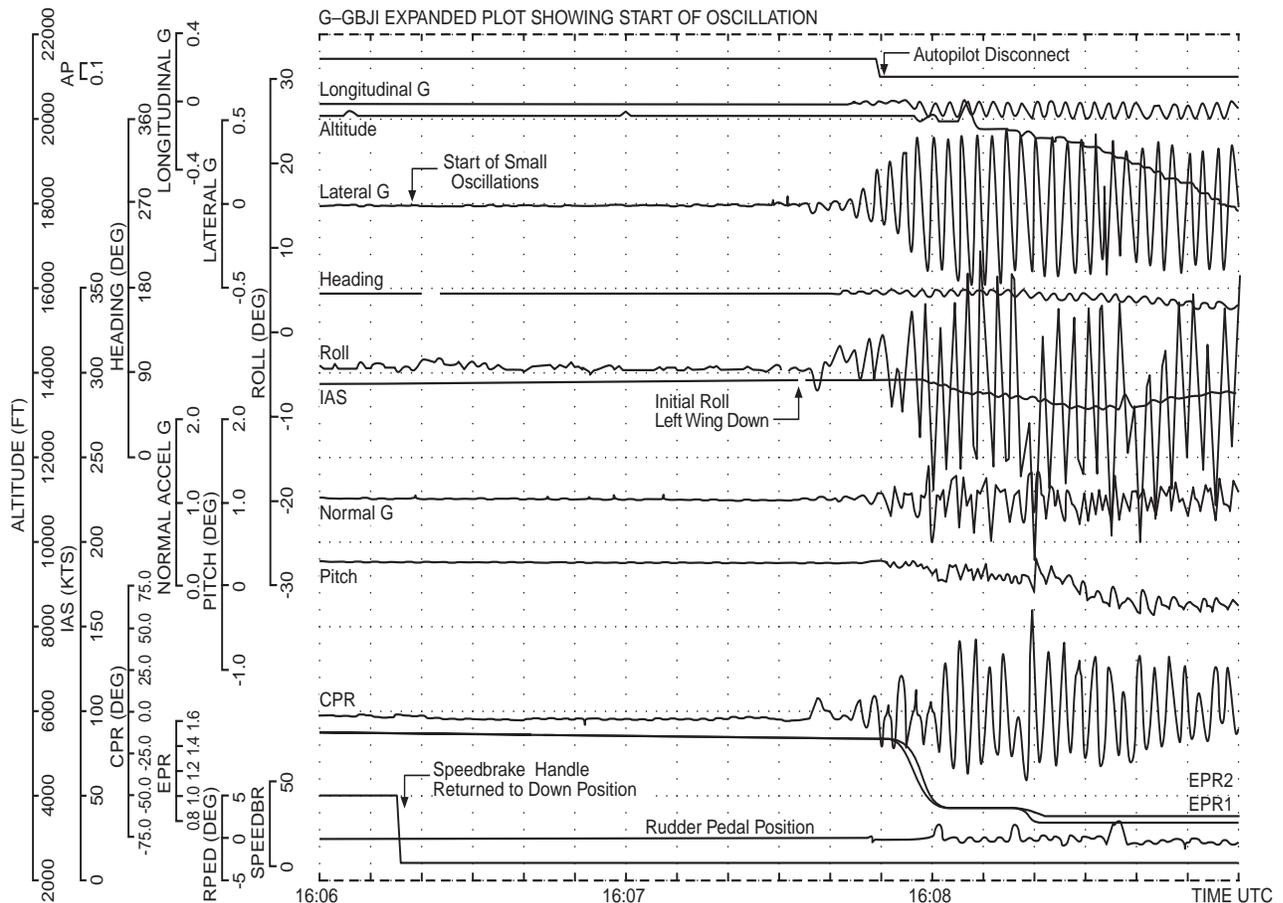
Figure 1

The report said that roll-and-yaw oscillations then began (Figure 1 and Figure 2, page 4). The oscillations became larger in amplitude for the next 15 seconds.

### Flight Data Recorder Plot Showing Start of Roll-and-yaw Oscillations, British Airways B-737, Oct. 22, 1995

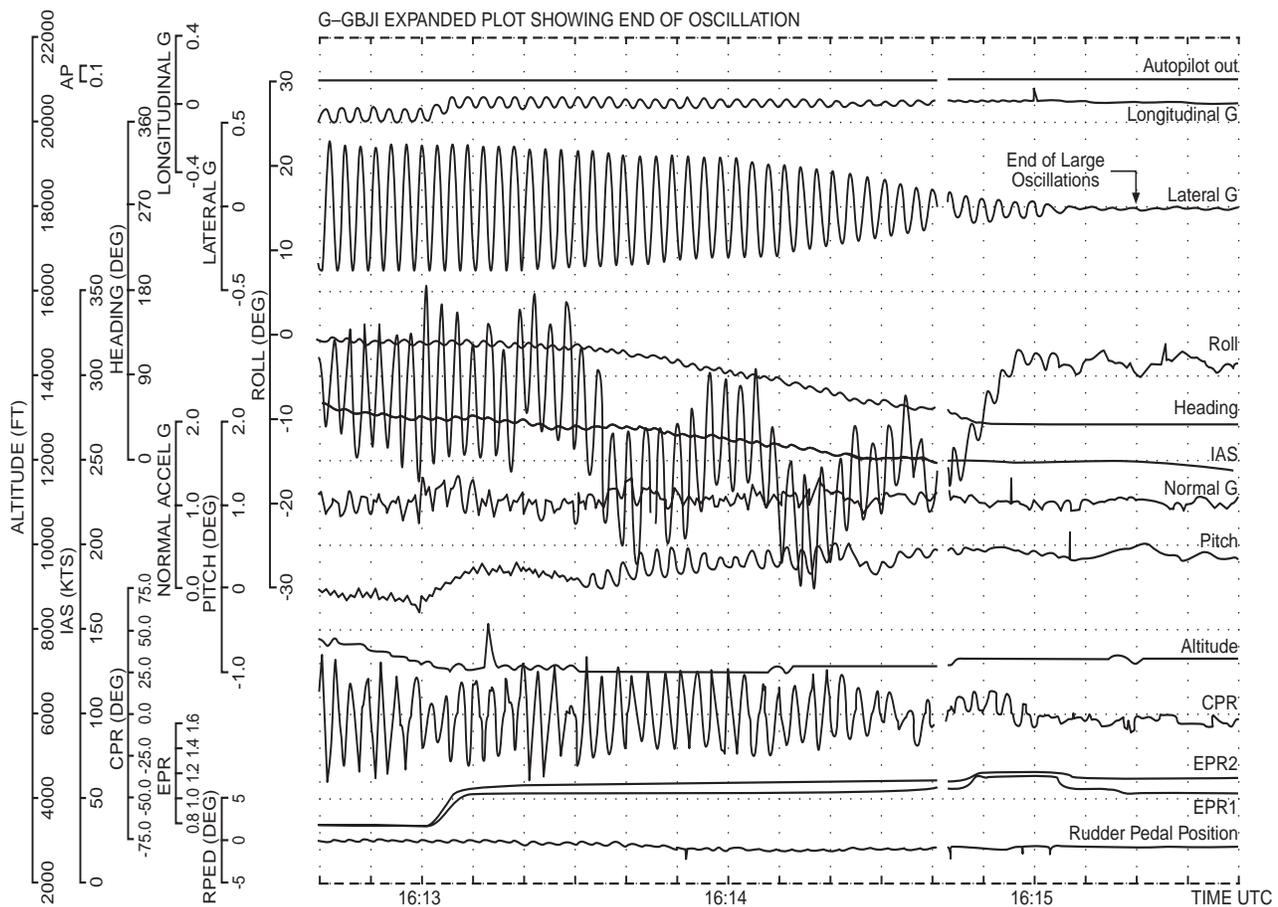
**Figure 2**

## Flight Data Recorder Plot Showing End of Roll-and-yaw Oscillations, British Airways B-737, Oct. 22, 1995

“Some power was reapplied once the aircraft had leveled off, and the airspeed was allowed to decay towards 250 knots,” said the report. “As the aircraft approached this speed, the oscillations began to decay rapidly and [then] stopped. The total duration of the roll/yaw event was about seven minutes.”

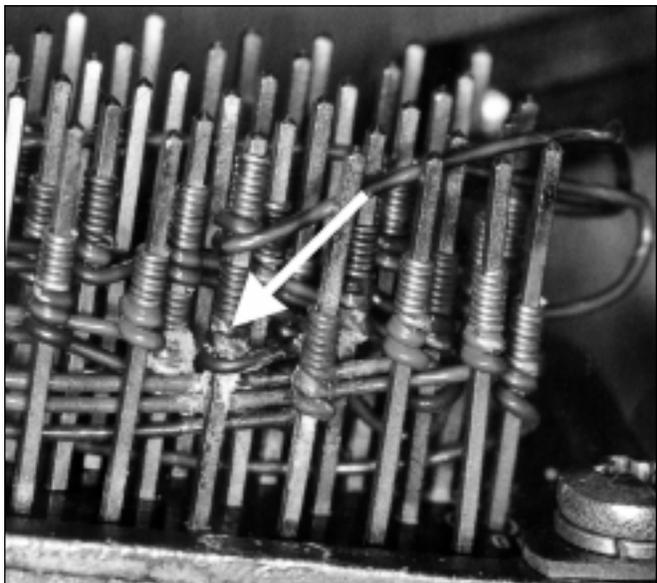
*Contamination and corrosion deposits on yaw-damper coupler disrupted electronic signals sent to yaw-damper actuator.* (Photo: U.K. Air Accidents Investigation Branch)

“Contamination [and] corrosion deposits were found on the back of the multipin connector inside the [yaw-damper coupler],” said the report. “This took the form of bluish white, powdery deposits around some of the wire-wrapped connections to the back of the pins. Closer inspection also showed evidence of light grey deposits on the outside of the connector shell.

“These observations, which pointed toward moisture impingement on the outside of the connector and subsequent ingress into the unit, were reinforced when the lower cover plate for the unit was examined and signs of dried-fluid residue were seen on its inner face.”

The moisture contamination created electrically conductive paths between pins on the yaw-damper-coupler connector. The contamination disrupted electronic signals sent from the yaw-damper coupler to the yaw-damper actuator and may have prevented the flight crew from turning off the yaw damper, said the report.

“Notwithstanding this, [the aircraft] operator has developed a modification which puts an aluminum tray between the plenum and the shroud,” said the report. “[The tray] completely covers the forward face of the E1 rack, thus preventing any fluid which penetrates the shroud from dripping onto the connectors.

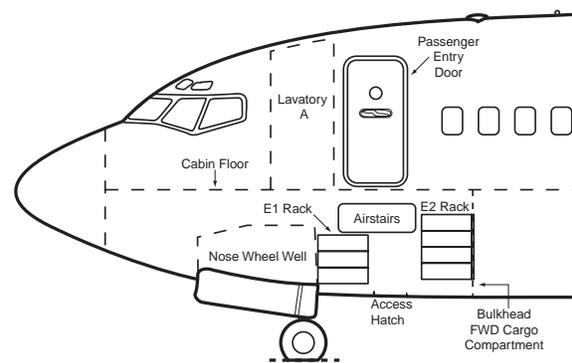
**Figure 3**

The E&E bay is in the forward section of the aircraft, between the nose-wheel well and the forward cargo compartment (Figure 3). The bay is below the passenger-door vestibule, the galley and the forward toilets. The retracted airstairs are stowed between three equipment racks. The bay has a fiberglass tray and a rubberized-fabric shroud to protect the equipment racks

from moisture. The yaw-damper coupler is on the forward (E1) equipment rack.

“It would appear that for any fluid leak to drip onto the subject connector, it is necessary to penetrate the rubberized-fabric shroud which is fitted above it. Once through this, [fluid] may drip onto the [avionics] cooling plenum, whose forward lip coincides with the array of connectors at the back of each unit on the E1 rack, particularly the [connectors for the] yaw-damper coupler, which is at the top [of the rack].”
