## Fatal Commuter Crash Blamed on Visual Illusion, Lack of Cockpit Coordination

*On a night visual approach to a northern Canadian airport, the crew failed to adequately monitor the aircraft's altitude. The captain's visual range was also restricted by his seating position.*

## ACCIDENT PREVENTION

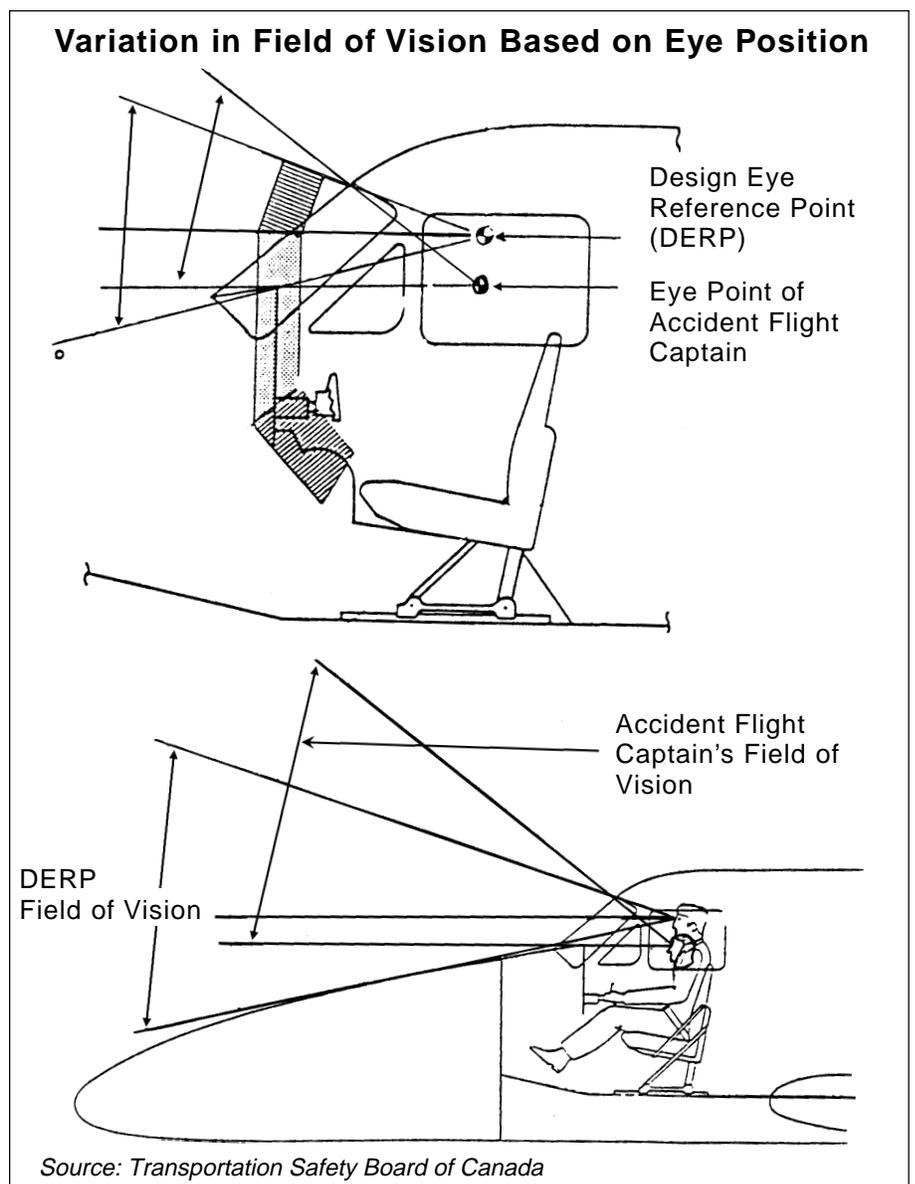
Figure 1

height and in certain seat adjustment positions. The report said that each aircraft cockpit has a design eye reference point (DERP) position that allows maximum cockpit visibility (Figure 1).

“The cockpit visibility in this type of aircraft can be limited because of the interface between height and fore/aft position of the pilot’s eyes, height of the glareshield and control column location and movement,” the TSB report said. “Without clear reference or guidance regarding where to position oneself in order to optimize external visibility, it is possible to position oneself where one cannot see anything outside the aircraft that is below the horizon.”

According to the report, the captain was seated in a position to “facilitate instrument flying, which was clearly at the expense of external visibility.”

The TSB concluded: "The fact that there is a design eye position that guarantees certain fields of visibility, but which cannot be achieved for a pilot the size of the [accident] captain because of cockpit layout and control interference is a problem in this type of aircraft.

"The captain on this flight was unable to adjust his seat to achieve the DERP and, therefore, was unable to see anything below the nose of the aircraft without either leaning forward and/or stretching or by lowering the nose, thereby introducing a descent.

"Measuring the captain in the C99 seat position he used during the accident flight and later repositioning him to achieve the DERP resulted in two specific findings. First, in order for him to see the runway lights, from breakout below the cloud to impact, as he indicated, the aircraft would have had to be in, and continued to be in, a descent. Second, he could not achieve the DERP because the seat could not be elevated high enough."

Based on its investigation, the TSB recommended that the Department of Transport provide guidance to air carriers in setting up crew-pairing plans, encourage the continuing implementation of crew resource management and human factors training and take steps to ensure that "pilots receive appropriate guidance for positioning their eyes at or close to the DERP."
